11590 Långtidsexponering av betong i marin miljö - utvärdering

**Evaluation of Chloride-Induced
Corrosion of Steel in Concrete
after Long-Time Exposure in a
Marine Environment**

SP Report 2005:54
Building technology and Mechanics
Borås 2005

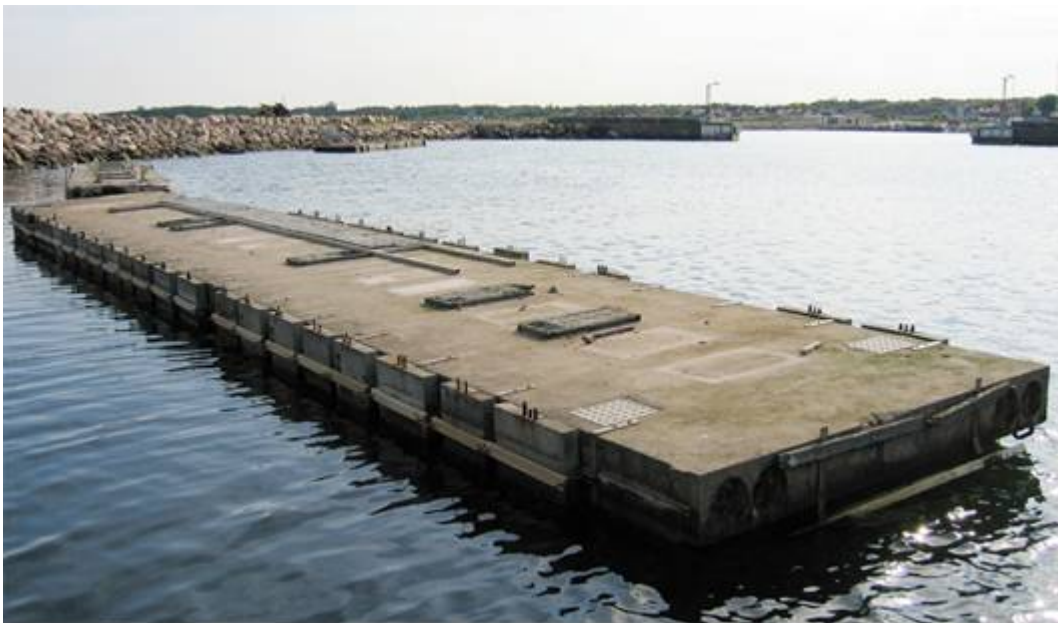
The field exposure site is situated in Träslövsläge harbour in the south western part of Sweden, 80 km south of Gothenburg. Three pontoons are placed behind a pier in the harbour (figure 1). Since 1991 a large number of specimens from different projects have been placed on top and on the sides of the concrete pontoons. The specimens investigated in this project were cast during the winter 1991/1992, and were placed at the earliest one week and at the latest one month after casting. In total there are around 40 concrete qualities (different binders, w/b-ratio and air contents) at the test site. Information about the concrete qualities can be found in [2]. The test specimens are slabs (height 100 cm, width 70 cm, thickness 10-20 cm). The panels are reinforced with rebar with different covers, between 10 – 30 mm.

Figure 1 – Swedish field site at the Träslövsläge Harbour, Varberg.

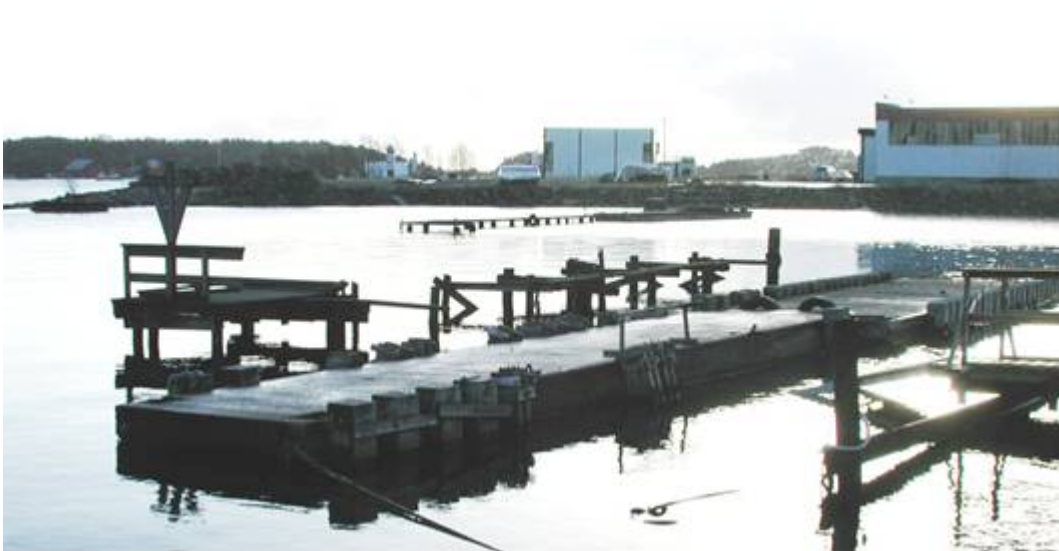
The exposure facility, a concrete pontoon with samples attached along the sides, was located at the end of the main wharf of Elkem's Fiskaa smelting plant, in an exposed marine situation (figure 2). After a few years, the pontoon was moved a little to the east, and remained here for a few more years. Because of the wear and tear, the pontoon was eventually moved to the north end of the main wharf, where it remains today. It can be mentioned that the Norwegian Road Directorate has established their own pontoon for testing of concrete compositions versus chloride ingress, a test that has now been running for 10 years.

Figure 2 – Norwegian field site at the main wharf of Elkem's Fiskaa smelting plant, Kristiansand.

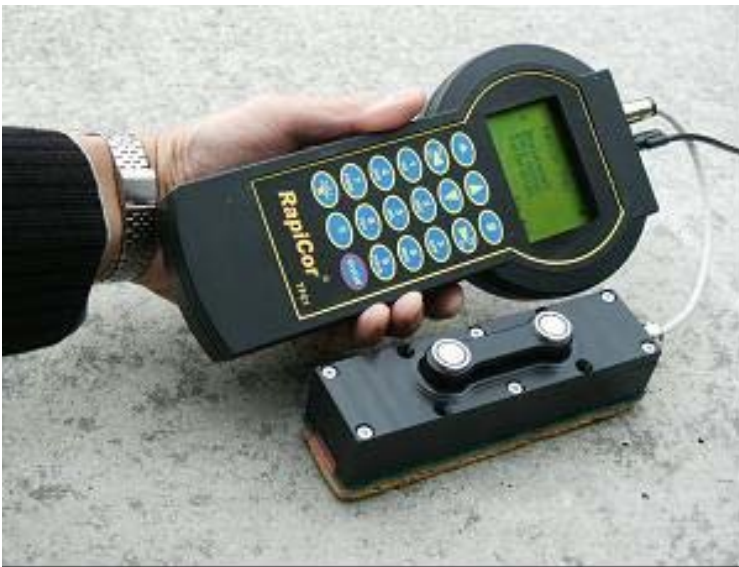
In this project, a handheld instrument RapiCor, which is based on the rapid technique newly developed at SP [9, 10], was used for measurement of corrosion of steel in concrete, see figure 3. The instrument measures half-cell corrosion potential, and then generates two galvanostatic pulses for corrosion rate and resistivity measurements. The measurement is quick and only needs a few seconds to obtain three parameters: corrosion potential, corrosion rate of steel and resistivity of concrete. These three parameters contribute a more accuracy estimation of the corrosion status of steel.

Figure 3 – Newly developed handheld instrument.

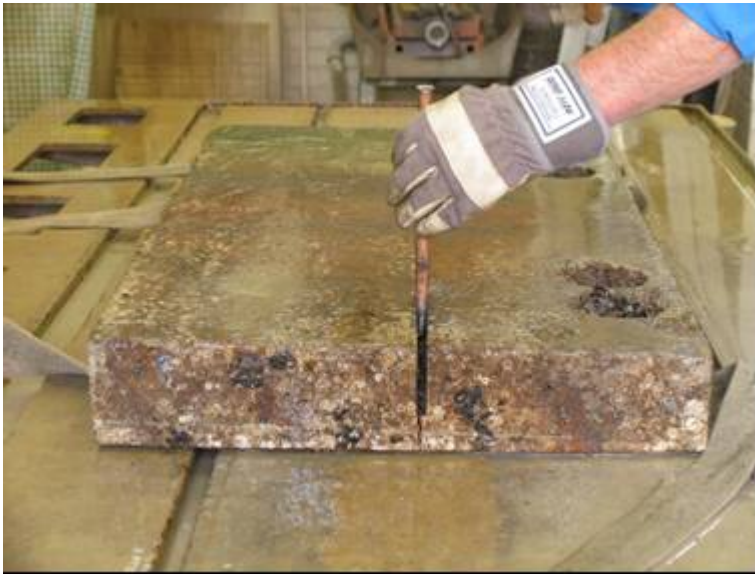
These five slabs were taken from the field site and covered with thick plastic sheet, and transported to SP's laboratory, where the corrosion measurements were carried out twice with an interval of five days, at the positions with an interval of 10 cm from the top edge of the slab, as shown in figure 5, right side. The measurement results are listed in Appendix 2. After the second measurement, a groove along each rebar was cut from the backside of the slab, so as to facilitate the release of rebar for visual examination in order to verify the non-destructive measurement, see figure 6.

Figure 6 – Release of steel bars for visual examination.

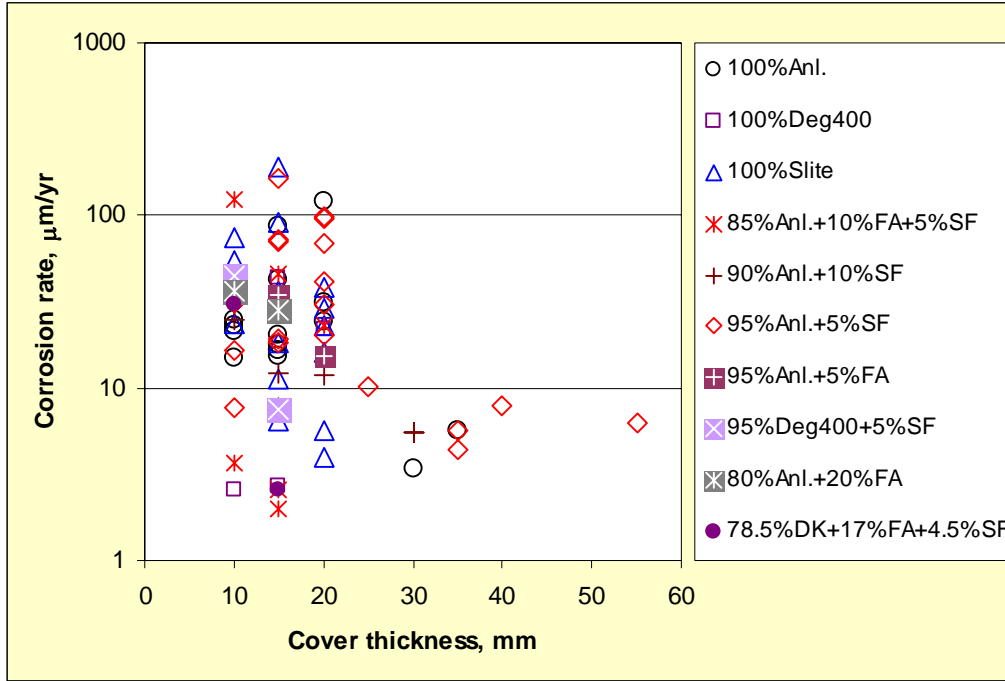
Based on the visual examination of the steel bars from the five selected slabs, it has been verified that the non-destructive RapiCor technique gives satisfactory estimation of corrosion, as will be presented in the next chapter. Therefore, it was decided to use this technique for the rest of slabs exposed in the Träslövsläge field site. In this case, the slabs were lifted up and the measurement was carried out at the positions as shown in figure 5, right side. The measurement results are listed in Appendix 3. The values of maximum corrosion rate on each steel bar are summarised in figures 8 and 9. It seems not clear to find the effect of water-binder ratio and type of binder on corrosion rate, due to the fact that the poor interface between concrete and distance spacer resulted in early corrosion. On the other hand, the corrosion rate was found relatively low when cover thickness is

larger than 30 mm. Therefore, as general conclusions, thicker cover is an effective way to protect the steel from corrosion.

Figure 8 – Summary of corrosion rate in concrete with different types of binder.

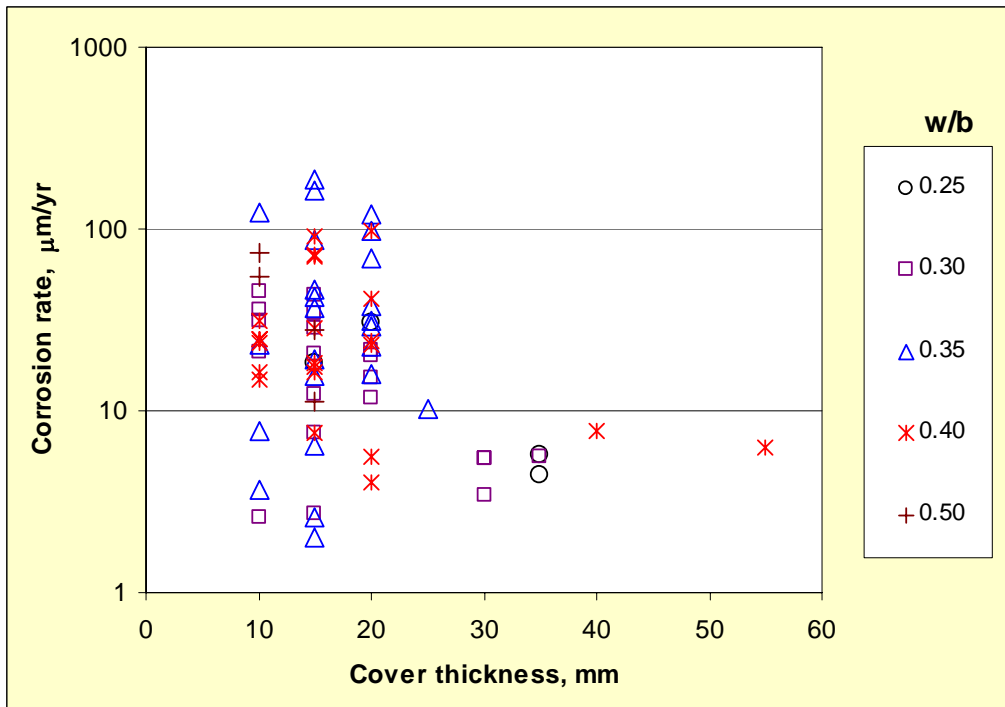
Figure 9 – Summary of corrosion rate in concrete with different water-binder ratios.

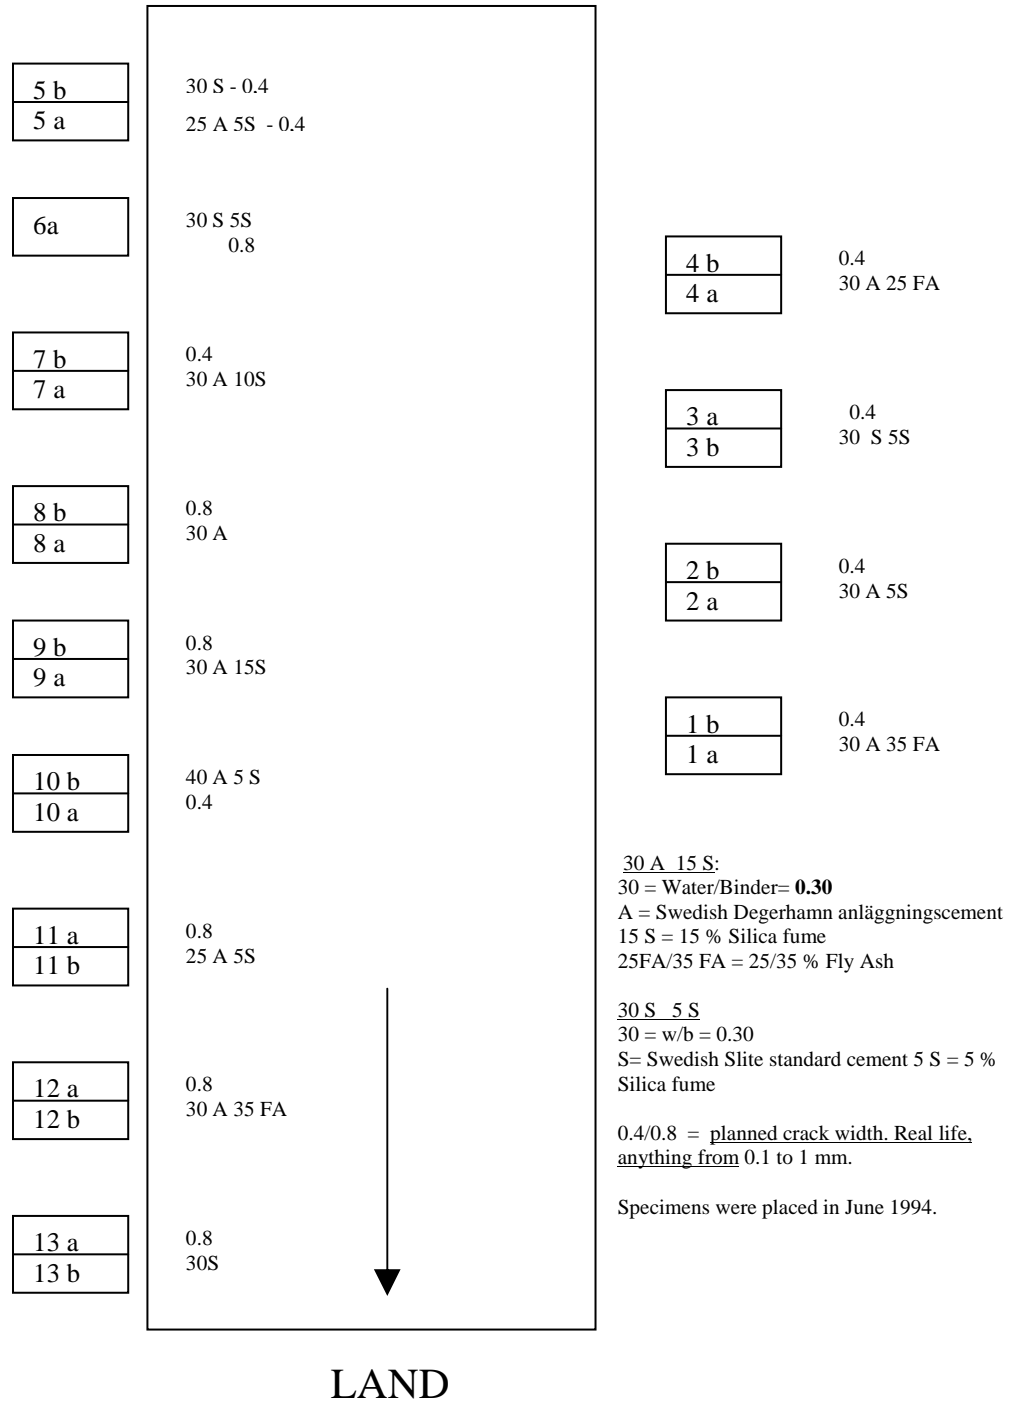
There were totally 25 slabs of size 1000×400×100 mm exposed at the Kristiansand field site, but two of them (Slabs 2a and 2b) were dropped in the deep water. The mixture proportions of concrete are summarised in Table 3. Figure 10 shows the positions of the concrete slabs around the pontoon. The slabs were intentionally cracked by tightening two slabs back-to-back with bolts in such a way as shown in figure 11. Similar to the measurement carried out at the Träslövsläge field site, the slabs were lifted up and the measurement was carried out at the similar positions as shown in figure 5, right side. The results are listed in Appendix 4

Figure 10 – Schematic of concrete slabs at the Kristiansand field site.

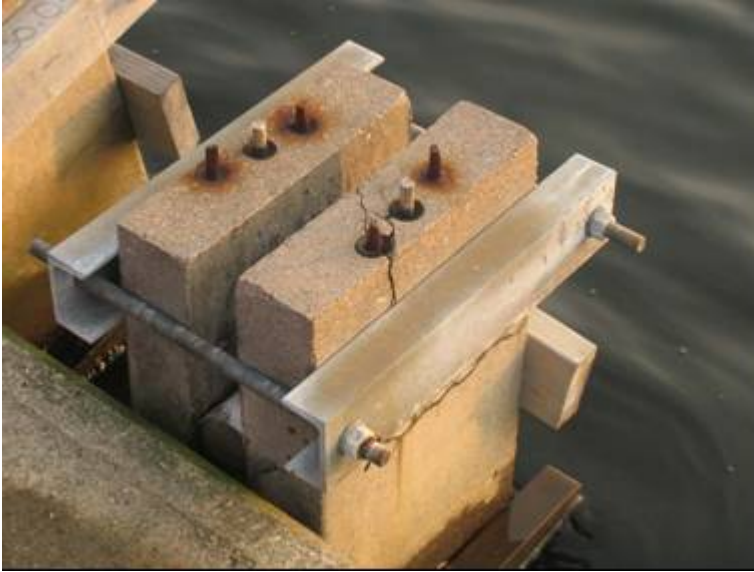
Figure 11 – Intentional cracks in the slabs at the Kristiansand field site.

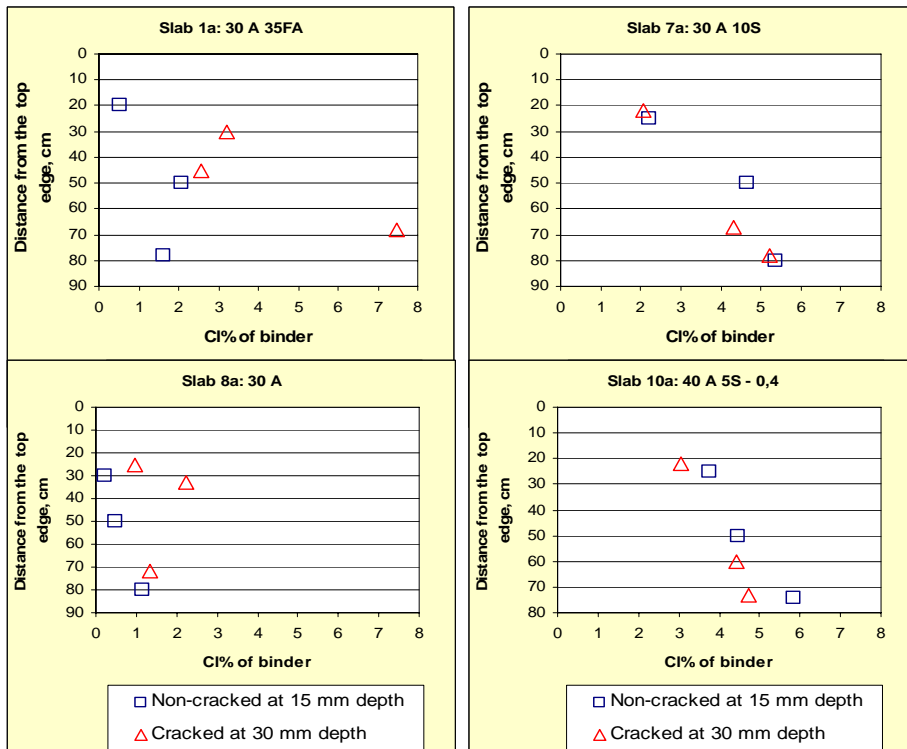
The results of chloride content measured at the cover level measured from the Träslövsläge slabs are summarised in figure 14 and those from the Kristiansand slabs are summarised in figure 15. It can be seen from figure 14 that the chloride content under the water level is normally over 1% by mass of binder, except for one point in the fly ash concrete H8 at cover 15 mm. The chloride content in the Kristiansand slabs is in general higher than in the Träslövsläge slabs. The higher salt concentration in the Kristiansand seawater is one reason while the cracks introduced in the Kristiansand slabs can be another reason for the higher chloride content as shown in figure 15.

Figure 15 – Results of chloride content measured at the cover level from the Kristiansand slabs.

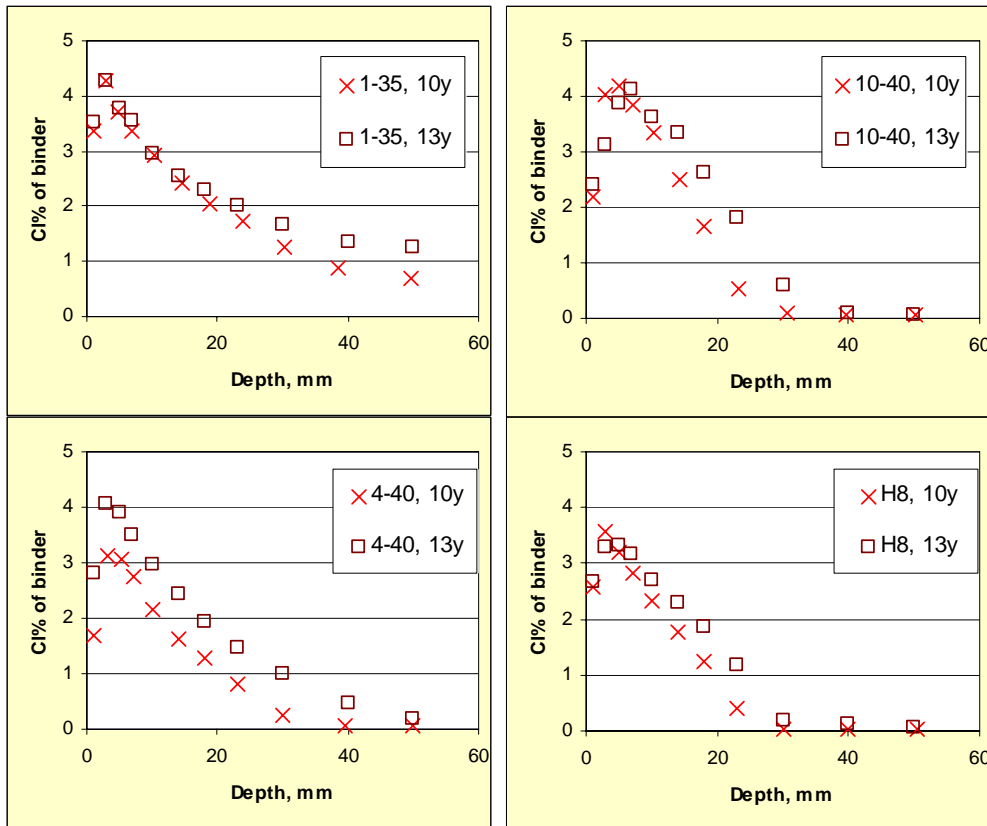
Figure 17 – Chloride penetration profiles measured after 10 and 13 years' exposure.

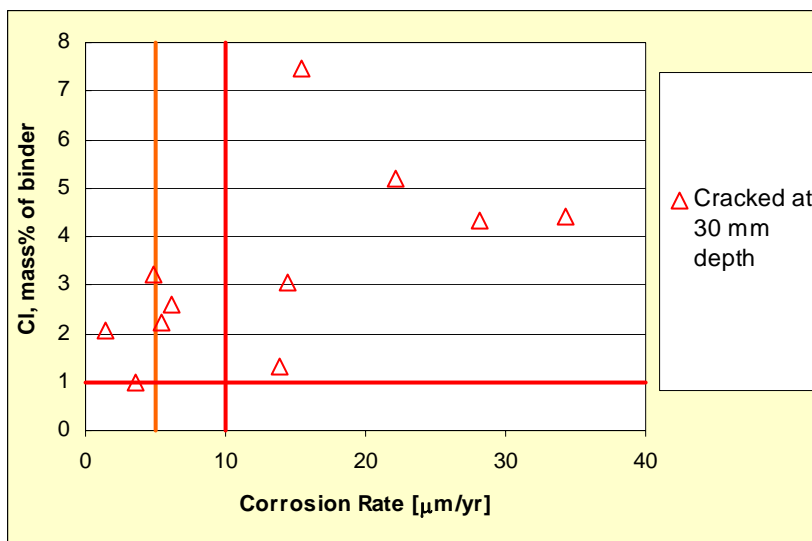
Some relationships between corrosion parameters and chloride content are shown in figures 18 and 19. Figure 18b shows that, the criteria for actual high corrosion are always related to chloride content $\geq 1\%$ by mass of binder, despite of the types of binder. However, without destructive visual examination, it seems difficult to find clear relationships between half-cell potential or resistivity and chloride content (see figure 18 a). On the other hand, the relationship between corrosion rate and chloride content seems clearer, that is, the measured high corrosion rate is in most cases correlated to high chloride content, see figure 18a, the middle diagram. It is understandable that high chloride content may not necessarily mean high corrosion rate, but high corrosion rate should be caused by higher chloride content with regard to chloride-induced corrosion. This indicates that the non-destructive corrosion rate measurement is the most reliable parameter, while the half-cell potential and resistivity can be used as complementary parameters in the assessment of corrosion status, in supporting to the findings reported in [13]. The results from the Kristiansand slabs in figure 19 also confirmed the relationship between corrosion rate and chloride content.

Figure 19 – Relationship between corrosion rate and chloride content (Kristiansand slabs).

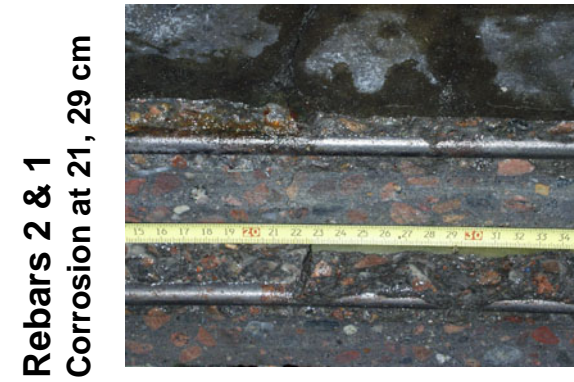
Rebars 2 & 1
Corrosion at 21, 29 cm

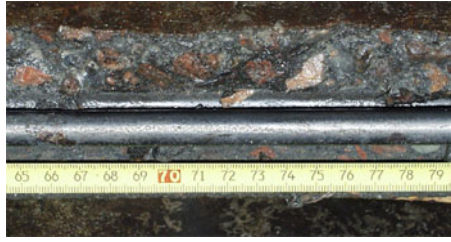
Rebar 1
Corrosion at 66, 78 cm

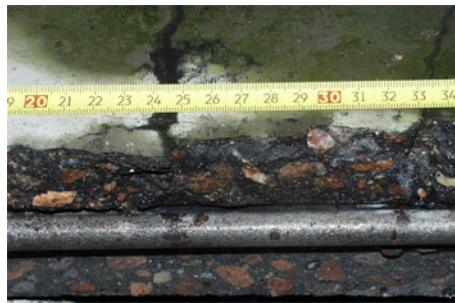
Corrosion at 24, 33 cm
