Licentiate Thesis in Civil and Architectural Engineering

Concrete pavements' repair techniques and numerical assessment of dowel bar load transfer efficiency

SAIMA YAQOOB

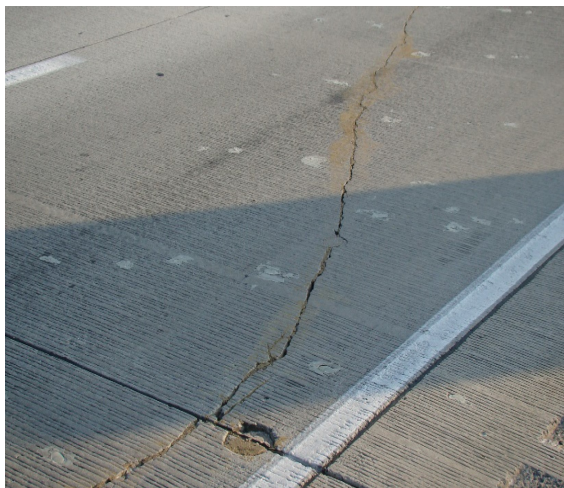
Figure 2.1: Longitudinal cracking crossing the transverse joint in JPCP (Harrington et al., 2018).

Longitudinal cracking in concrete pavement refers to cracks that develop parallel to the direction of traffic flow; see Figures 2.1 and 2.2. Several factors can lead to longitudinal cracks, i.e., frost heave, erosion, timing of joint saw cuts (too early or too late), depth of joint sawing, joint failures, imposed traffic loading, heavy number of load repetitions and environmental loading.

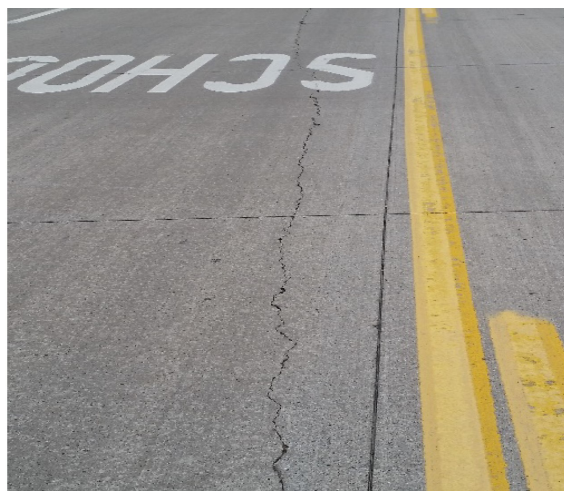
Figure 2.2: Longitudinal cracking due to delayed sawing in JPCP (Harrington et al., 2018).

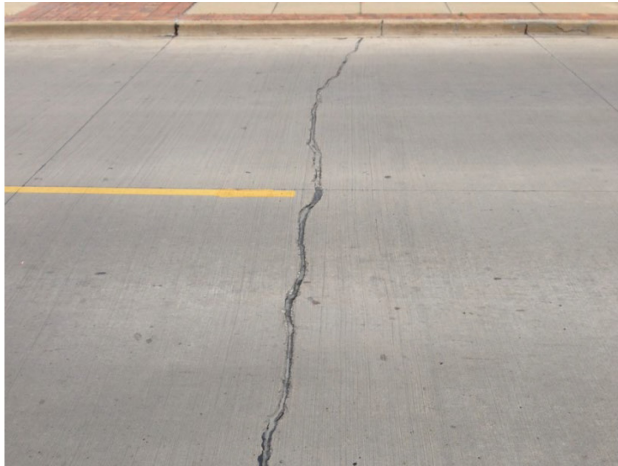
Figure 2.3: Illustration of transverse cracks on JPCP (Harrington et al., 2018).

Cracks oriented perpendicular to the pavement centreline are known as transverse cracking; see Figure 2.3. These cracks form due to temperature variations, shrinkage, inadequate slab thickness and saw cut depth, the timing of joint saw

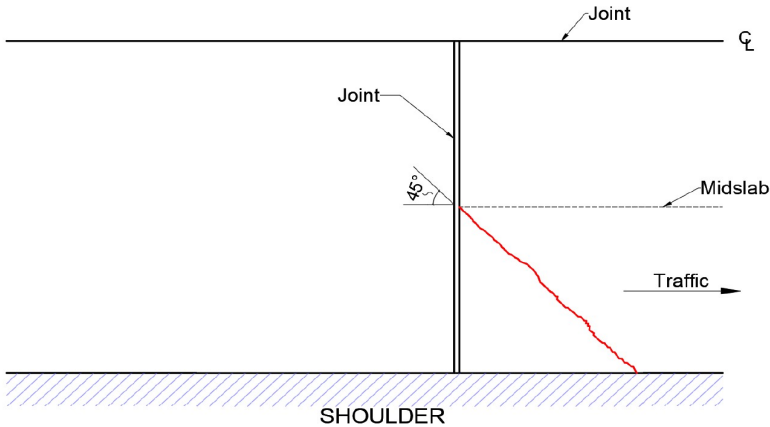
Figure 2.4: An illustration of corner cracking redrawn from Miller et al. (2014).

A corner break or corner cracking is a crack that intersects the adjoining joints (i.e., the longitudinal and transverse joint at an angle of approximately 45°) along the traffic direction. Each side must be at least 300 mm (12 inches) long and can extend to half the width of the slab; see Figure 2.4. Corner cracking occurs due to shrinkage, erosion, pumping, poor load transfer at the transverse joint and joint lockup; for details, see Shahin (2009) and Harrington et al. (2018). Corner cracking is quantified by counting the number of existing cracks. A photo of corner cracking in a concrete pavement is presented in Figure 2.5.

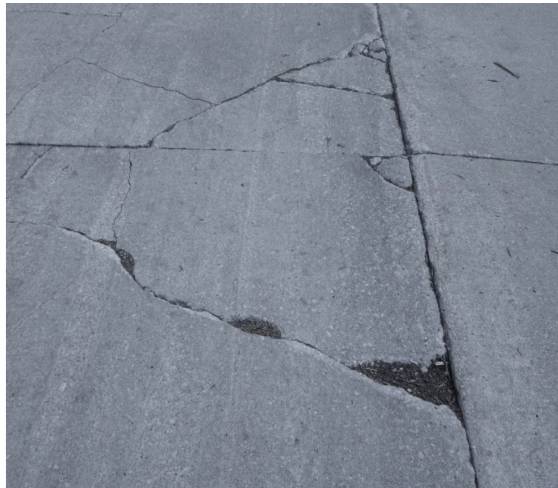
Figure 2.5: Corner cracks in concrete pavement (National Concrete Pavement Technology Center (used with permission)).

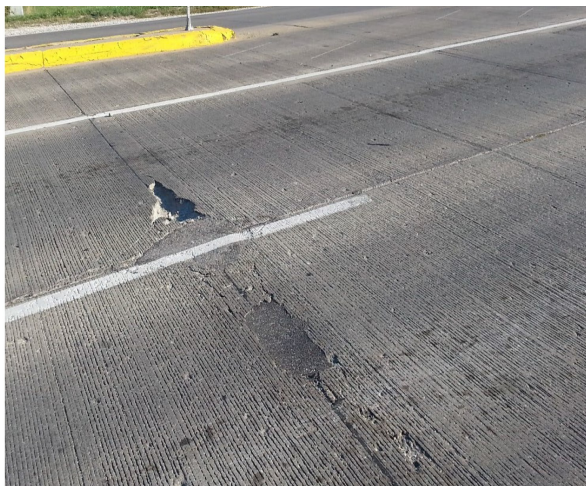
Figure 2.7: *Spalling from heavy loads (Harrington et al., 2018).*

Figures 2.6, 2.7 and 2.8 present the spalling due to the incompressible joint damage, heavy loads and misaligned dowel bar, respectively.

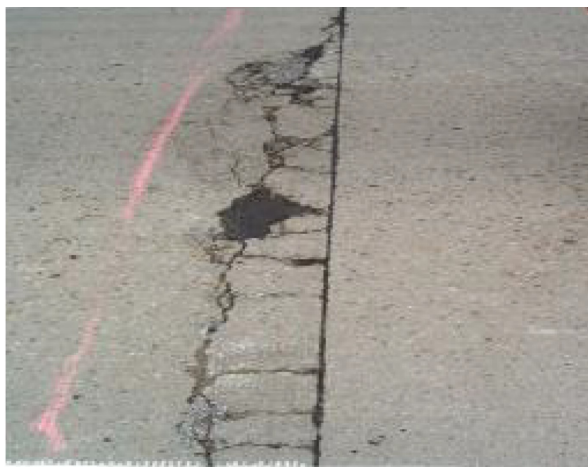
Figure 2.8: *Spalling due to misaligned dowel bar (Harrington et al., 2018).*

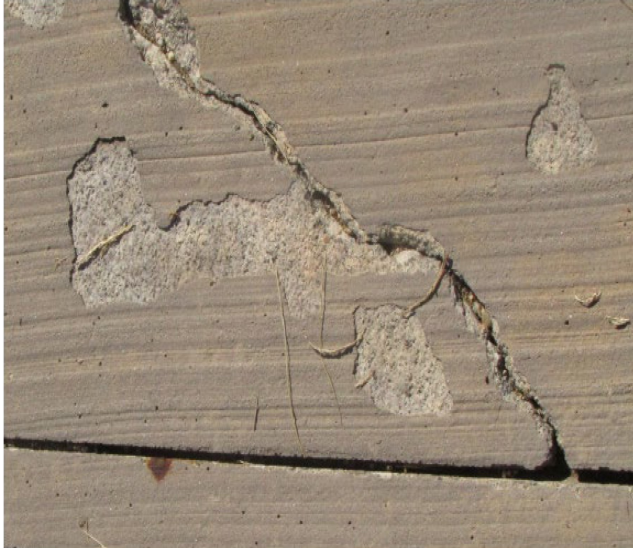
Figure 2.9: *Scaling (National Concrete Pavement Technology Center (used with permission)).*

Scaling is the flaking of hardened concrete surfaces, as shown in Figure 2.9. It typically occurs on the upper surface of the concrete slab and can vary in thickness, ranging between 3 mm and 13 mm. Scaling can manifest at various locations across the pavement's top layer. Typically, too little entrained air causes scaling—as adequate air entrainment is required to protect against freezing and thawing damage.

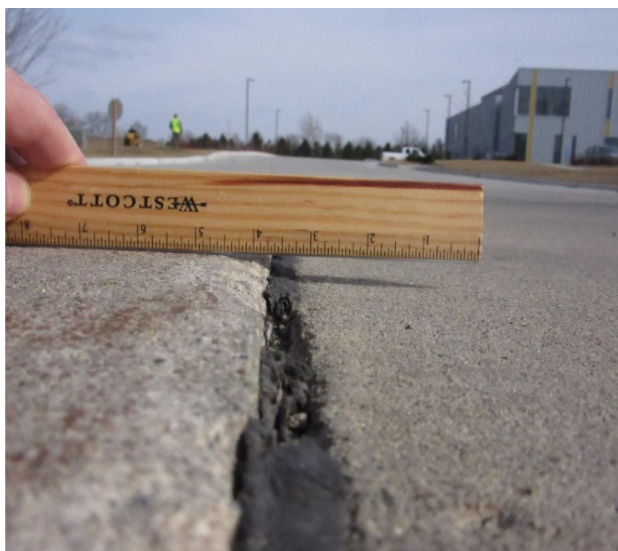
Figure 2.10: *Faulting in JPCP (National Concrete Pavement Technology Center (used with permission)).*

The difference in the elevation between adjacent concrete slabs is known as faulting; see Figure 2.10. Faulting can occur due to the loss of materials under the trailing slab or the settlement of the concrete slab. Additionally, traffic loads and improperly sealed joints can lead to joint faulting - as traffic loads induce cracks and spalling at joints in concrete pavement, while poorly sealed joints provide channels for water intrusion, resulting in the saturation of the underlying layer. According to Khazanovitch et al. (2009), the corroded dowel bar system promotes faulting by diminishing the load transfer capacity between adjacent slabs.

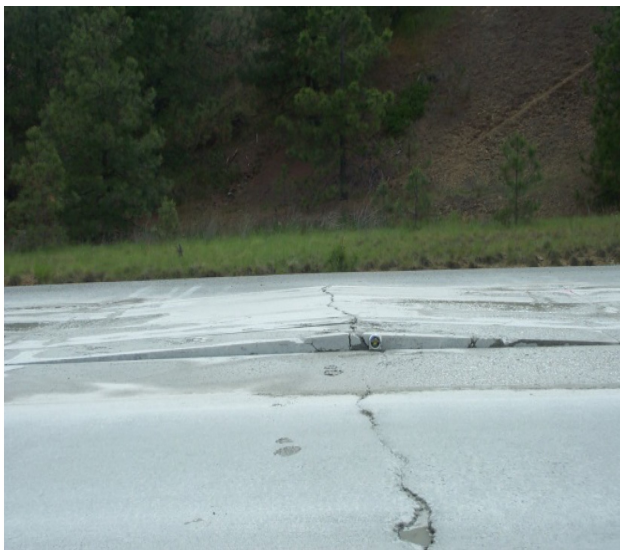
Figure 2.12: *An illustration of blowup in JPCP (Harrington et al., 2018).*

Concrete slabs expand when exposed to high temperatures, and joints in the pavement are designed to accommodate this expansion. During winter, concrete slabs tend to contract, resulting in wider joint gaps. When these gaps are filled with incompressible materials, the subsequent expansion of the concrete slabs during hot weather can generate significant compressive stresses. If these stresses are not relieved, the slab edges can locally move upward, or shattering can occur in the vicinity of joints, a phenomenon known as blowup. The blowup in JPCP is illustrated in Figure 2.12.

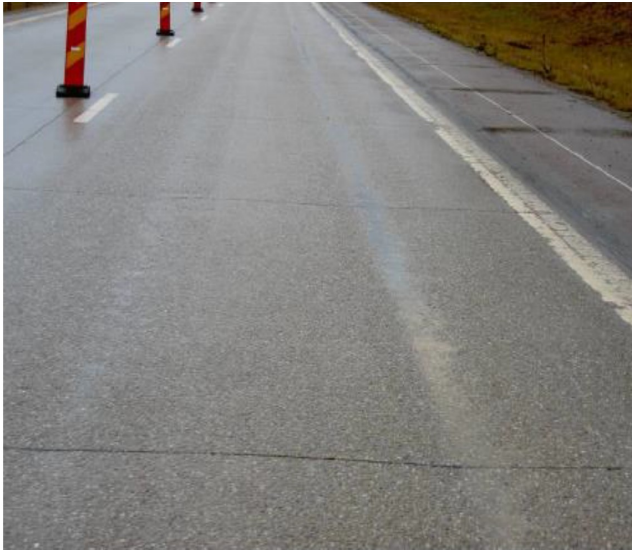
Figure 2.13: Rutting due to studded tires in JPCP used with permission of Ellen Dolk (Hultqvist and Dolk, 2014).

Rutting is the formation of surface depressions or grooves along the wheel path. The primary cause of rutting in concrete pavements is studded tires (Brunette and Lundy, 1996; Cotter and T., 2010). When it rains, the rutted surface poses safety risks, generating a layer of water between the tire and the road surface. Consequently, the vehicle may experience hydroplaning or loss of steering. Additionally, scraping surface materials from studded tires produces dust, contributing to air pollution (Zubeck et al., 2004). An illustration of rutting on JPCP due to studded tires is presented in Figure 2.13.

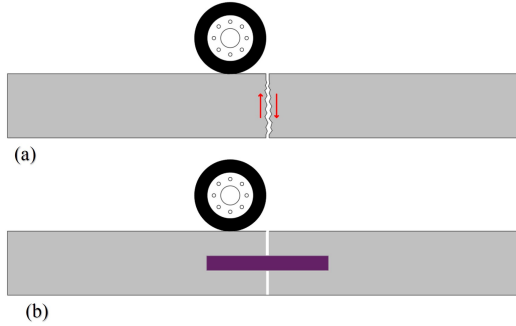
Figure 3.1: Load transfer mechanism in JPCP (a) Aggregate interlocking redrawn from FHWA (2019) (b) Steel dowel bar load transfer system.

In the jointed plain concrete pavement system, the load across the joints can be transferred via aggregate interlocking (the irregular faces of adjacent slabs interlock with each other) or steel dowel bars, see Figure 3.1. The numerical simulation investigated the efficiency of interaction between slabs in terms of load transfer capacity, considering dowel-related parameters.

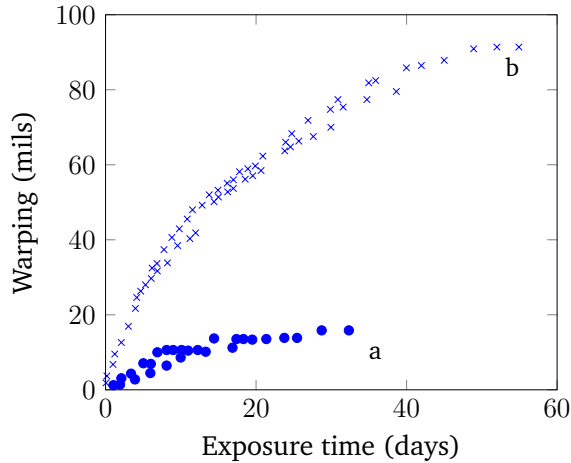
Figure 4.5: Warping uplift measurement for two cases (a) Drying at the top only (b) Drying at the top and wetting at the bottom redrawn from Hansen and Wei (2008), [1 mil=0.0254 mm].

Hansen and Wei (2008) conducted a laboratory test on two concrete beams for each case, imitating the conditions of the existing field slab to measure the influence of uplift. The two cases studied were: (i) drying at the top and bottom with sealing and (ii) drying at the top with saturation at the bottom (water present at the base). Their findings indicated that the uplift was more pronounced in the beam with a saturated bottom; see Figure 4.5.

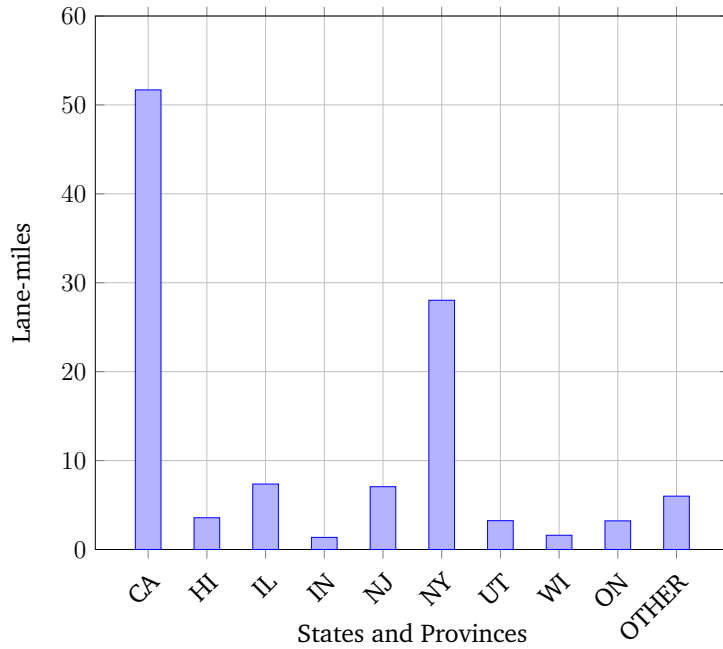
Figure 4.7: Concrete pavement repair with JPrCP in the United States and Canada over 1 lane mile (1.6 lane km) redrawn from Smith and Snyder (2019).

Since 2001, the jointed precast concrete pavement (JPrCP) has been used for more than 113 lane miles (180 lane km), covering approximately 185 projects across 26 states in the United States and two provinces in Canada. Most of these slabs were installed during a nighttime work window of 8 hours or less. However, on some projects, the work duration was limited to five hours, with the work area confined to one lane and an adjacent shoulder. Figures 4.6 and 4.7 illustrate the cumulative use of precast slabs in the United States and Canada through 2018, demonstrating that this technique is the best repair technology for concrete pavements. More details about this technology can be found in Paper II.
