Brandstopp i byggnadskonstruktioner

Resultat från SBUF projekt 12993

Model scale tests with fire stops

SP Rapport 2016:79

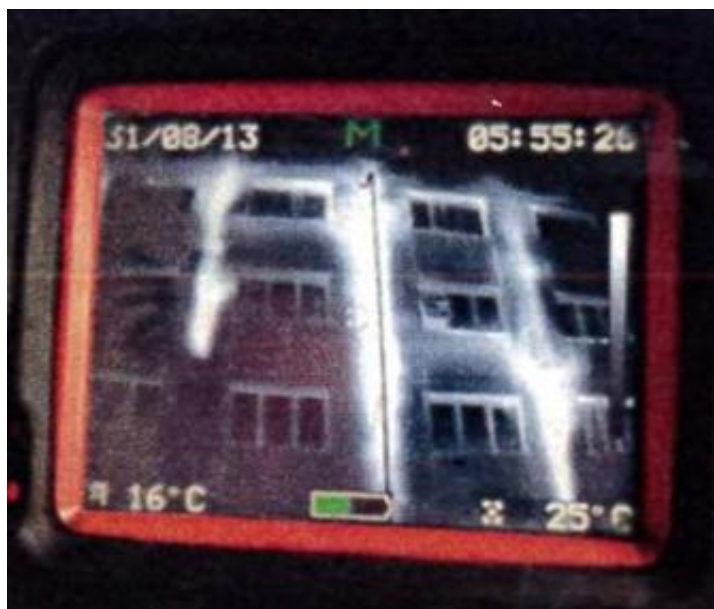
Figur 1. Brandspridning neråt i modulskarvar, bild med IR kamera /3/.

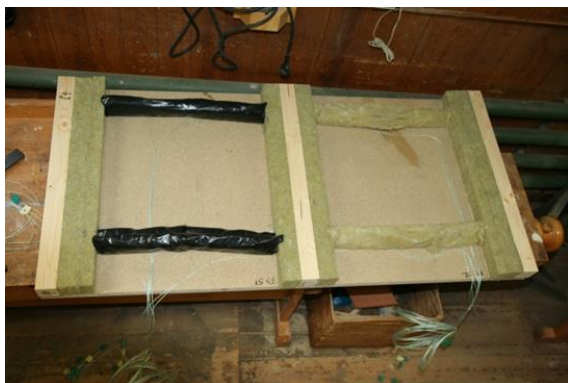
Figur 2. Exempel på provelement för provning av brandstopp i modulkonstruktioner.

Provelementen består av två självstående delar med var sitt hålrum. De innehåller två träreglar (50 x 50 mm) som ger ett hålrum och skyddas av stenull (133 kg/m³), se figur 2 och 3. Denna träram täcktes med gipsskivor (typ F, 15 mm) och spånskivor (11 mm) på hålrummets insida, som fästes med träskruvar (längd 41 mm och diameter 3,0 mm) mot träramen.

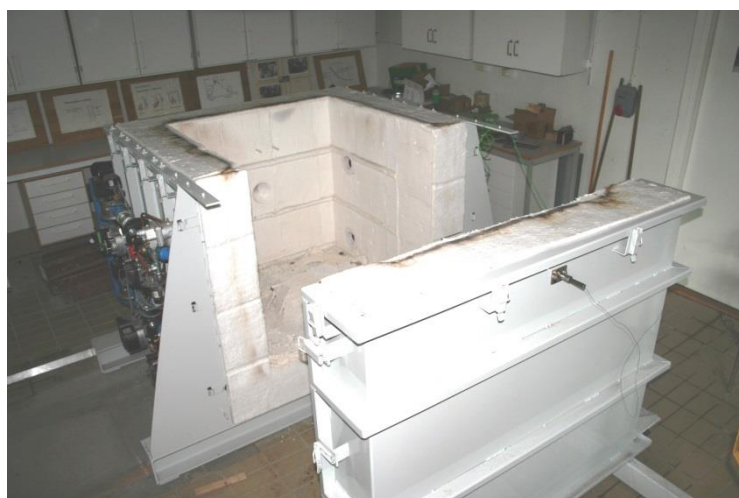
Figur 4. Kubikmetersugn för brandprovning.

Brandstoppen provades i modellskala i en kubikmetersugn, se figur 4. Provelementen placerades över ugnen och brandexponerades underifrån, se figur 5. Alla fogar tätades med stenull och ugnslöcket slöts genom stålramar. Provelementen utsattes för s. k. standardbrand under en timme. Därefter stängdes brännarna, men provelementen fick ligga kvar i ytterligare tre timmar och temperaturmätningar och observationer fortsatte.

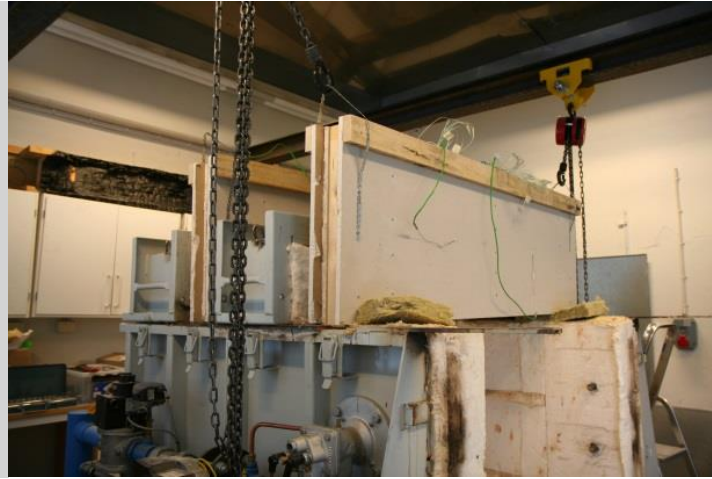
Figur 5. Provelementen placeras över ugnen och brandexponeras underifrån.

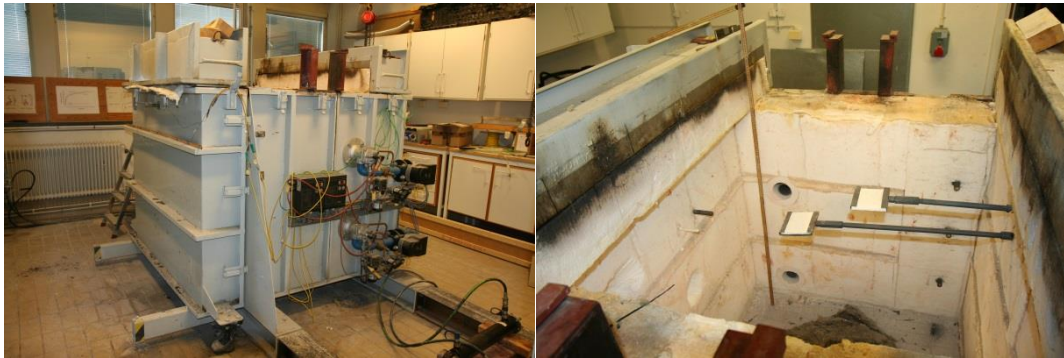
Figure 1. Model scale furnace

Fire tests were conducted at model scale furnace of SP Wood Building Technology.

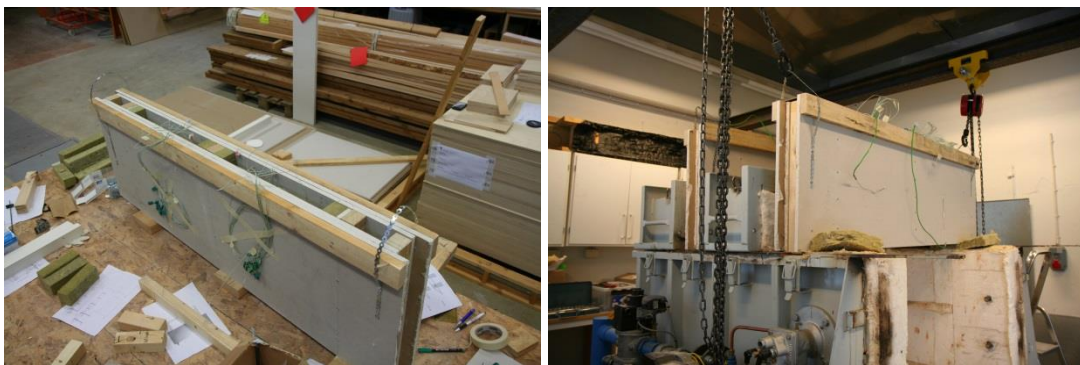
Figure 2. Test assembly

The test rig consists of two equal self-supporting test assemblies. Each test assembly had one cavity. This rig was placed on top of the horizontal furnace. All discontinuities were sealed with soft stone wool. The rest of the furnace top was closed by steel lockers.

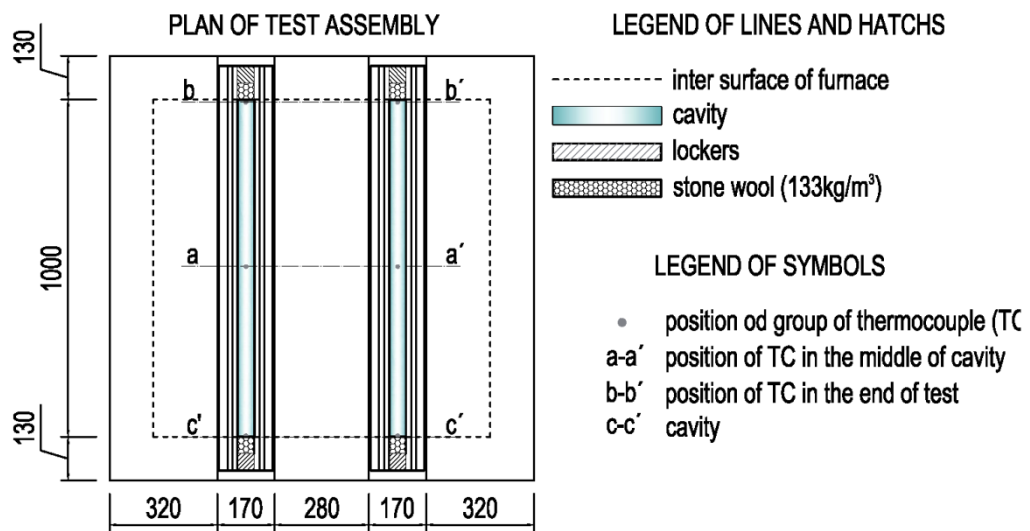
Figure 3. Plan of test assembly for specimens FS1 to FS4

The test assembly consisted of two timber studs (500 x 50 x 30 mm) providing a distance for cavity. These studs were protected by stone wool (density 133 kg/m³) from cavity side. This frame was covered by gypsum plasterboards (type F with thickness 15 mm) and wooden board on the cavity side.

Specimens for tests FS1 to FS4 were constructed with cavity width of 30 mm and cavity length 1000 mm. Cavities had wooden surfaces.

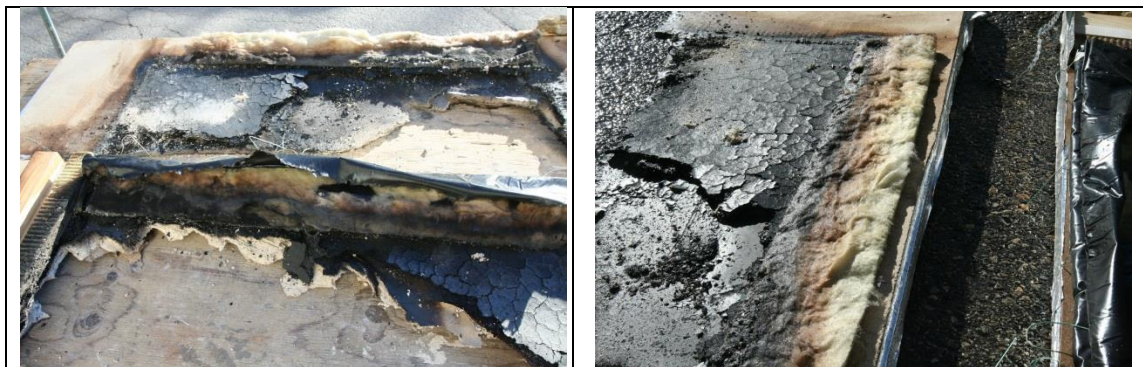
Table 3. Photos during and after fire test of specimen FS1 and FS2.

Building of the specimen FS1, FS2 is shown on the photos on Table 2. Pictures during and after test see Table 3. Temperature measurements see Figure 5 and Figure 6.

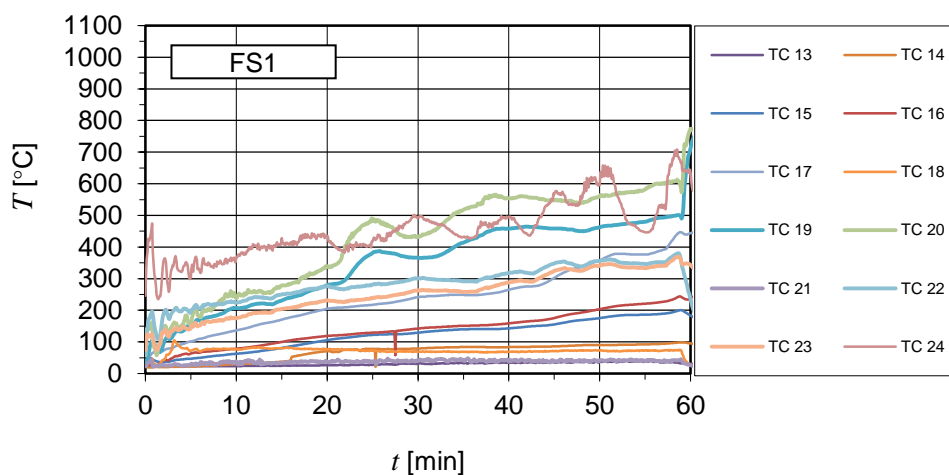
Figure 5. Temperature recording on specimen FS1.

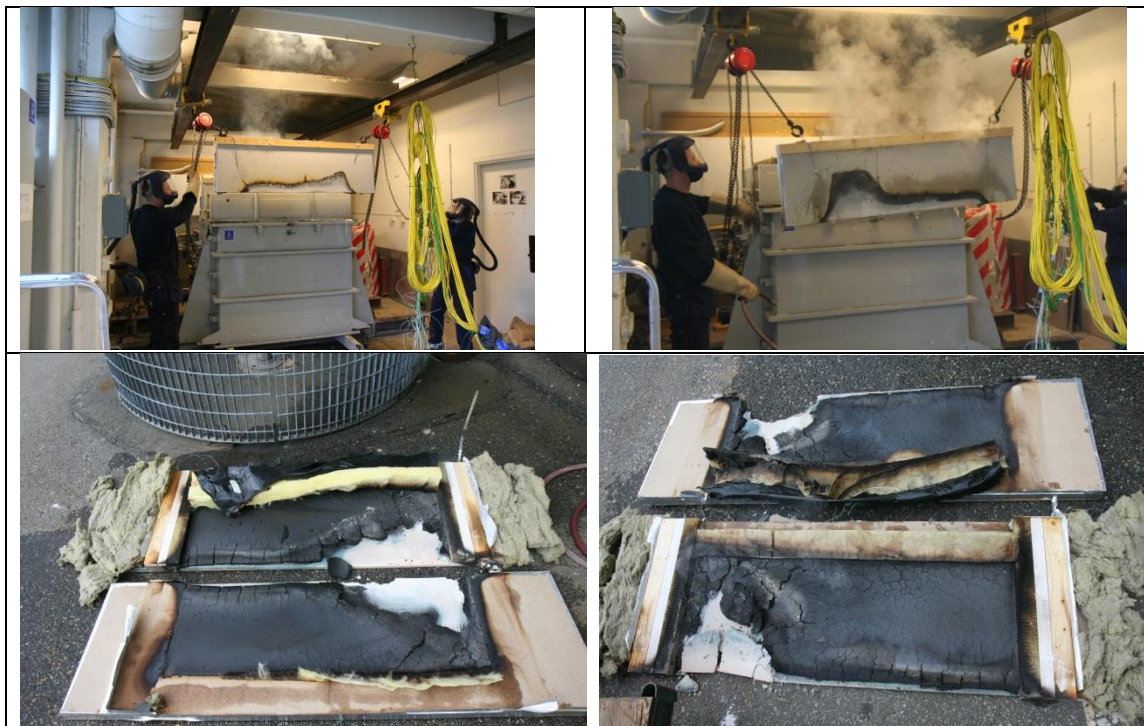
Table 5. Photos during and after fire test of specimen FS3 and FS4.

Building of the specimen FS3, FS4 is shown on the photos on Table 4. Pictures during and after test see Table 5. Temperature measurements see Figure 7 and Figure 8.

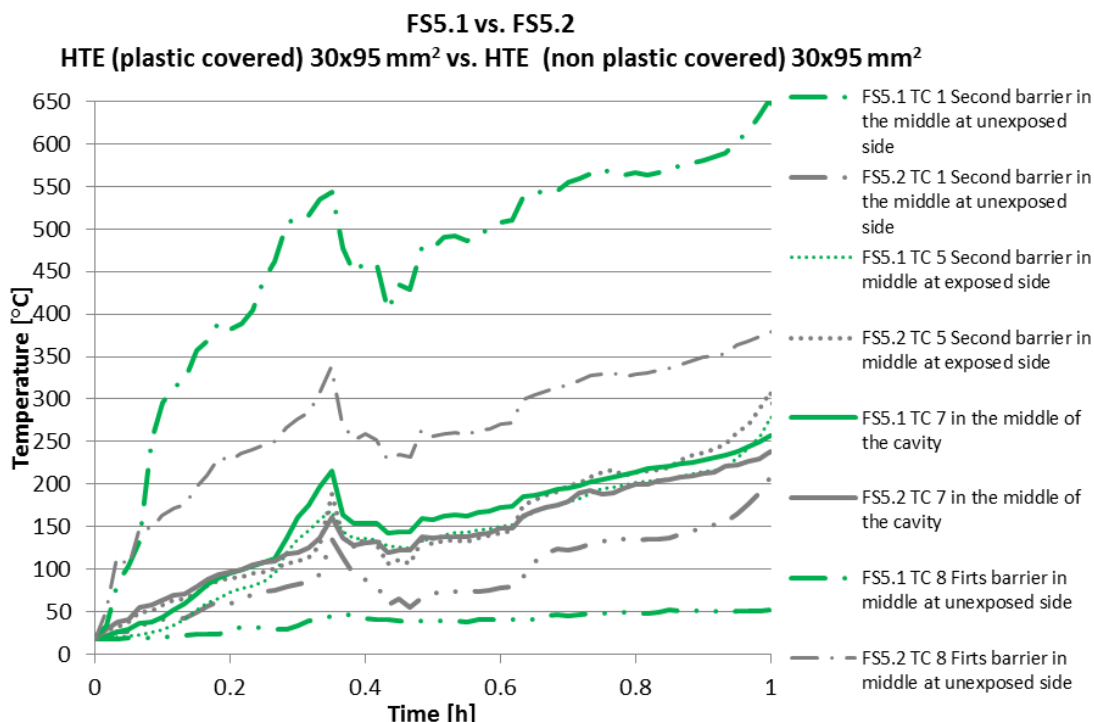
Comparison of temperature measurements for cavity barriers FS5.1 and FS5.2 is shown on Figure 29. The barriers are made of the same mineral wool. Difference between the materials of the barriers is the plastic cover; the material HTE has a plastic cover.

Figure 29. Comparison between FS5.1 and FS5.2 with the plastic cover as varying factor.

First cavity barrier of HTE mineral wool with plastic cover, resulted in higher temperatures on the unexposed side compared to the first cavity barrier of the same material without plastic cover.

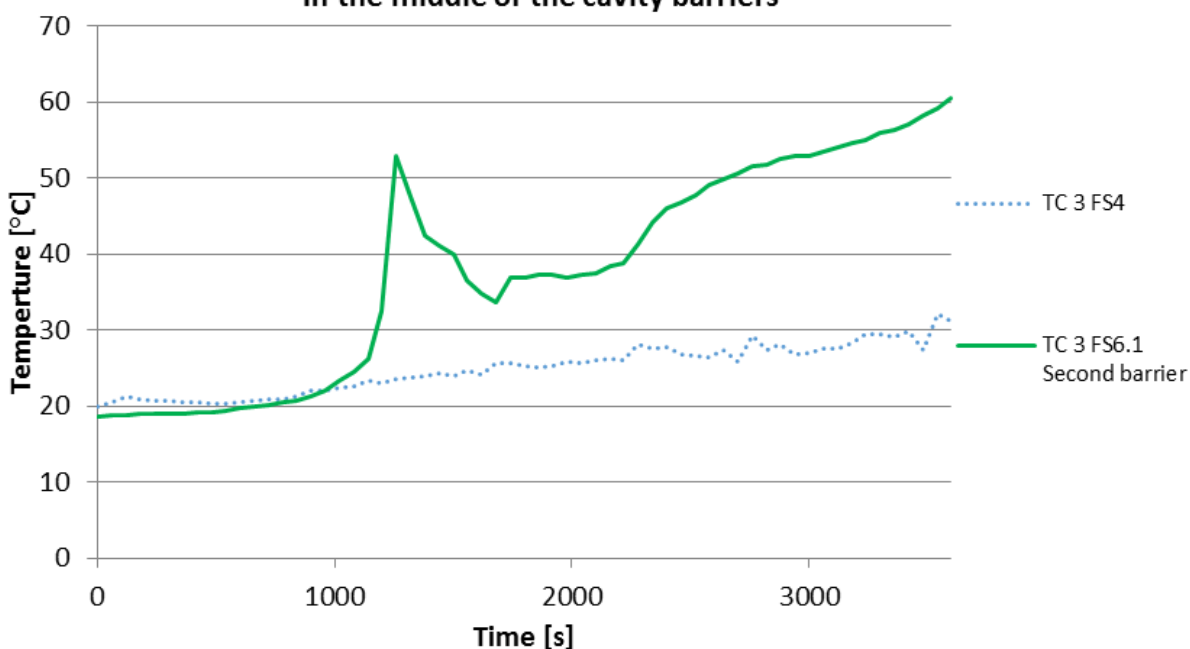
In the middle of the cavity barriers the measured temperatures are shown in Figure 31. The temperatures from FS4 and FS6.1 follow each other during the first 15 minutes and then the temperature in FS6.1 peak 30 degrees. Furthermore, the temperature in FS3, middle if the barrier, is approximately the same during the whole test. The temperature differs with 10 °C from the start to the end of the test for FS4.

Figure 31. Comparison between cavity FS4 and FS6.1 at TC3.

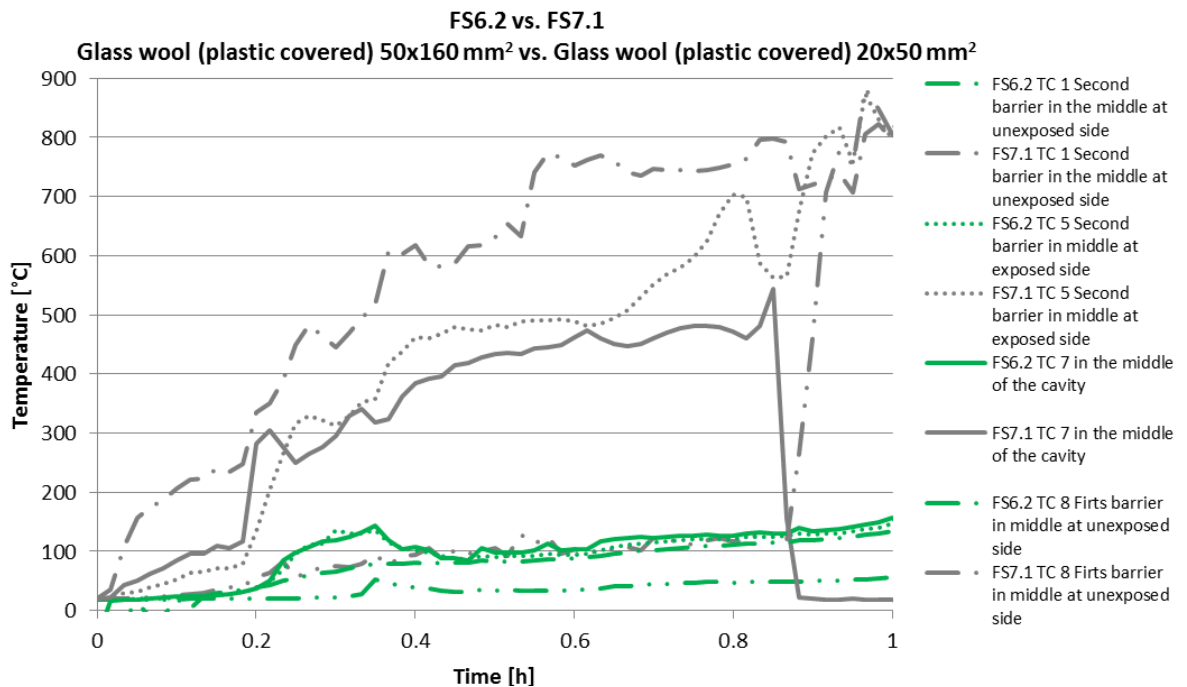
Figure 32 presents the difference between the cavity barriers FS6.2 and FS7.1. Cavity barriers are made of glass wool with different cross section area. Cavity barriers are placed as U-shape. The barrier FS6.2 with cross section area of 50 x 160 mm² closes the cavity more efficient than the barrier with the cross section area of 20 x 50 mm².

Figure 32. Comparison between FS6.2 and FS7.1 with the cross section area as varying parameter.

The sudden decrease of the measured temperature at position TC7 after approximately 50 minutes may due to a defection of the thermocouple. The temperature decrease of FS7.1 after 0,8 h is caused by closing the cavity with stone wool because of failure of the cavity barriers.

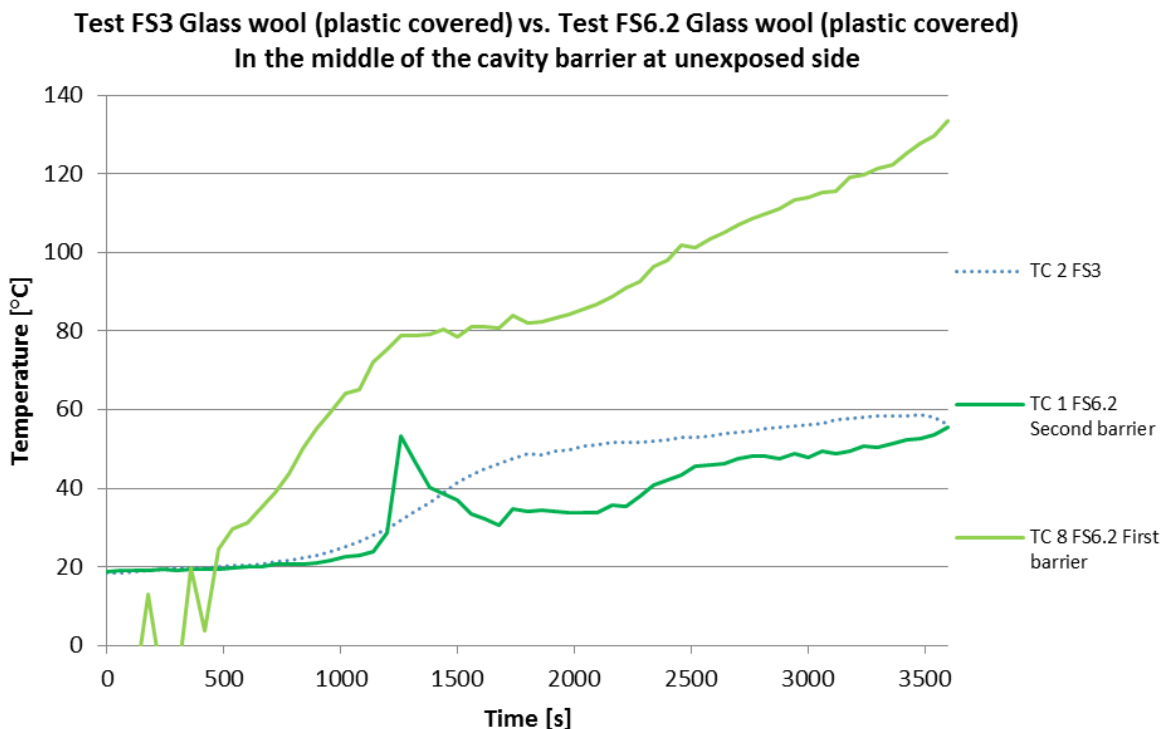
In Figure 33 the measured temperatures for the unexposed side on the middle of the barriers are presented. The temperature from FS3 follows the temperature for the second barrier more than the temperature from the first barrier in test FS6.2. The positions at the second barrier in FS6.2 show a lower temperature comparison to the temperature in FS3 due to the protective effect of the first barrier.

Figure 33. Comparison between cavity FS3 and FS6.2 at TC1 and TC8.

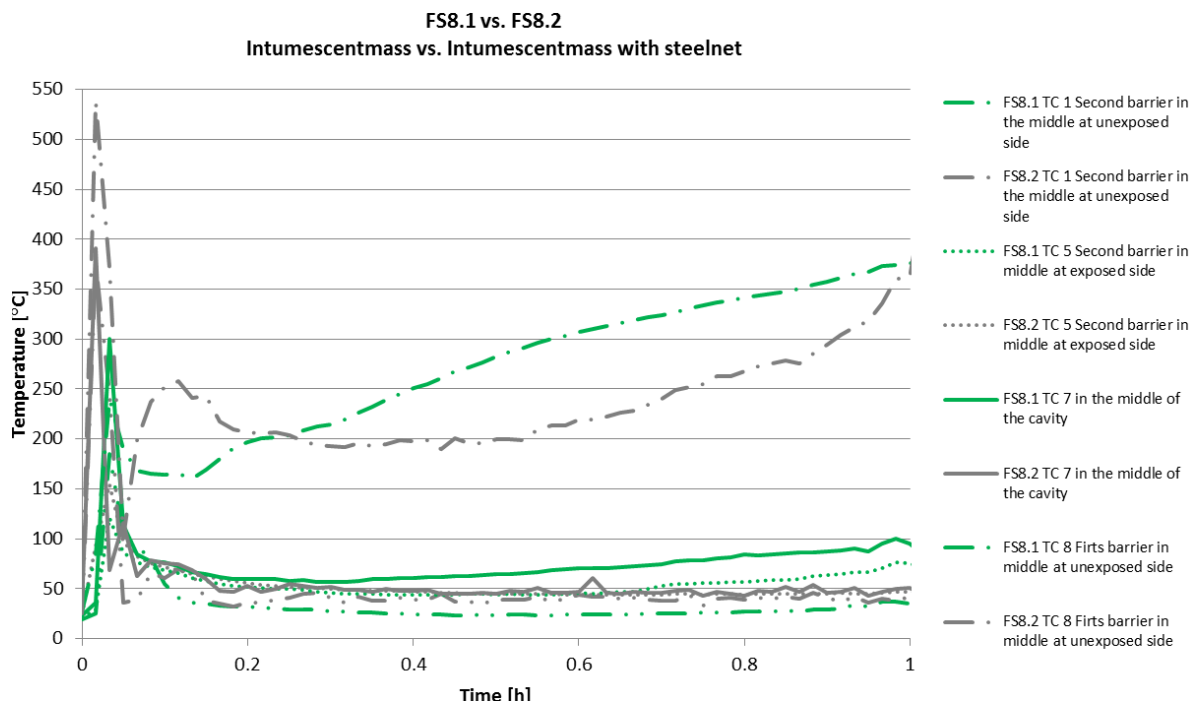
Figure 35 shows the comparison between two intumescent cavity barriers. The intumescent mass result in a lower temperature during the test compared to the intumescent mass with steel net. The temperature in FS8.1 shows more legible curves, they vary not as much as the intumescent mass with steel net.

Figure 35. Comparison between cavity FS8.1 and FS8.2, the intumescing mass compared to the intumescing mass with steel net.
