Innovativa metoder för förstärkning av befintliga konstruktioner med förspänt kompositmaterial

Förstärkning och brottbelastning av bro i full skala

Jonny Nilimaa, Luleå Tekniska Universitet

2015-10-15

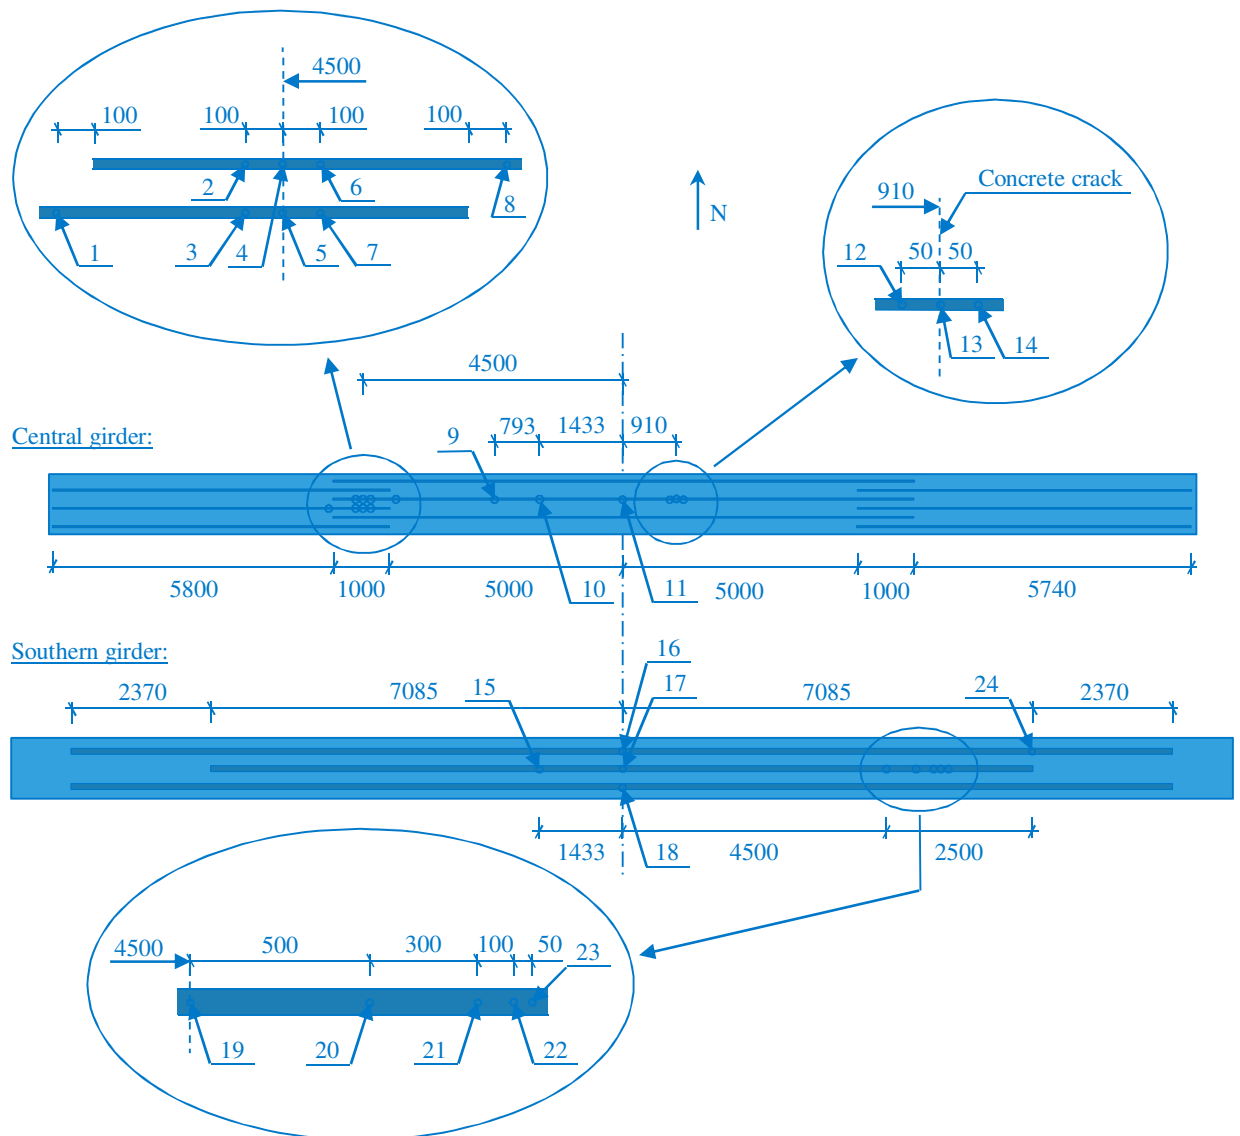
Figur 10. Placering av töjningsgivare på kolfiberförstärkningen.

Töjningsgivare 13 mätte NSM-töjningen rakt över en spricka och SG12 och 14 var placerade 50 mm ifrån sprickan på bägge sidor, se Fig. 10. Den skjuvspänning $\tau(x)$ som uppstår i limmet mellan betongen och en NSM-stav beror på följande faktorer: stavens höjd h_f , tjocklek t_f , E-modul E_f och skillnaden i stavens normalspänning $d\sigma_f$ eller töjning $d\varepsilon_f$ över en viss sträcka dx . De Lorenzis och Nanni (2002) och Teng et al. (2006) beräknade skjuvspänningen med hjälp av följande ekvation:

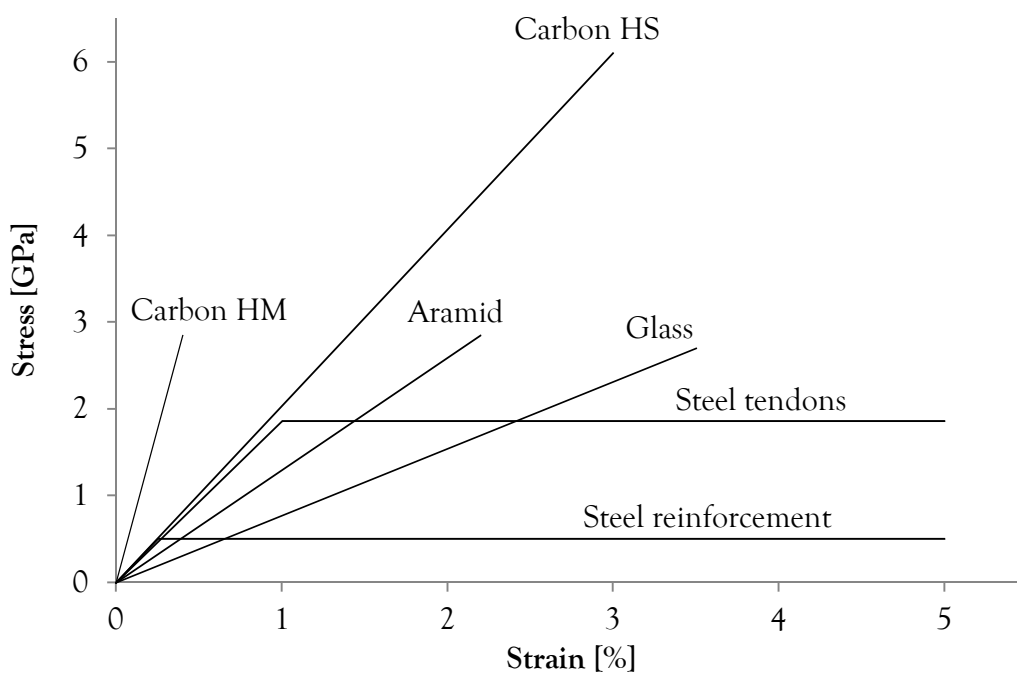
Figur 11. Typiska materialegenskaper för fibrer, värden hämtade från Täljsten et al. (2011).

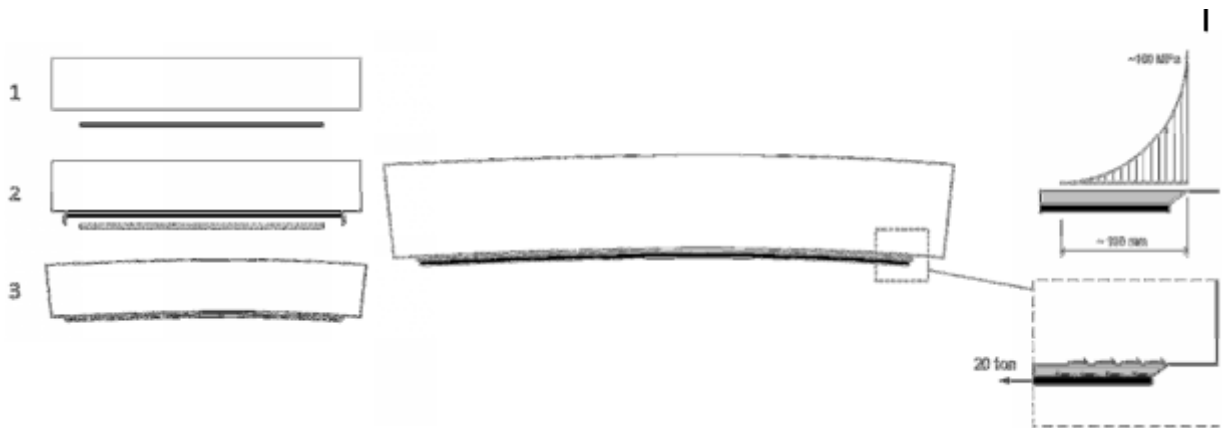
Figur 12. T.v. steg i samband med förspänning. T.h. höga skjuvspänningar i änden på laminat i samband med förspänning och vidhäftning.

De olika stegen i samband med förspänning av laminat som limmas mot en betongkonstruktion är redovisade i Figur 12. Det första steget omfattar att betongunderlaget förbereds för limning samt att laminatet förbereds inför förspänningen. Det andra steget innefattar att laminat förspänns, dvs. att en kraft förs in i laminaten, samt limmas mot betongunderlaget med bibehållen förspänningskraft. Det tredje steget omfattar att kraften i laminatet frigörs och överförs mellan laminat och betongkonstruktion. I det tredje steget innebär kraftöverföringen att den förstärkta betongkonstruktionen får en överhöjning, se Figur 12. I de fall laminaten förspänns med en moderat förspänningskraft, motsvarande 5 % av laminatets totala draghållfastheten, är sannolikheten stor att laminatet lossnar från betongunderlaget (fläknings-/förankringsbrott), El-Hacha et al. (2001). Skjuvspänningar motsvarande 100 MPa kan byggas upp i änden på laminaten om en förspänningskraft om 200 kN tillämpas, se Figur 12. Skjuvhållfastheten för typiska bindemedel (epoxi) som används i samband med kompositförstärkning är 25 MPa och betongunderlaget klarar sällan skjuvspänningar över 3-5 MPa. Det är alltså av stort intresse att utveckla förspänningssystem som motverkar uppkomsten av dessa höga skjuvspänningar i kompositens ände.

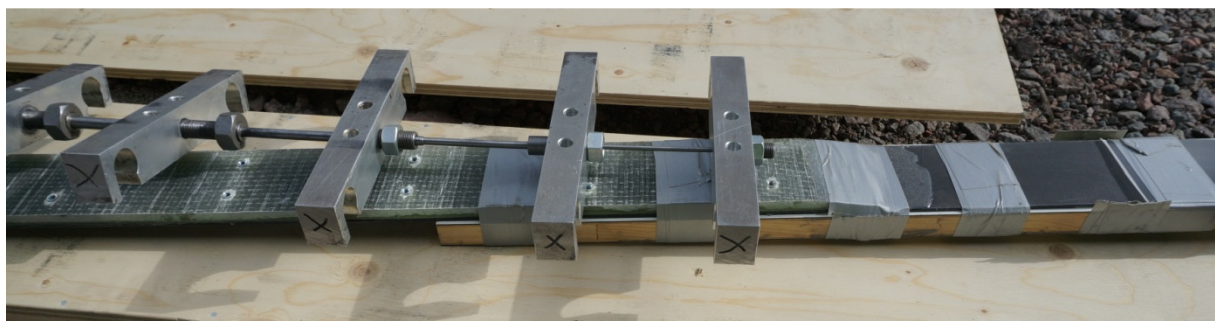
Figur 16. Övre, glasfiberlaminat, med monterade muttrar, limmad mot ena änden på kolfiberlaminat. Förankringsanordning monterar mot glasfiberlaminat med två skruvar. Nedre, förankringsanordning fastskruvad i glasfiberlaminat.

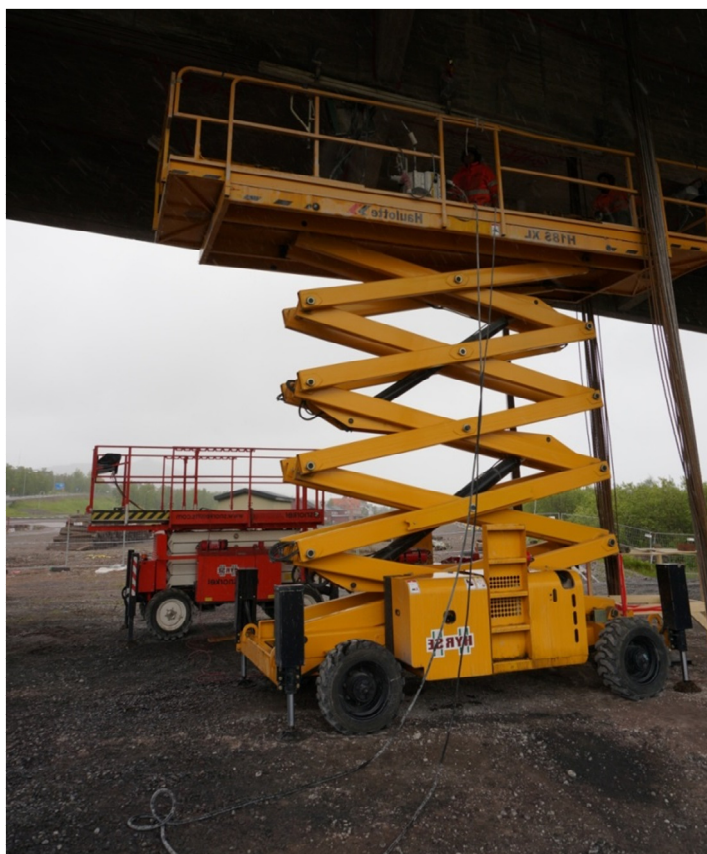
Figur 18. Saxlyft som mobil ställning.

I det förekommande fallet av förstärkningen av Gruvvägsbron i Kiruna utgjordes underlaget av tämligen jämn mark, en gammal bangård. Bron var dock relativt hög och markfrigången varierade mellan 6-10 m. Av denna anledning gjordes bedömningen att mobila saxlyftar skulle vara den absolut mest kostnadseffektiva lösningen jämfört med platsbyggda ställningar. På plats under förstärkningsarbetet fanns tre mobila saxlyftar till förfogande, se Figur 18.

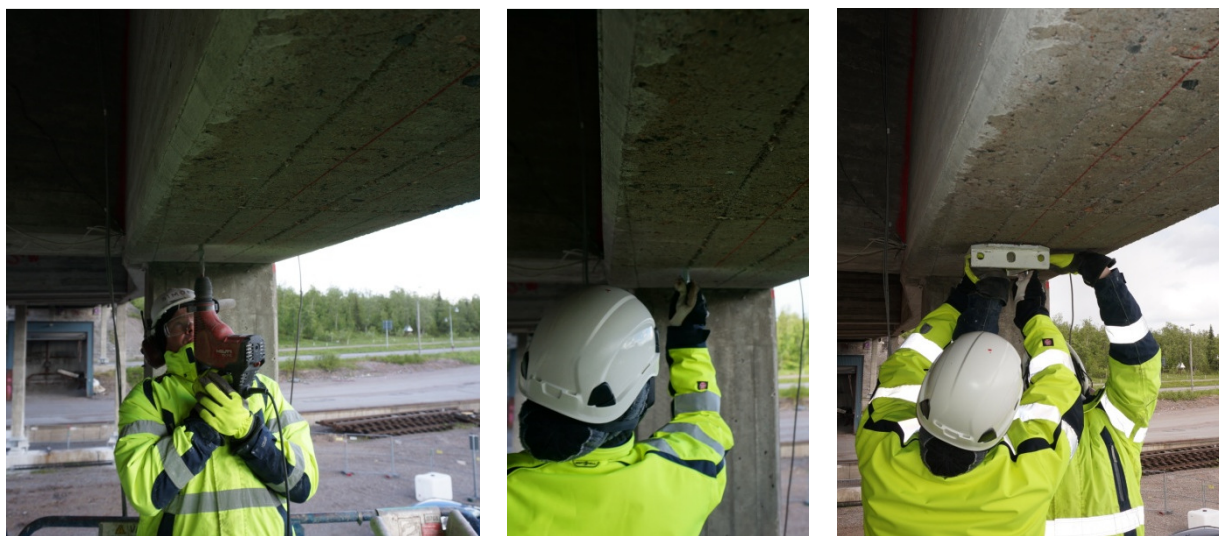
Figur 19. Borrning av hål, insättning av bult samt montering av tillfälligt stöd (förankringslåda)

Borringen av hålen är redovisade i Figur 19, i det aktuella fallet så användes manuell styrning av borr. Det hade med fördel gått att använda en bormaskin med fastmonterat stöd. I synnerhet med tanke på att flertalet järn var tvungna att borraras genom. Arbetsmomentet med borring tog avsevärt längre tid på grund av armeringsjärnen, kärnborring hade i detta fall kunnat minimera tidsåtgången. Efter att hålen borraras förs förankringen till bulten in i hålet, sedan justeras de temporära stöddetaljerna och skruvas fast med bultarna, se Figur 19.

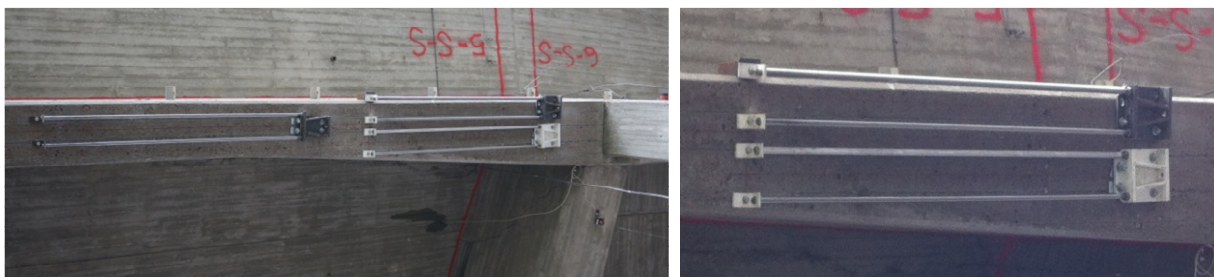
Figur 20. Samtliga tillfälliga stöddetaljer monterade vid en ände av förstärkningssystemet.

Installationen av tillfälliga stöddetaljer (inklusive förankringslåda) skedde stegvis och för respektive ände av förstärkningssystemen omfattades totalt 15 temporära delar, se Figur 20.

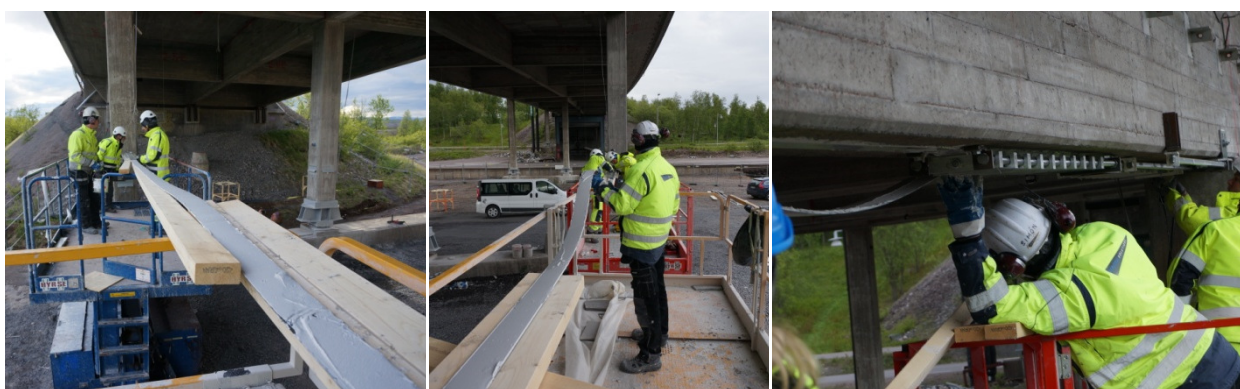
Figur 22. Montering av förstärkningslaminat mot betongbalkens undersida. Till höger, särskild noggrannhet iaktas vid monteringen av förankringsanordning.

När limmet applicerats på förstärkningslaminatet ska denna appliceras mot betongunderlaget. Förstärkningslaminatet med lim transporterades därmed från limstationen till ställningen (3 saxlyftar), se Figur 22. Det första steget i appliceringen av förstärkningslaminatet är att installera förspänningsanordningen i de tillfälliga stöden. Detta genomförs på sådant sätt att förspänningsanordningens dragstag förs in i förankringsplattan och sedan placeras ståklackarna mot gejderstängerna. På detta sätt erhålls första anvisningen av förstärkningslaminatets riktning. Samtidigt som detta sker pressas förstärkningslaminatet för hand mot betongunderlaget med en hård roller för att få full anliggning. När den fulla anliggningen erhålls pressas en liten mängd lim ut på kanterna längs med förstärkningslaminatet, när detta sker så har en limfog om 2 mm uppnåtts. Detta arbetsmoment krävde flest resurser och involverade 8 personer, om icke-förspänt laminatsystem tillämpats hade motsvarande resursbehov varit 2-3 personer.

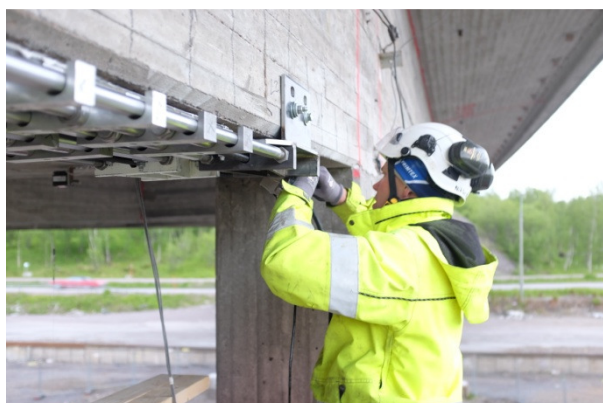
Figur 23. Montering av domkraft och lastcell för kontroll av förspänningskraft.

När laminatet sedan, tillsynes, är sträckt och full anliggning mot underlaget råder låses den passiva sidan av förankringen. Lastcell och domkraft monteras sedan vid den aktiva förankringen, se Figur 23. Förspänningskraften införs successivt via domkraften till dess att erforderlig förspänningskraft erhålls (100 kN per laminat, uppmätt med lastcell). När de första lägre belastningarna av förspänningen sker kan en viss efterjustering av den passiva delen av förankringen behövas. När den fulla förspänningskraften erhållits låses muttern vid förankringslådan (aktiv del) och domkraften/lastcell kan demonteras, se Figur 24.

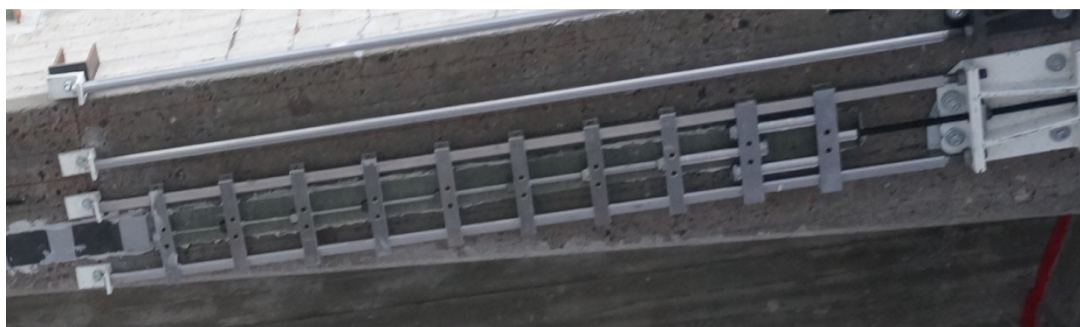
Figur 24. Aktiv del av förspänningsanordning, precis låst efter påförd spännkraft om 100 kN.

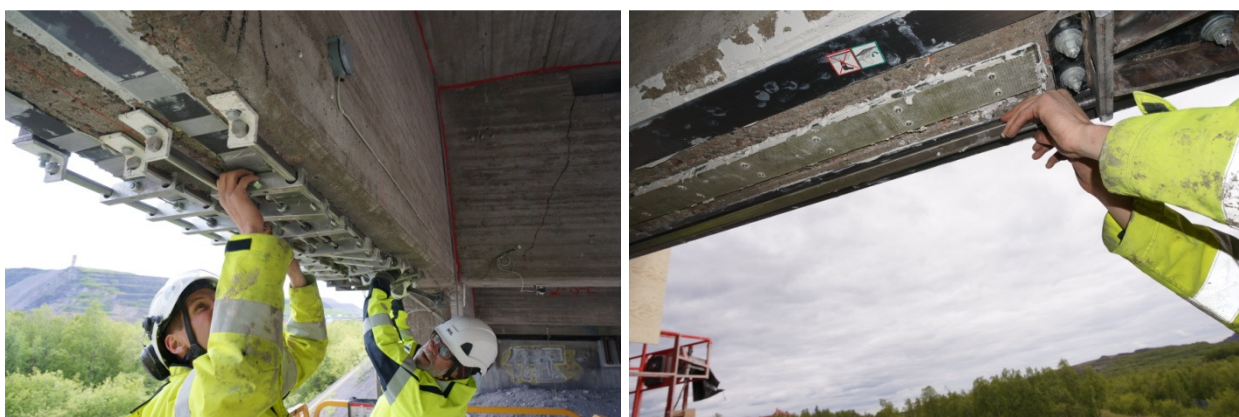
Figur 25. Demontering av förspänningsanordning och tillfälliga stöddetaljer.

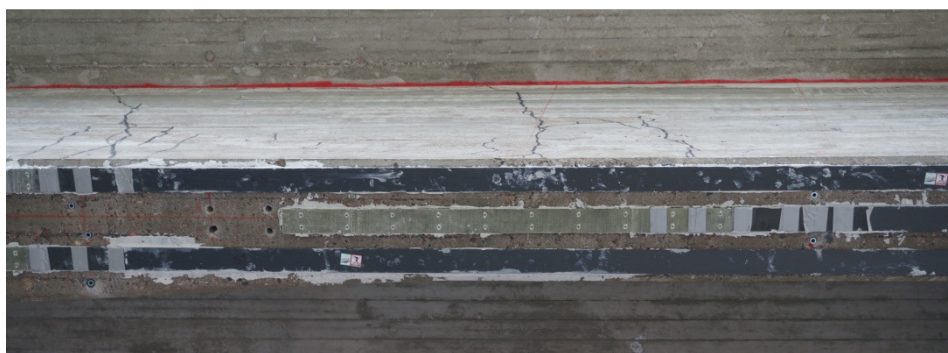
Figur 26. Förstärkningslaminat efter att förankringsanordning och tillfälliga stöddetaljer demonterats.

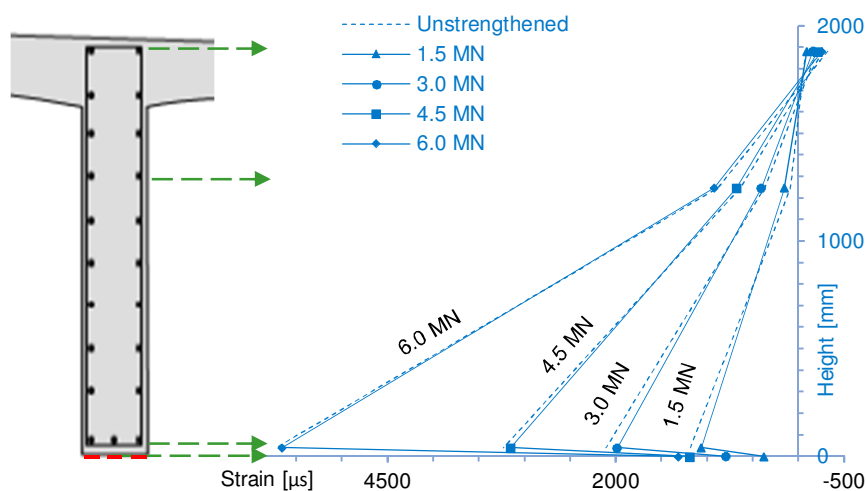
Figur 28. Töjningsfördelning vid mittspannet för den södra balken innan förstärkning (streckad linje) och efter laminatförstärkning (heldragen linje).

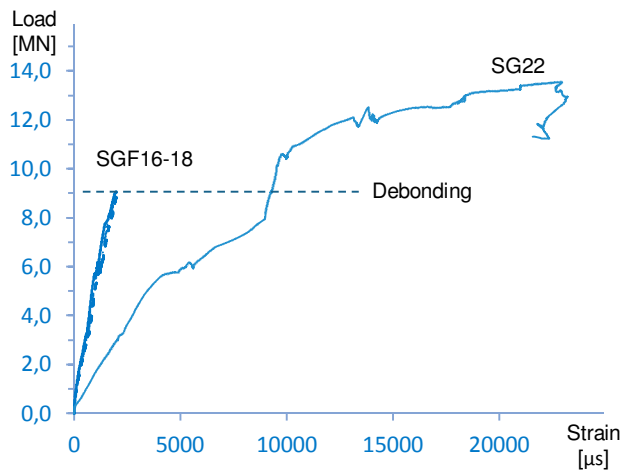
Figur 29. Töjningar i laminat (SGF 16-18) och dragarmering(SG22).

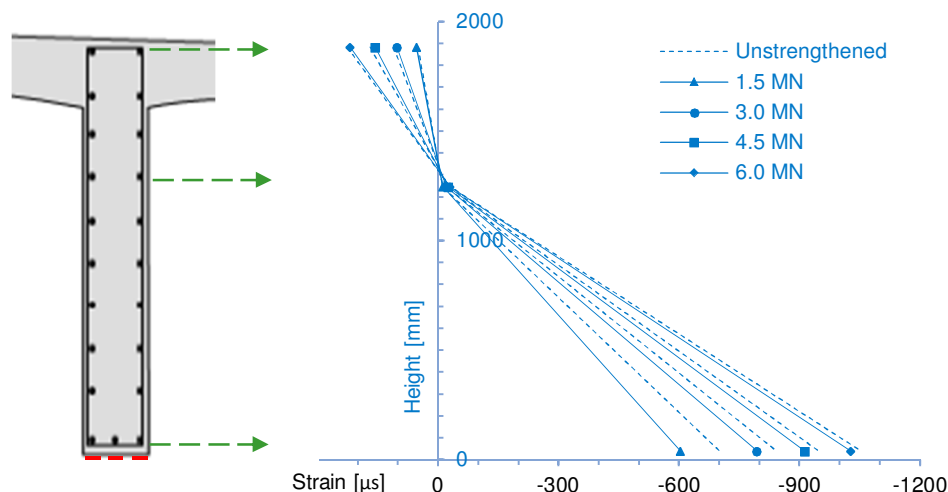
Figur 31. Töjningsfördelning över stöd 3 för den södra balken innan förstärkning (streckad linje) och efter laminatförstärkning (heldragen linje).

Töjningsfördelningen för tre nivåer ($h = 40, 1248$ och 1893 mm från balkens underkant) ovanför stöd 2 och 3 redovisas i Fig. 30-31. Fyra lastnivåer redovisas och de streckade linjerna representerar den oförstärkta bron medan de heldragna linjerna representerar den förstärkta bron. Resultaten visar återigen att påkänningarna i underkantsarmeringen, i detta fall trycktöjningar, var på en lägre nivå efter förstärkningen. Dessutom upprepas tendenserna för en minskad förstärkningseffekt på högre lastnivåer, vilket återspeglas genom minskade skillnader mellan de heldragna och streckade linjerna i Figur 30. Resultaten i Figur 30 och 31 visar även att töjningsnivåerna konsekvent var högst över stöd 3.

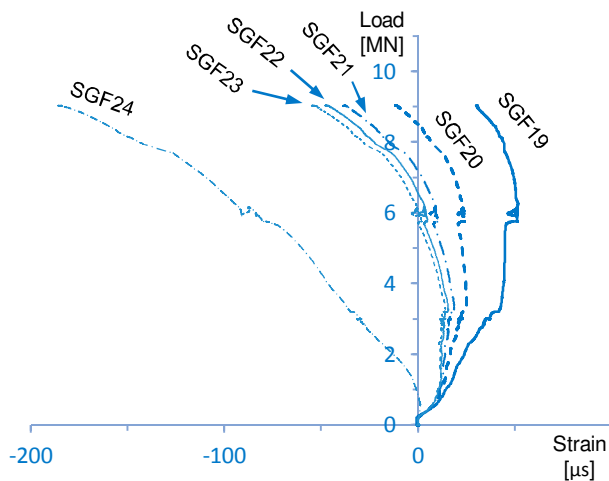
Figur 32. Laminattöjningar i förankringszonen upp till förankringsbrott.

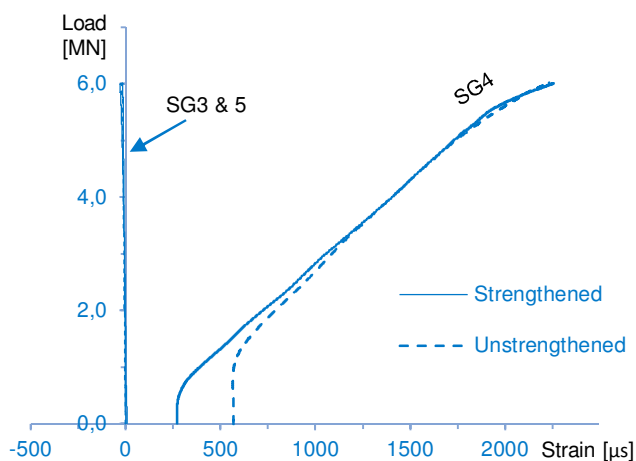
Figur 33. Töjningsnivåer för tre givare på samma bygel, SG4 låg rakt ovanför en spricka.

Töjningsnivån i skjuvarmeringen påverkades inte nämnvärt av förstärkningen. Figur 33 visar last-töjningskurvorna för tre givare (SG3-5) monterade på olika nivåer av samma bygel, se placering i Figur 9. SG3 och 5 noterade en liten trycktöjning på ungefär 20 μs vid försök 1-2 och SG1, 2 och 9 visade samma nivåer. Töjningsgivaren SG4 hamnade rakt över en spricka och uppmätte maximala dragtöjningar på ungefär 2250 μs vid en total last på 6,0 MN under försök 1 och 2. Noterbart var att trots att den maximala dragtöjningen låg på samma nivå före och efter förstärkningen stängdes sprickan betydligt snabbare vid avlastningen av den förstärkta balken. Återigen påverkades starttöjningen mycket av lasthistoriken och tiden mellan avlastning och pålastning eller snarare sega deformationer. Övriga töjningsgivare på skjuvarmeringen noterade maximala töjningar på 100 - 200 μs .

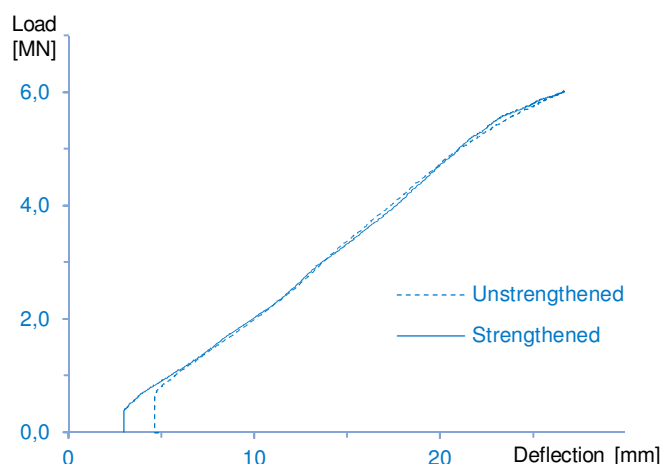
Figur 34. Mittnedböjning för den södra balken innan förstärkning (streckad linje) och efter laminatförstärkning (heldragen linje).

Varken mittnedböjningen eller den övervakade spricköppningen visade någon tydlig påverkan av laminatförstärkningen. Den maximala mittnedböjningen för den södra balken låg på 27 mm för en last på totalt 6,0 MN och resultaten var i samma nivå både före och efter förstärkningen, se Fig. 34. Den maximala spricköppningen för den spricka som övervakades i mittspannet uppnådde 0,66

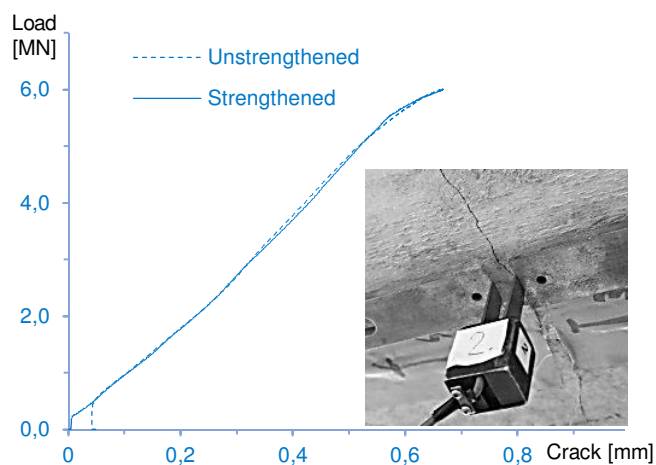
Figur 35. Spricköppning för en spricka i mittspannet på den södra balken innan förstärkning (streckad linje) och efter laminatförstärkning (heldragen linje).

mm vid en total last på 6,0 MN, se Fig. 35. Både nedböjningen och spricköppningen bekräftar de tidigare iakttagelserna att spricköppningar och deformationer minskar snabbare vid avlastning efter att balken förstärkts.

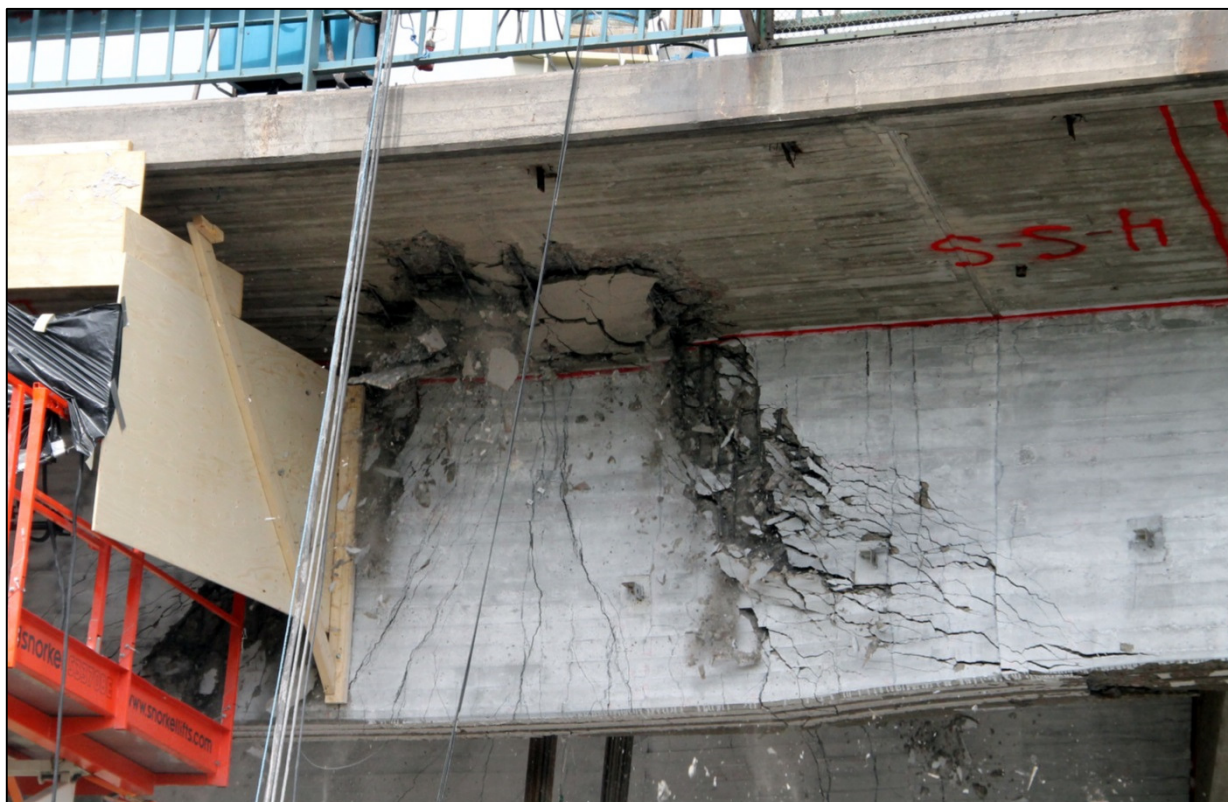
Figur 36. I slutskedet av belastningen av den södra balken uppstod skjuvsprickor.

försök 3, delvis tack vare spännarmeringen. Det övergripande beteendet för bron var segt med tydliga varningssignaler i form av deformationer och sprickor. Det slutgiltiga brottet som initierades av brott i bygelarmeringen var däremot sprött, se Figur 36. Uppsprickningen startade med vertikala böjsprickor i balkens underkant som efterhand sneddade in mot lasten och det slutliga brottet var en tydlig skjuvspricka. I slutskedet uppstod även ett betongkrossbrott rakt under lastpunkten.

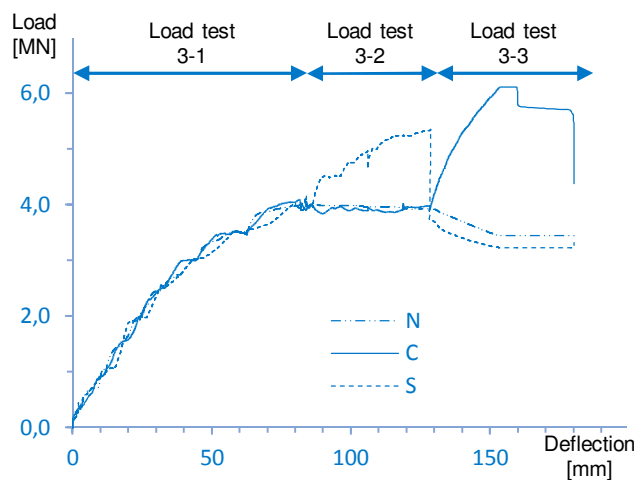
Figur 38. Mittnedböjning för den mellersta balken innan under försök 3. Lasterna redovisas här separat för norra (N), mittersta (C) och södra (S) balkarna.

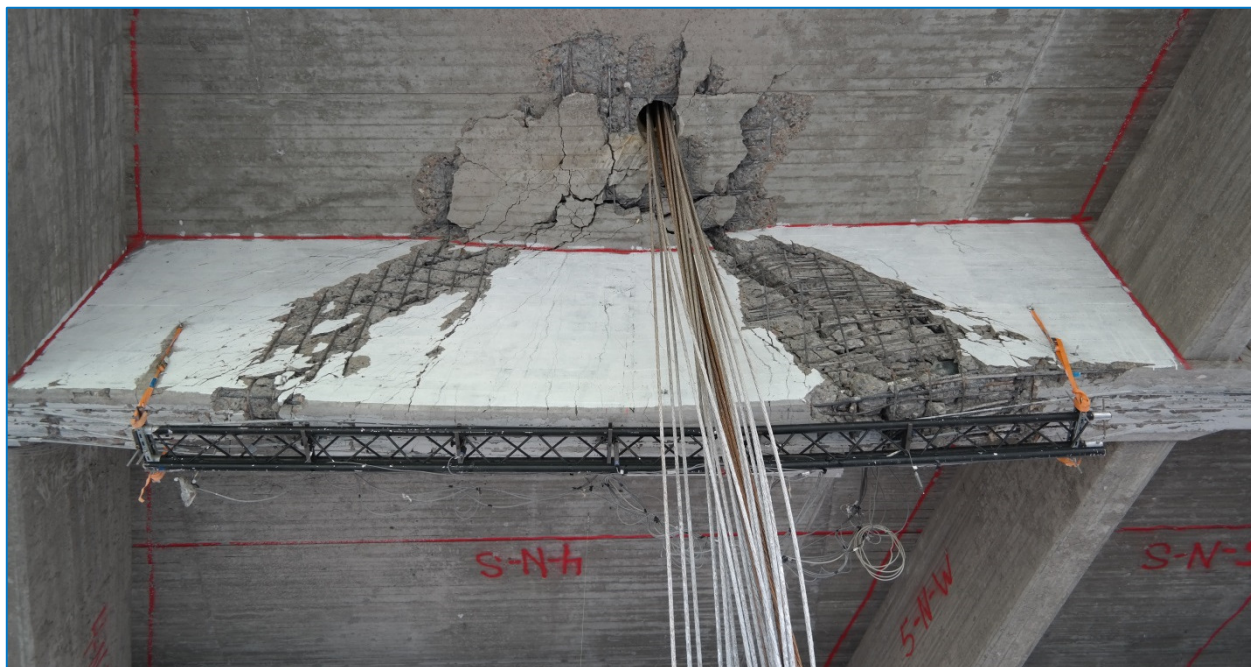
Figur 39. Brott i den mittersta balken.

Mittenbalken hade ett segt beteende med omfattande uppsprickning och brottet initierades av flytning i såväl dragarmering som byglar. I likhet med den södra balken var brottmoden en kombination av böjning och skjuvning med betongkrossbrott i plattan, se Figur X13. En flytplåtå kan tydas i Fig. 39 strax innan maxlasten uppnåddes, men förloppet var för snabbt för att uppfattas på plats.

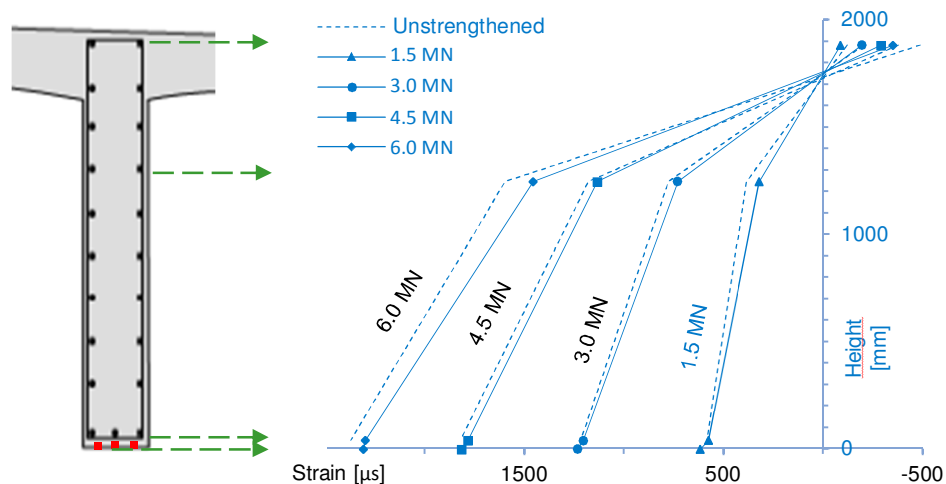
Figur 40. Töjningsfördelning vid mittspannet för den mittersta balken innan förstärkning (streckad linje) och efter NSM-förstärkning (heldragen linje).

Figur 41 visar töjningsprofilen för tre lastnivåer under brottbelastningen: 9,0; 12,0 och 14,1 MN (strax innan brott). Kurvornas form för de två lägre lastnivåerna följer samma form som de i Fig. 40, med skillnaden att NSM-töjningen är betydligt högre än töjningen i dragarmeringen. Vid dessa lastnivåer var spricktillväxten av balken större än tidigare och dragarmeringen hade uppnått flytning. Det betyder dels att NSM-förstärkningens utnyttjandegrad var högre än tidigare och dels att töjningsnivån för dragarmeringen var extremt beroende på var givaren var placerad i förhållande till sprickorna. Om man bortser från dragarmeringen (placerad på $h = 40$ mm i Fig. 41) som inte uppvisar tillförlitliga töjningsvärden efter flytning, var töjningsfördelningen nästan linjär vid brottgränstillståndet med en NSM-töjning på ungefär 1,2%, motsvarande 2520 MPa. Den totala kraften i de tre NSM stavarna uppgick därmed till ungefär 0,8 MN. Fig. 41 antyder att balkens neutrallager låg på ungefär 1,7 m från balkens underkant och NSM-systemet bidrog därför med ungefär 1,3 MNm i böjmotstånd. Motsvarande siffror för dragarmering och spännstål kan beräknas till 0,4 och 7,8 MNm, antaget att de flyter i brottgränstillståndet.

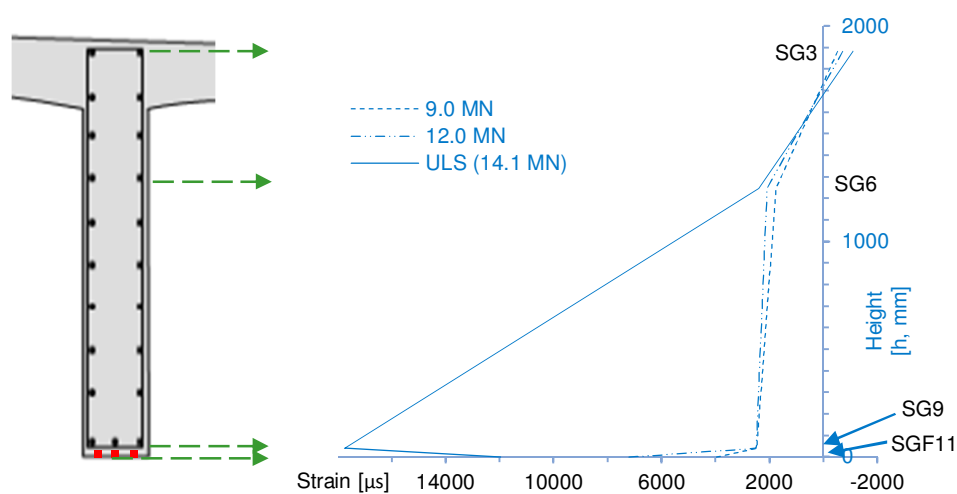
Figur 41. Töjningsfördelning vid mittspannet för den mittersta balken under brottprovingen (försök 3).

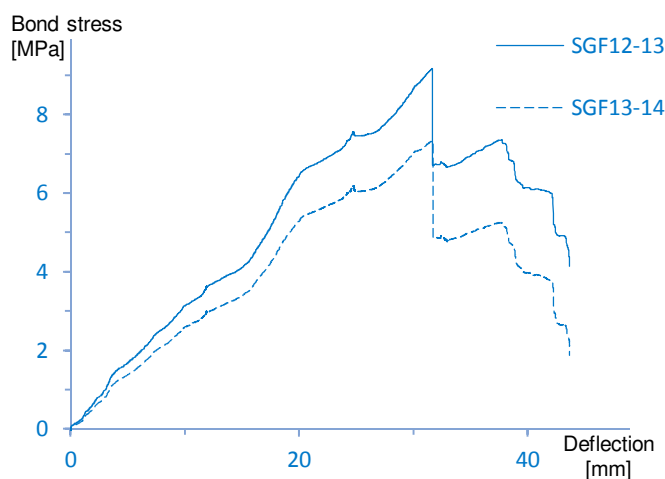
Figur 42. Beräknade skjuvspänningar mellan betong och NSM.

I Figur 42 sammanställs de beräknade skjuvspänningarna i anslutning till sprickan som övervakades med SG12-14 under brottbelastningen. Tyvärr slogs dessa givare ut då laminatförstärkningen lossnade och resultaten gäller bara upp till en total belastning på 9,0 MN. Skjuvspänningen ökade nästan linjärt upp till maxspänningen 9,2 MPa vid en last på ca 7,5 MN (mittnedböjningen var då 31 mm). Vid denna last inträffade ett momentant spenningsfall, troligtvis till följd av förankringsslidning i NSM-systemet då den maximala skjuvspänningen sjönk till 6,7 MPa. Efter glidningen återhämtade sig skjuvspänningen till 7,4 MPa innan den började avta. Då mätningen slogs ut hade skjuvspänningen mellan SG12 och 13 sjunkit till 4,1 MPa och det kan antas att nedgången fortsatte mot noll innan balken gick sönder. En nedgång till noll i skjuvspänning indikerar ett lokalt förankringsbrott mellan två töjningsgivare. Den angivna skjuvhållfastheten för det tvåkomponents-epoxi som användes på Gruvvägsbron var 19,2 MPa och trots att resultaten i Fig. 42 visar en maximal skjuvspänning på 9,2 MPa mellan SG12 och 13 så skulle ett kortare avstånd mellan givarna troligtvis ha resulterat i betydligt högre värden på uppmätta skjuvspänningar. Däremot låg skjuvspänningarna över betongens draghållfasthet utan att orsaka skador i betongen.

De skjuvspänningar mellan NSM och betong som kontrollerades i anslutning till en spricka vid mittspannet uppnådde ett maxvärde på 9,2 MPa innan spänningarna började avta till följd av ett lokalt förankringsbrott. Skjuvspänningen beräknades utifrån töjningsskillnaden mellan två givare på 50 millimeters avstånd. Trots att den maximalt uppmätta skjuvspänningen låg under epoxilimmets skjuvkapacitet, 19,0 MPa, är det mycket troligt att de högsta skjuvspänningarna låg i närheten av detta värde om de hade mätts över en kortare sträcka. Trots att temperaturen vid bron låg på i snitt +7 °C (som lägst +1 °C) under härdningsperioden på 8 dagar visade det sig att skjuvspänningarna var betydligt högre än betongens draghållfasthet, 2,3 MPa.

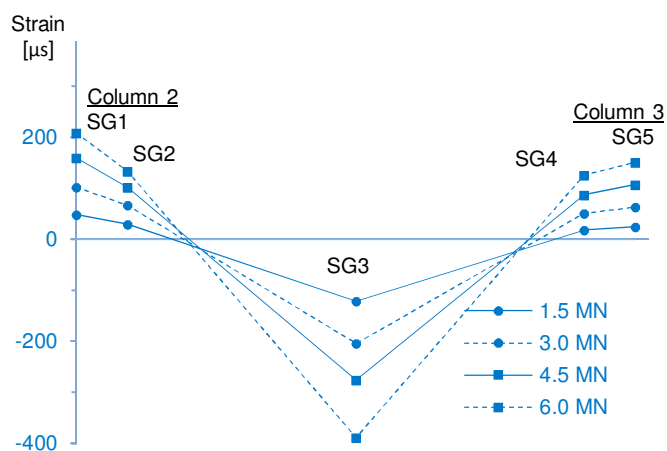
Figur 44. Töjningsnivåer i mittenbalkens överkantsarmering under försök 2.

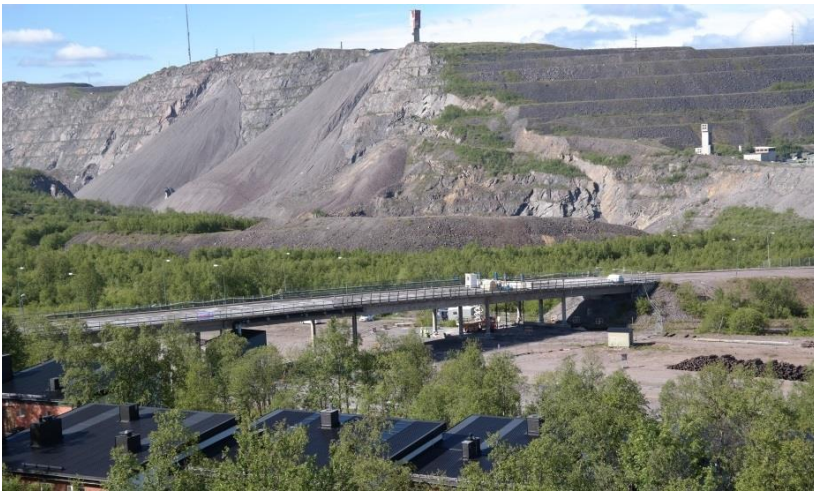
Figure 1 – Photograph of the Kiruna Bridge from the north-east, showing the slag heap from the LKAB iron ore mine in the background (2014-06-25).

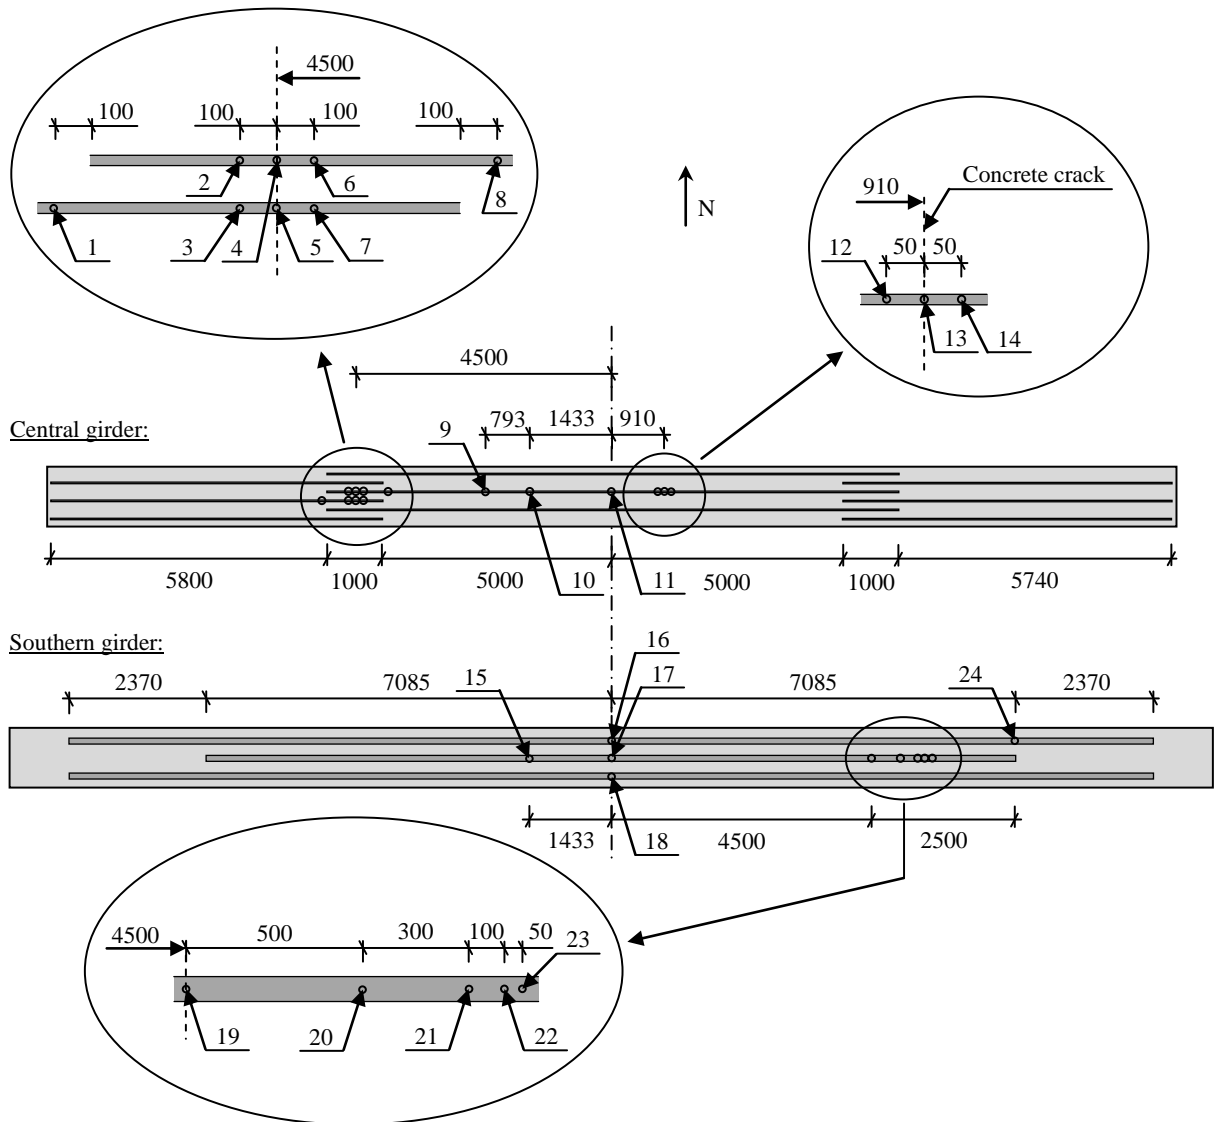
Figure 10 – Geometry of bridge strengthening systems in span 2-3 and positions of the strain gauges on the NSM CFRP rods and prestressed CFRP laminates.

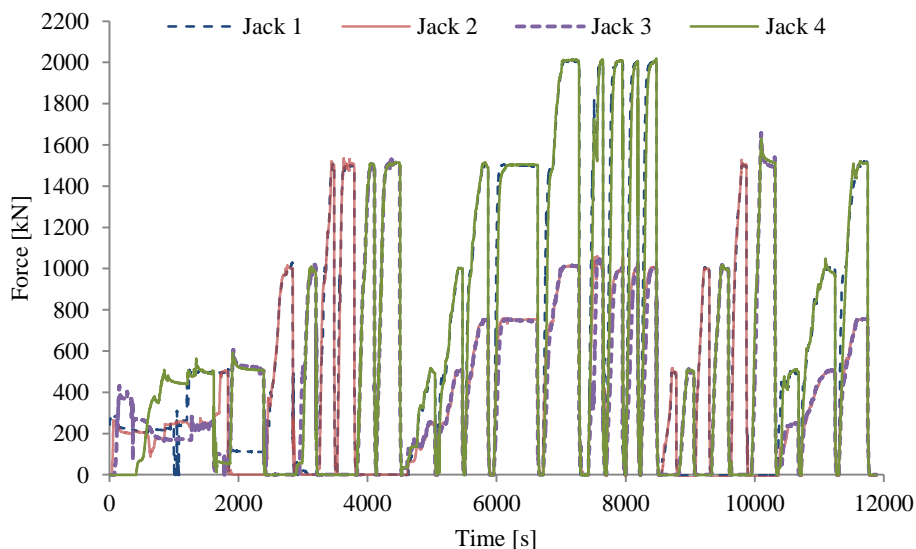
Figure 12 – Observed loadings during Preloading Test Schedule 1, unstrengthened girder.

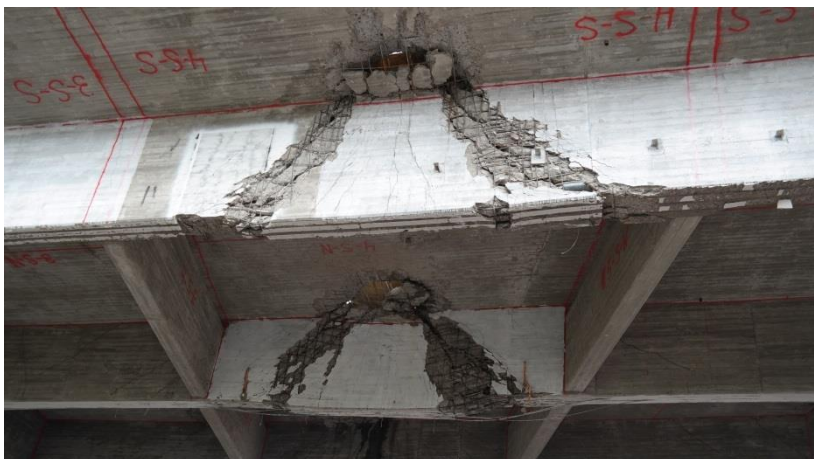
Figure 16 – Photograph of the bridge girders after failure, view from the south (2014-08-26).

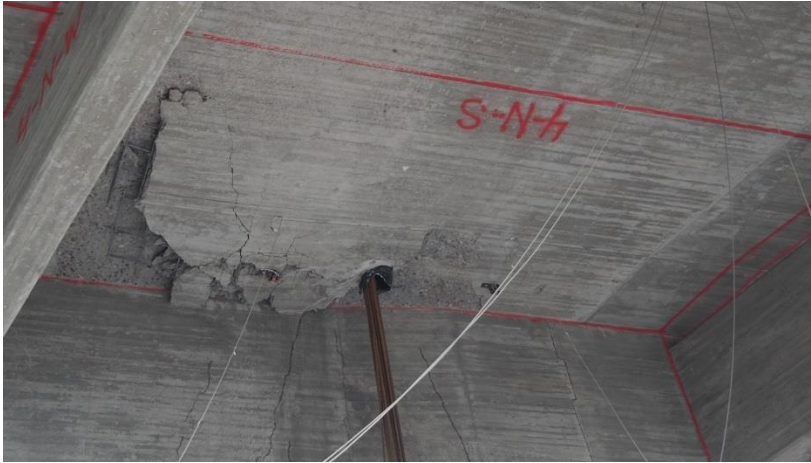
Figure 17 – Photograph of the bridge slab failure, view from south (2014-06-27).

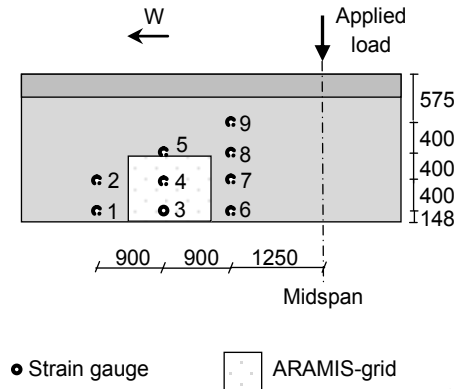
Fig. 8. Locations of strain gauges (1-9) for monitoring vertical strains in stirrups.

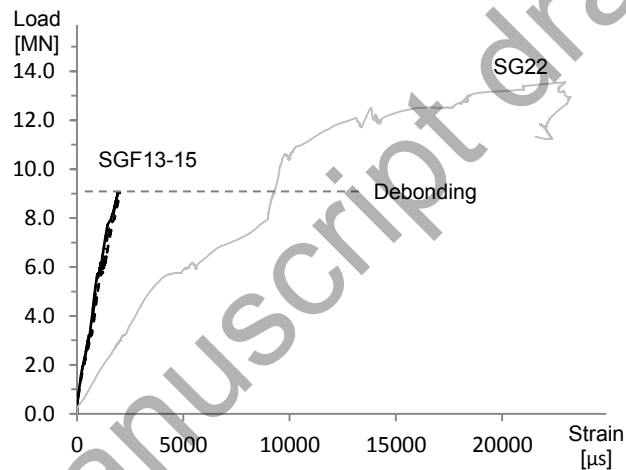
Fig. 11. Load-strain curve for the strengthened bridge. SGF13 – 15 show the laminate strains up to debonding and SG22 show strains in the tensile reinforcement up to failure.

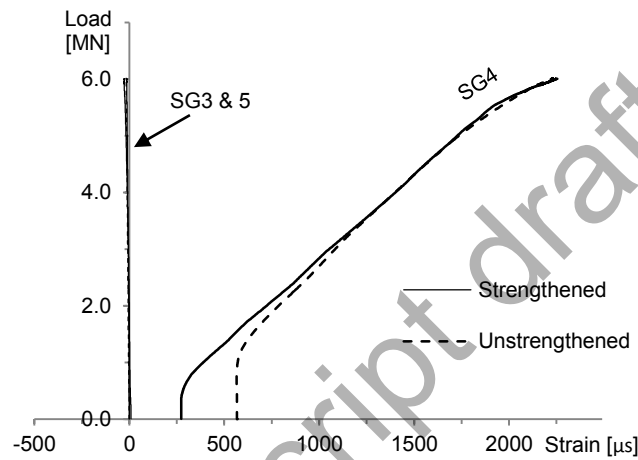
Fig. 15. Load-strain curve for one stirrup, before and after strengthening (dashed and solid lines, respectively).

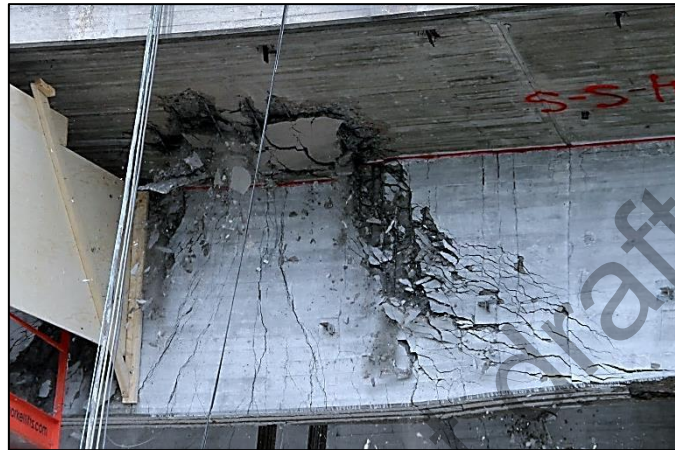
Fig. 18. The southern girder at failure.
