Screening test methods for determination of fire spalling of concrete

RISE Report : 2018:05

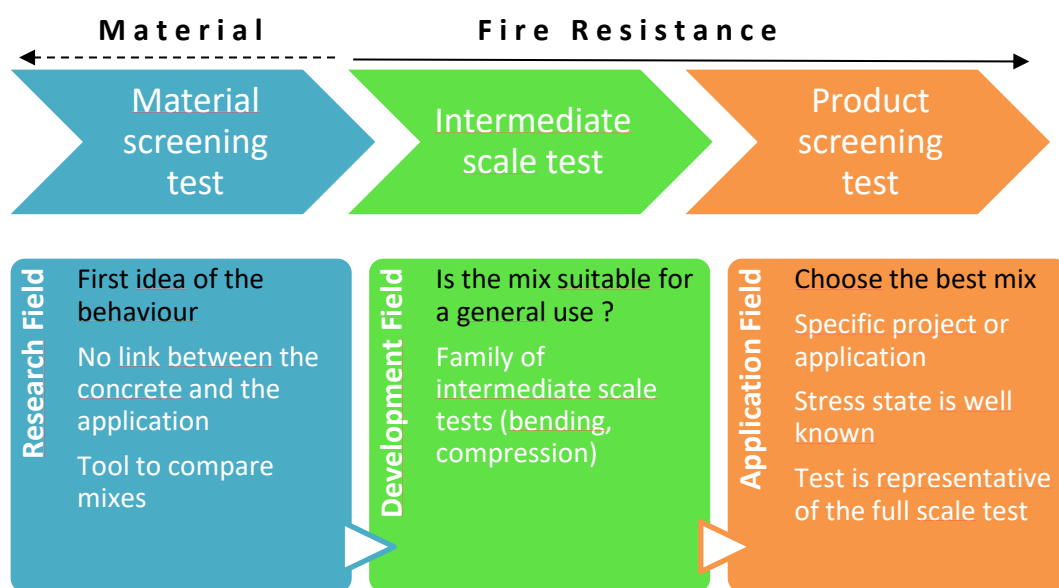
Figure 1. Schematic view on different scale of tests and their applicability¹.

Testing of concrete can be done on many different scales, and they have different objectives. Figure 1 show three scales of tests used for examining spalling of concrete, material screening tests, intermediate scale tests and product screening test.

A typical material screening test is when a cube or cylinder, with a size like the specimens used for determining the strength of concrete, is exposed to high temperature. The link between this scale of test and the behaviour of a final product such as a concrete wall is very weak regarding the spalling behaviour.

An intermediate scale test has a much better correlation to a large scale test, and is thus a good tool for screening different concrete mixes before performing a full scale test.

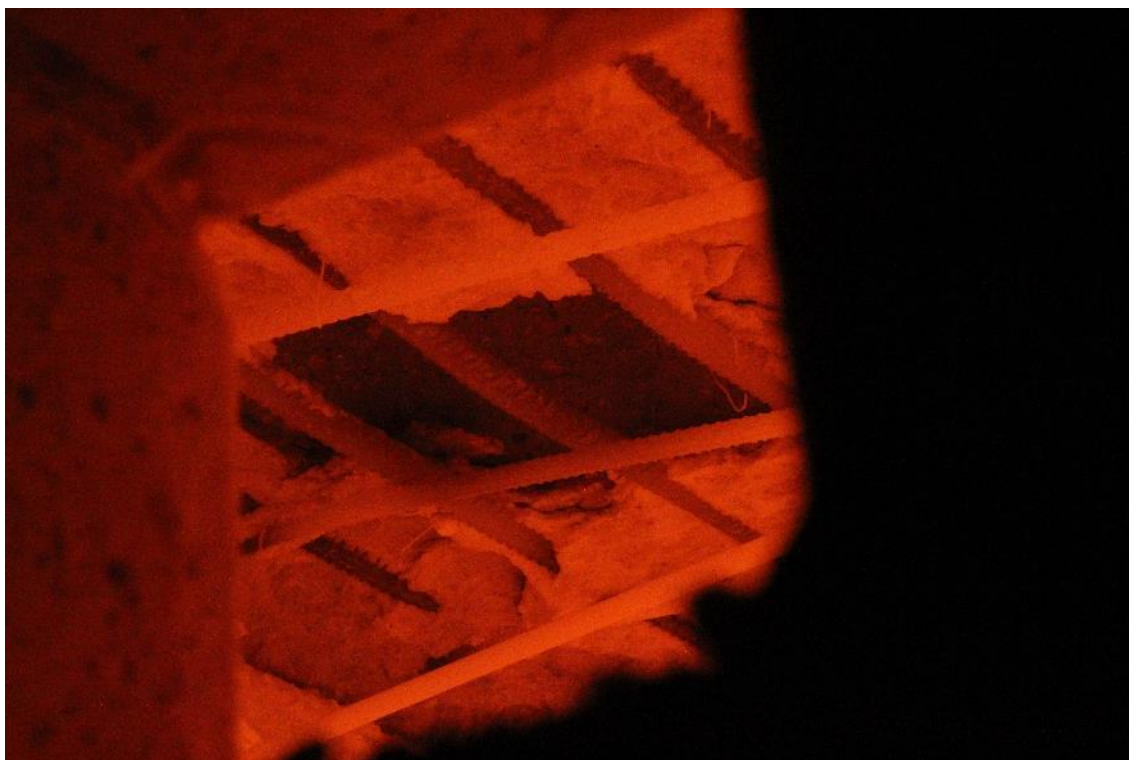
Figure 16. Spalling continues beyond the reinforcement in a spot on both large slabs without PP fibres tested in series 1.

Furthermore, during the test on large slabs one zone of each specimen spalling continued in a spot with very low intensity until the termination of the test after 60 minutes, see Figure 16. The reason for this spot wise spalling with a diameter of around 30 cm digging out a cavity in the specimen is difficult to know in detail. A possible explanation is that these zones were less cracked then the rest of the specimen so higher stresses were created during heating. This spalling in cavities also indicates that spalling beyond the reinforcement layer can and should not be assessed with this test setup.

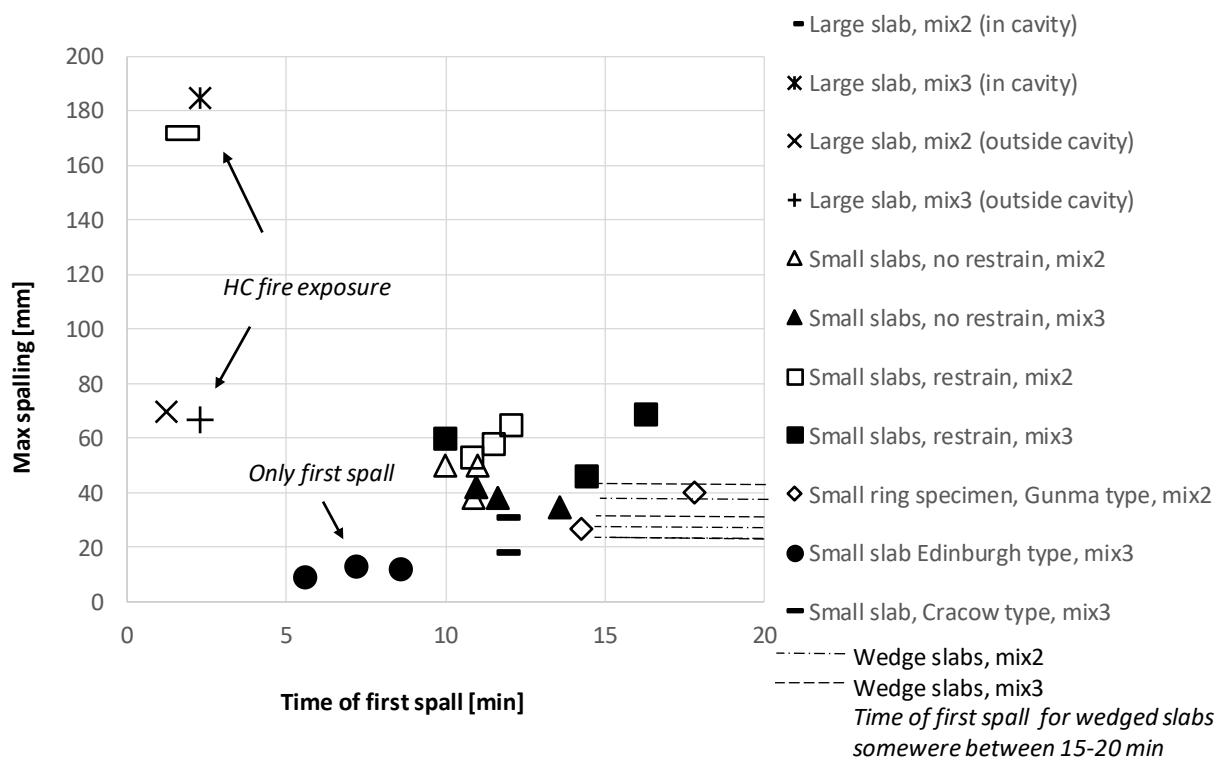
Figure 17. Spalling time and maximum spalling depths for all specimens that spalled in test series 1. All specimens, except when indicated, were exposed to the standard fire curve and were fire exposed until spalling stopped.

All results on spalling from the test series 1 are summarized in Figure 17. None of the tests on mix 1 with 1 kg/m³ PP fibres included spalled. Also, the small ring specimens of Gunma type mix 3 did not spall. In Figure 18 and 19 results from the two mixes that spalled are separated in one diagram each.

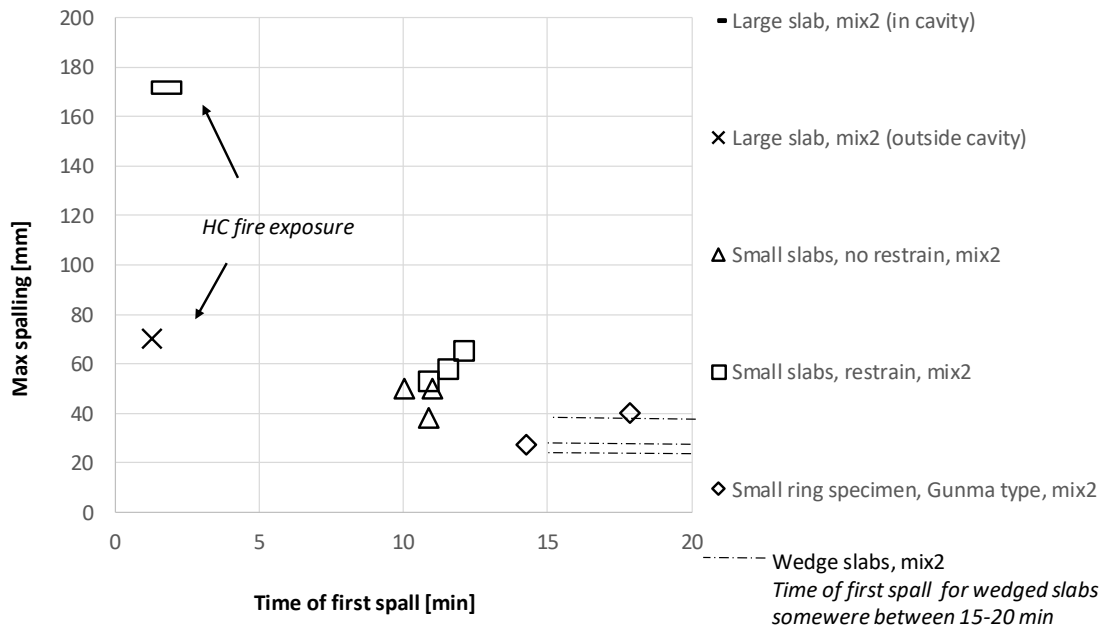
Figure 18. Spalling time and maximum spalling depths for specimens mix2 that spalled in test series 1. All specimens, except when indicated, were exposed to the standard fire curve and were fire exposed until spalling stopped.

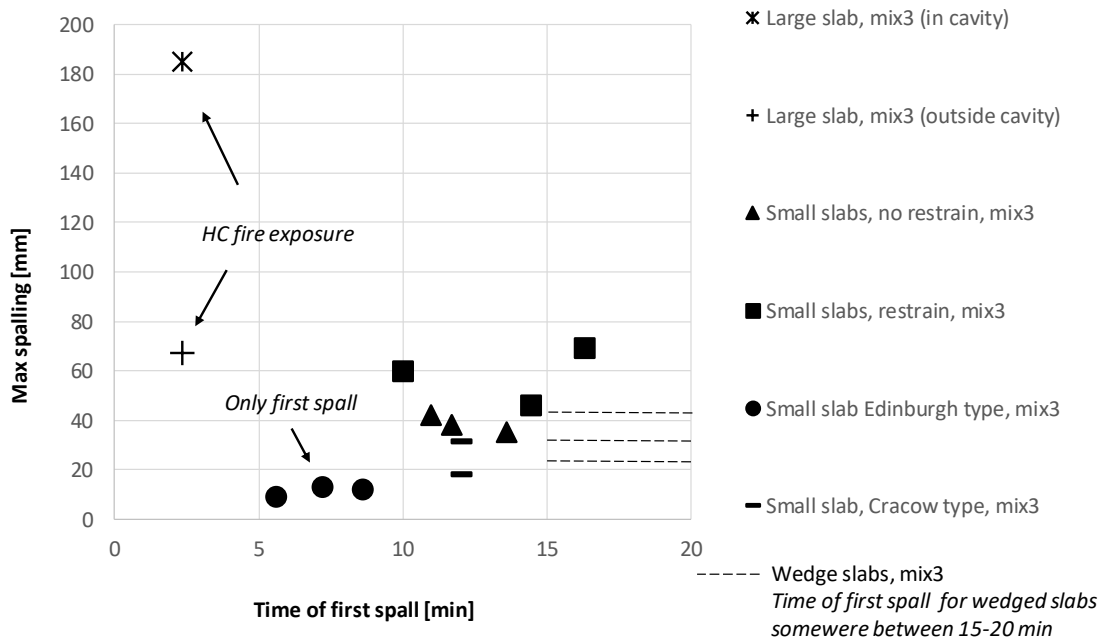
Figure 19. Spalling time and maximum spalling depths for specimens mix3 that spalled in test series 1. All specimens, except when indicated, were exposed to the standard fire curve and were fire exposed until spalling stopped. Gumma type specimens (small ring specimens) of mix 3 did not spall.

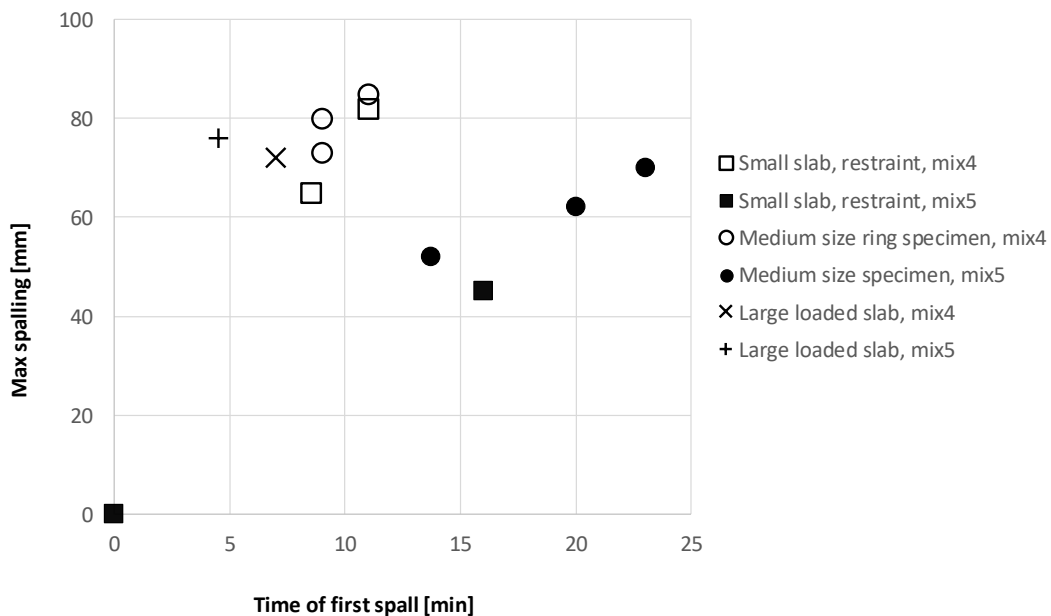
Figure 20. Spalling time and maximum spalling depths for all specimens that spalled in test series 2 with an addition of the small restraint slab of mix 5 that did not spall.

Results in test series 2 showed that all specimens without PP fibers, mix 4, spalled with all three test methods. When testing the mix with 0.2 kg/m³ PP fibres, mix 5, one of the small restrained slabs did not spall whereas all three large ring specimens and the loaded large slab did spall. All results can be seen in Figure 20 and in Table 6. Based on the result that one of the small restrained slabs of mix 5 did not spall the large ring specimen was shown to be the most representative test method compared with the large loaded slabs.

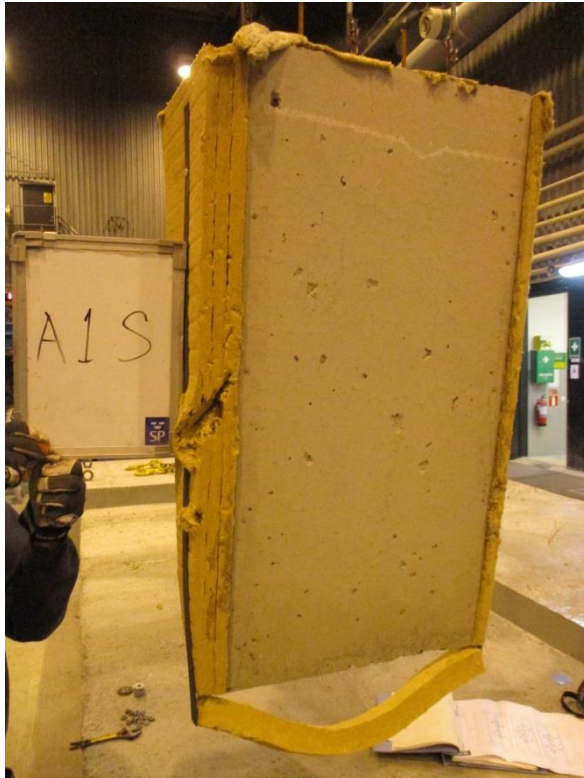
Figure A55. Test specimen Wedge-Slab 25: 1000x500-50-300 Mix 1 0.33-1.0kgPP after the test.

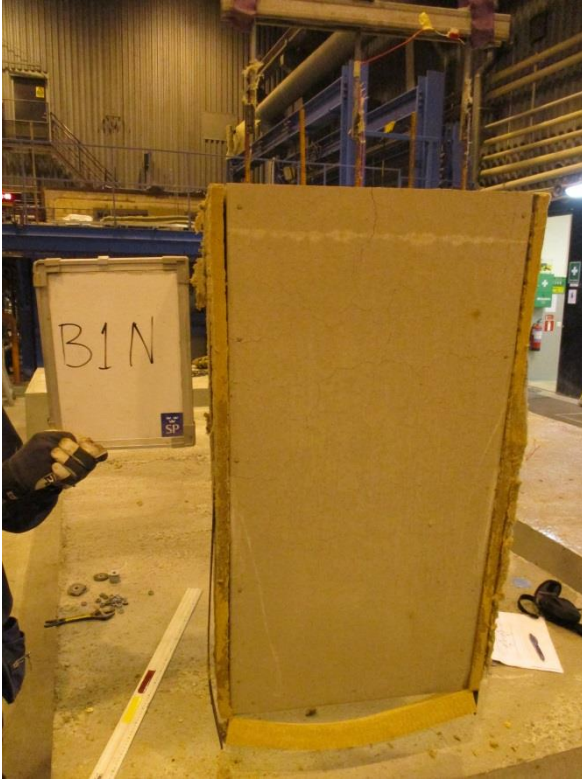
Figure A62. Test specimen Wedge-Slab 19: 1000x500-50-300 Mix 2 0.33-0,0kgPP after the test.

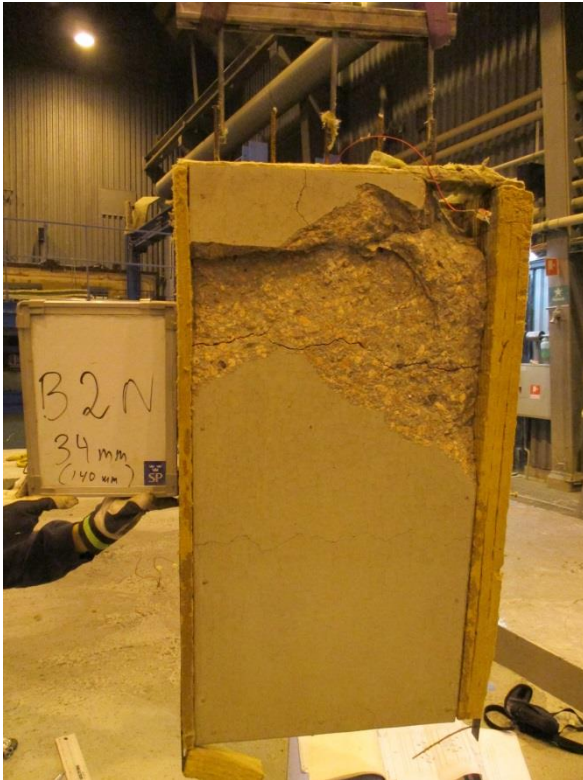
Figure A64. Test specimen Wedge-Slab 20: 1000x500-50-300 Mix 2 0.33-0.0kgPP after the test. **Maximum spalling: 34 mm**

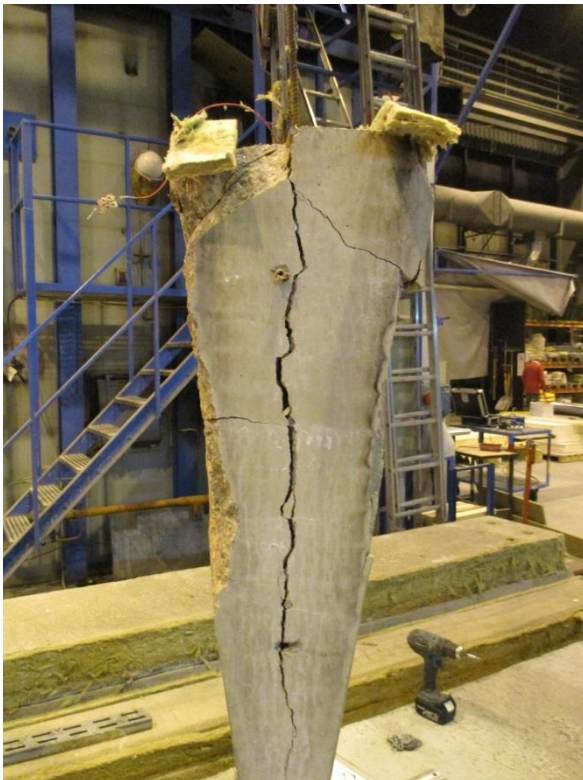
Figure A65. Test specimen Wedge-Slab 20: 1000x500-50-300 Mix 2 0.33-0.0kgPP after the test. **Side view.**

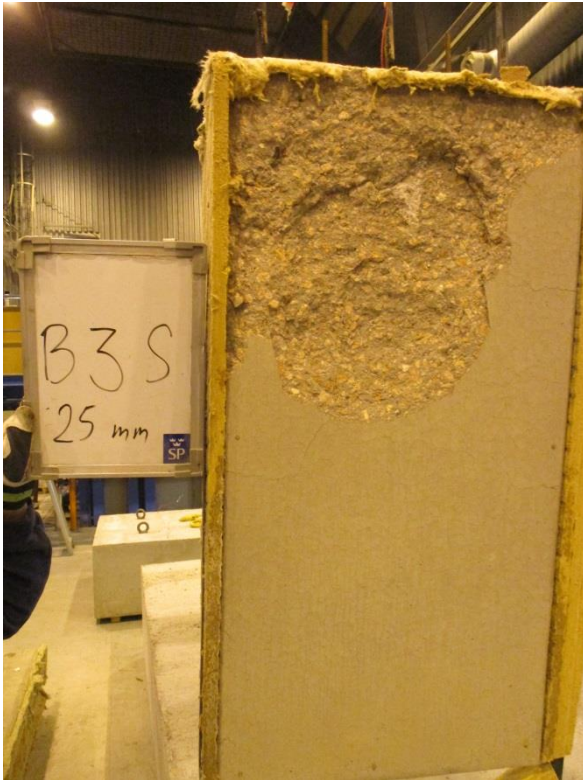
Figure A66. Test specimen Wedge-Slab 21: 1000x500-50-300 Mix 2 0.33-0.0kgPP after the test. **Maximum spalling: 25 mm**

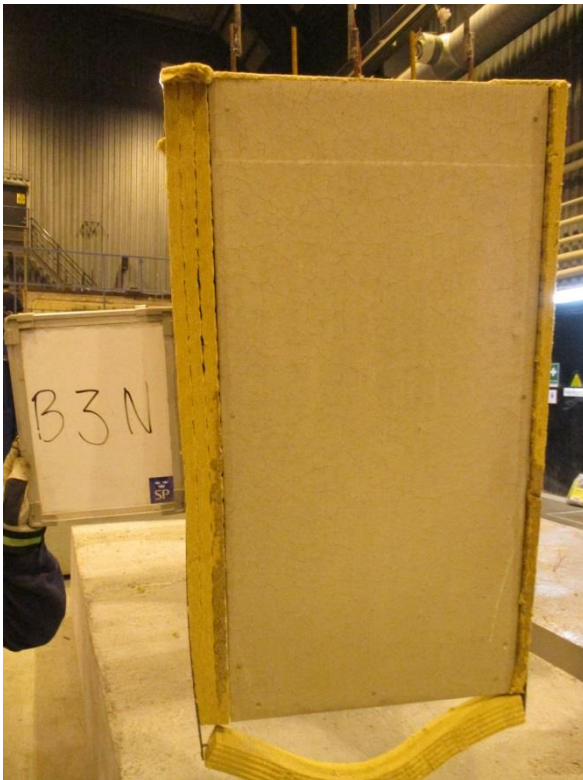
Figure A67. Test specimen Wedge-Slab 21: 1000x500-50-300 Mix 2 0.33-0.0kgPP after the test.

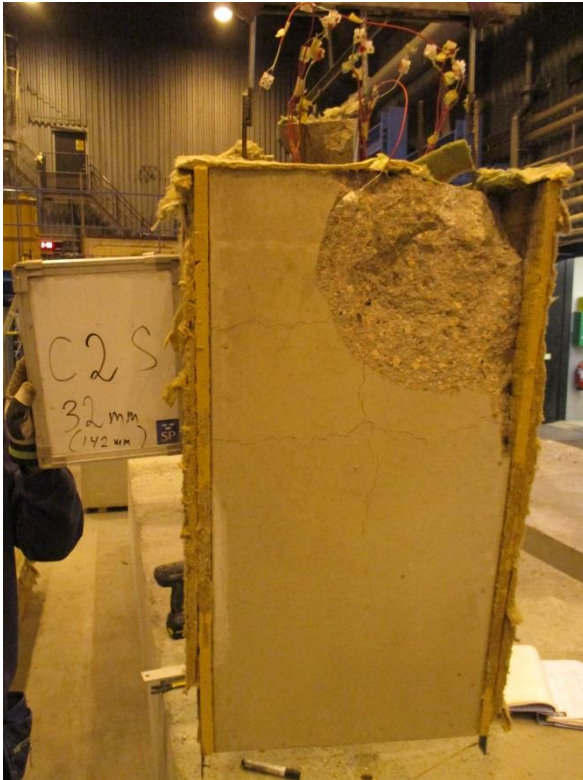
Figure A70. Test specimen Wedge-Slab 23: 1000x500-50-300 Mix 3 0.40-0.0kgPP after the test. **Maximum spalling: 32 mm**

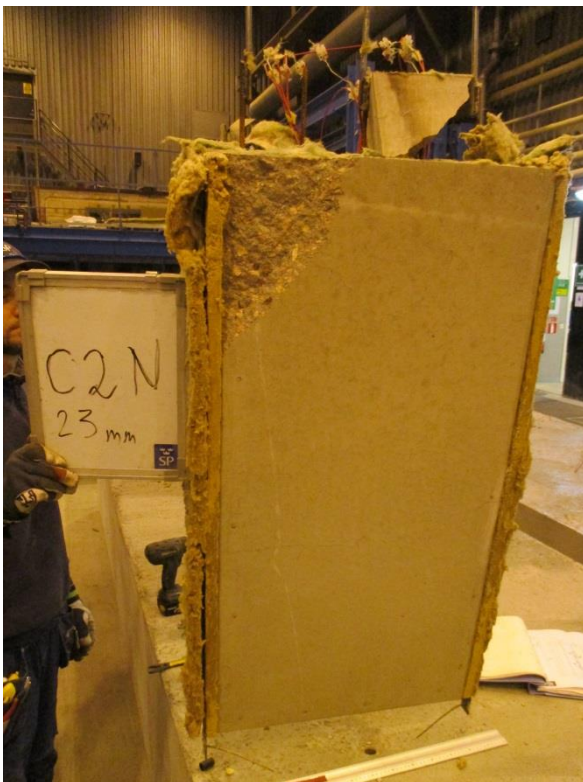
Figure A71. Test specimen Wedge-Slab 23: 1000x500-50-300 Mix 3 0.40-0.0kgPP after the test. **Maximum spalling: 23 mm**

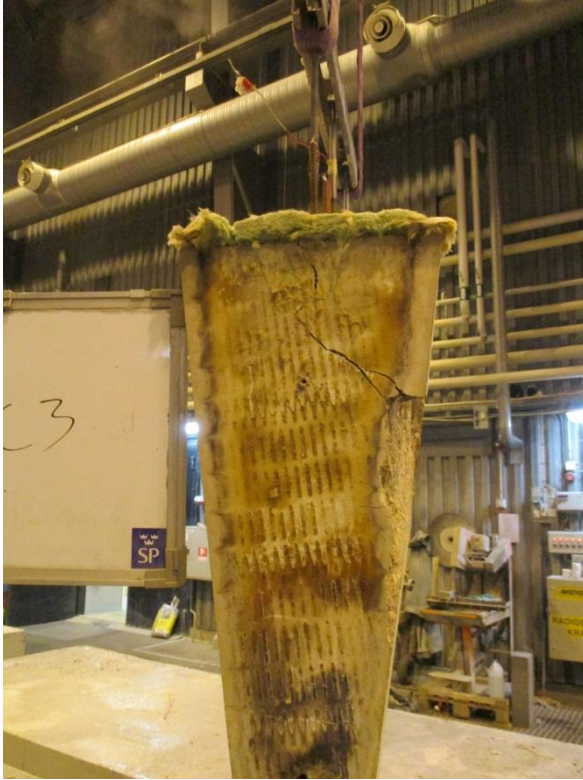
Figure A74. Test specimen Wedge-Slab 24: 1000x500-50-300 Mix 3 0.40-0.0kgPP after the test. Side view.

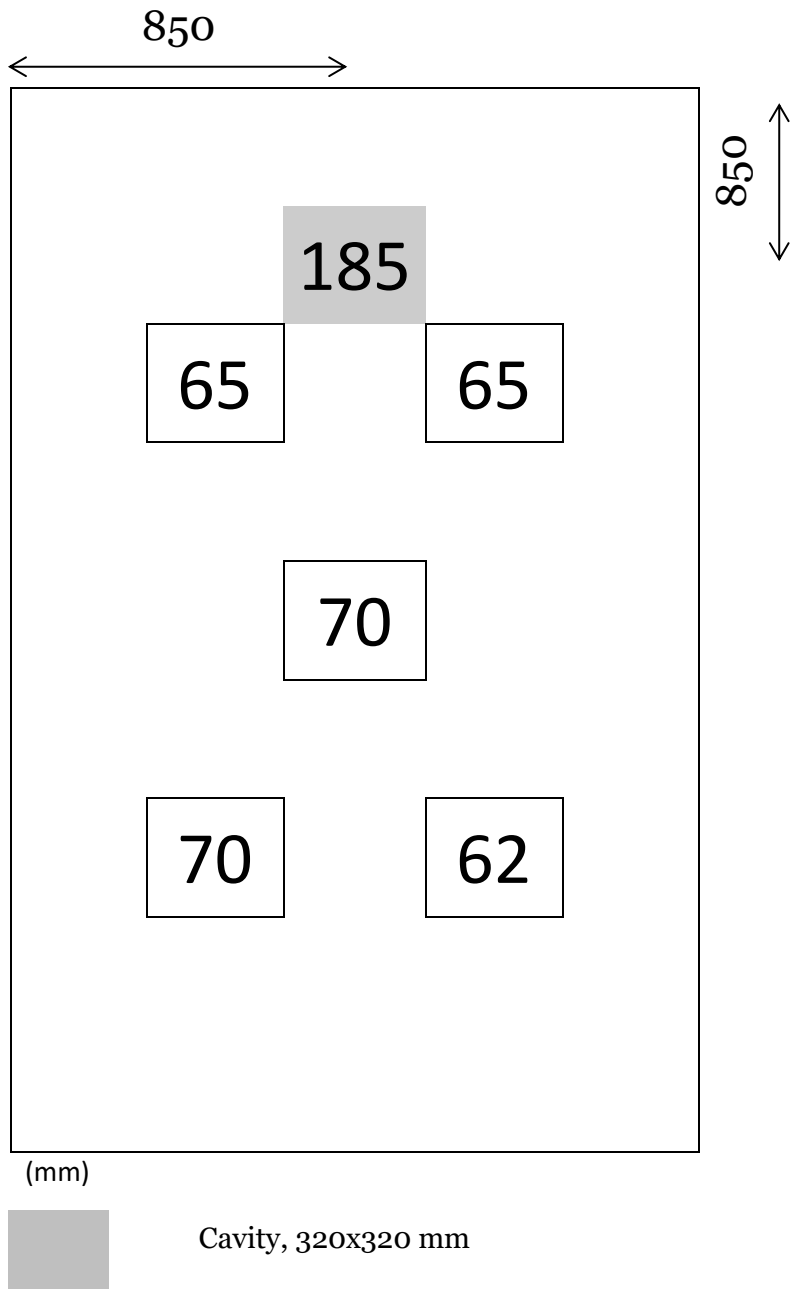
Figure A88. Spalling measurements on test specimen Large slab 29: 4000x1670-600 Mix 3 0.33-0.0kgPP. **Max spalling depth: 185 mm**

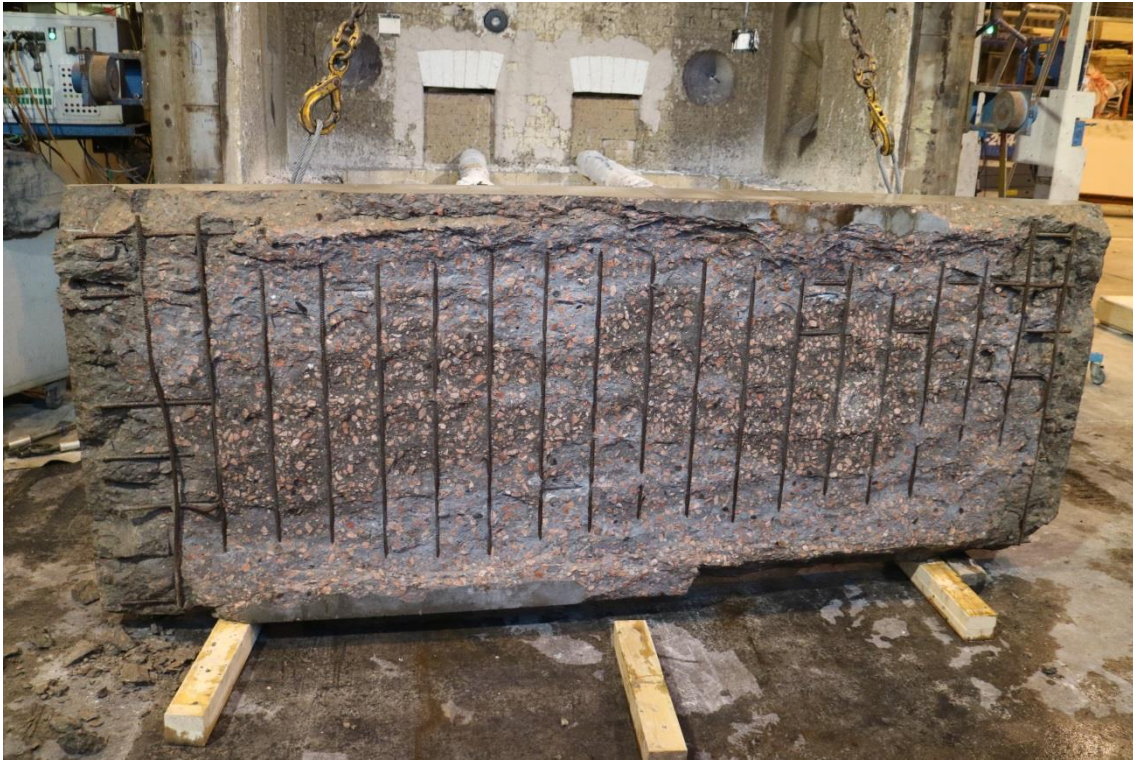
Figure A152. Test specimen after the test. The whole surface is spalled to the depth of the reinforcement.

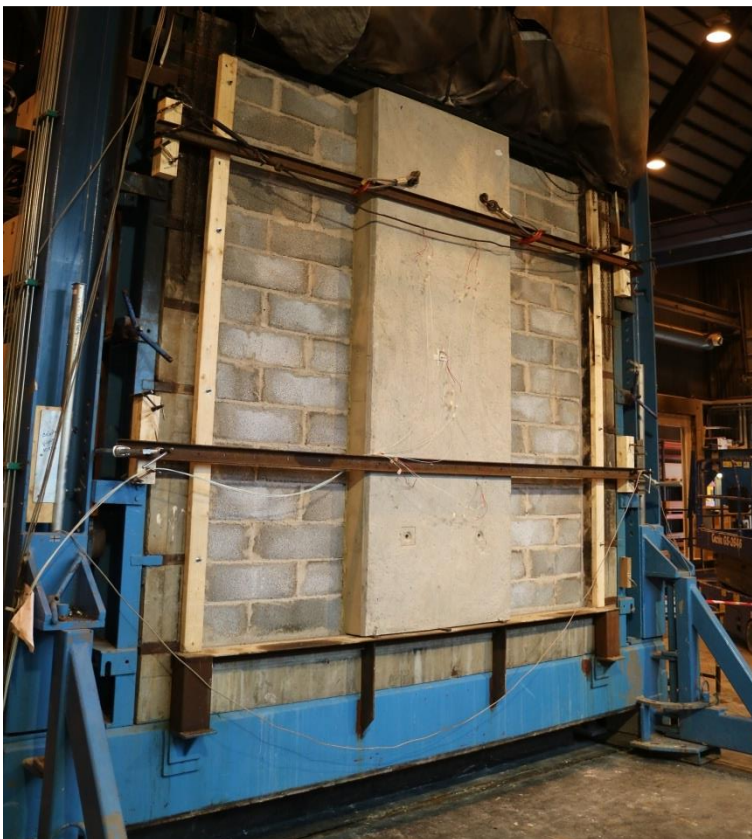
Figure A153. The test setup at the beginning of the test.

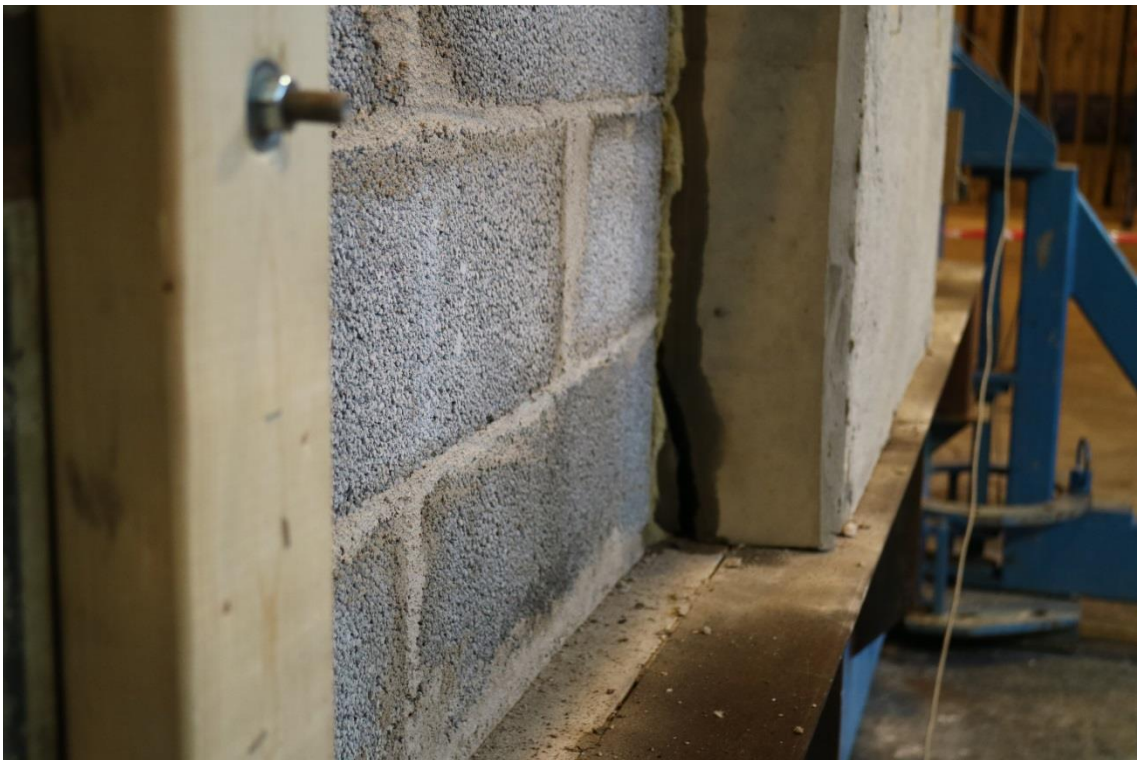
Figure A155. The slab is cracked at the bottom.

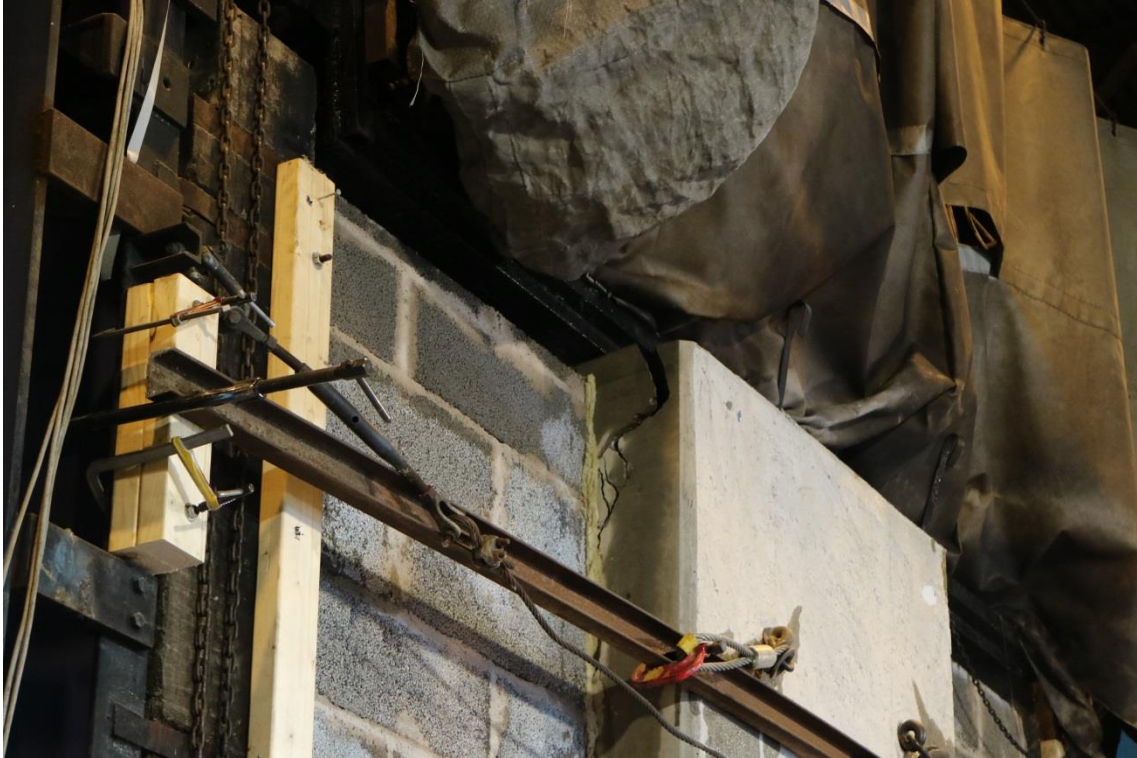
Figure A156. The slab is cracked at the top.

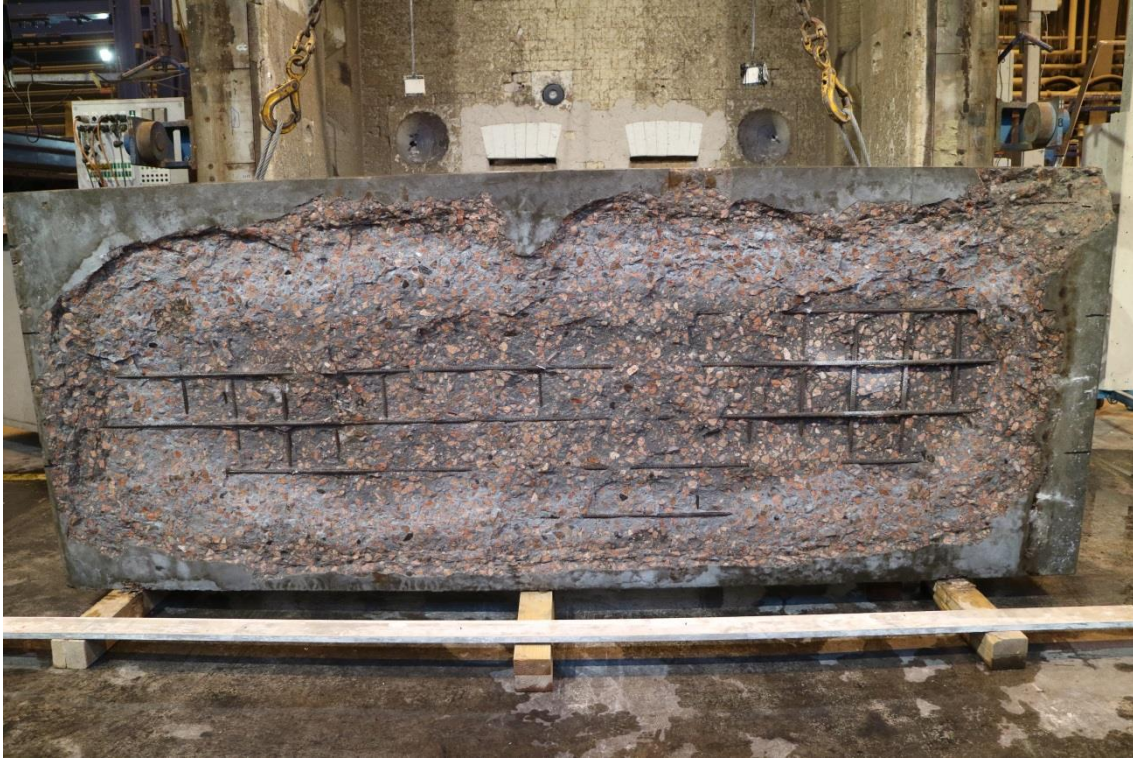
Figure A162. Test specimen after the test. The whole surface is spalled to the depth of the reinforcement

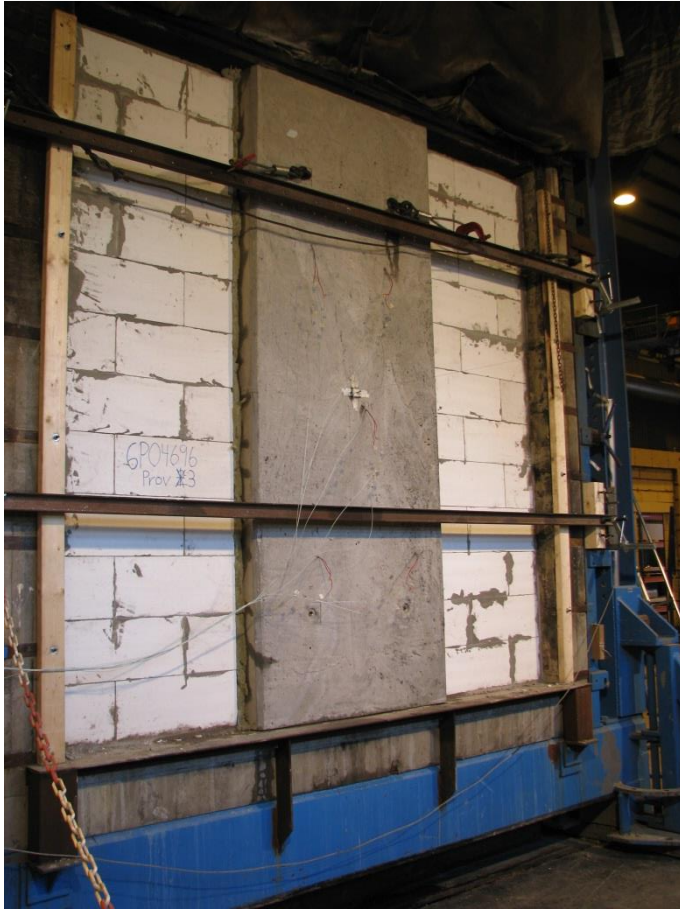
Figure A166. The slab after the test. The slab is cracked on the sides. Water is coming out from the cracks.

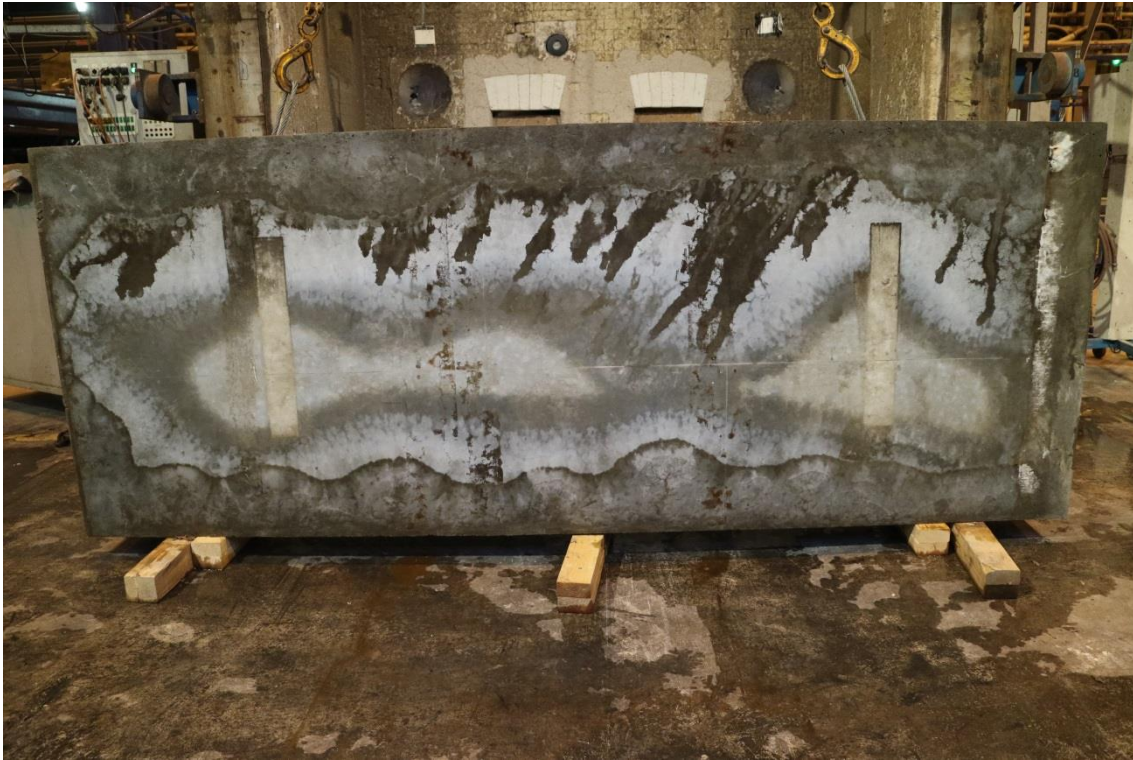
Figure A171. Test specimen after the test. No spalling was observed.
