# **A Practical Guide to Non Destructive Examination of Concrete**

2004

A Project sponsored by Nordic Innovation

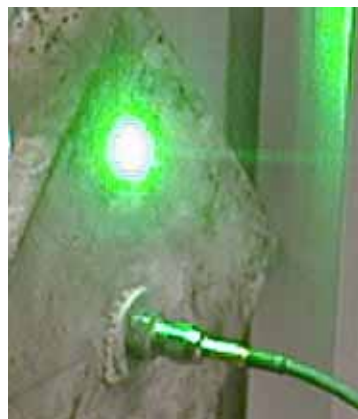
Trial using laser to create surface waves in concrete

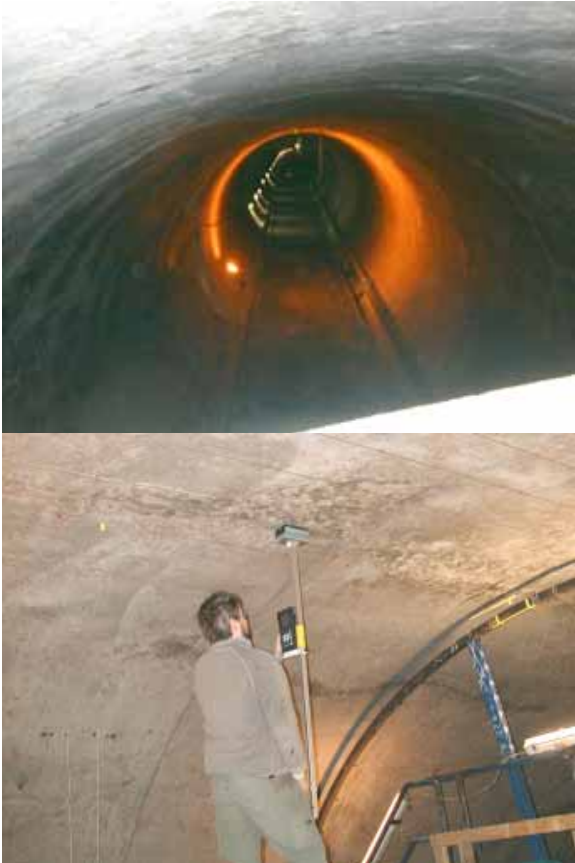
**Fig. 2.2.1:** Tunnel with in-situ cast concrete liner (nominal thickness 600 mm). The thickness of the concrete is being measured using ultrasonic pulse echo.

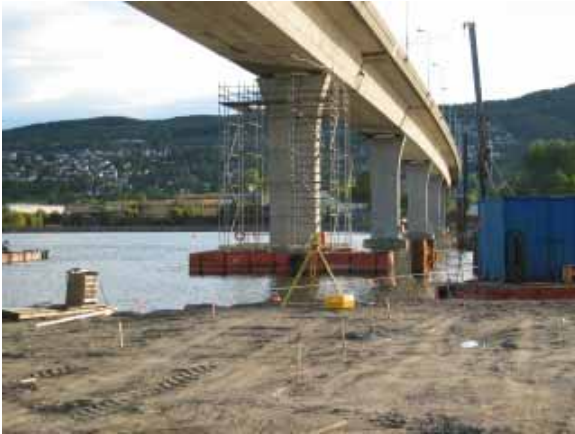
**Fig. 2.4.1:** A box-girder bridge in Norway. The pre-stressed cables in the beams are being examined using a Cobalt isotope and Betatron.

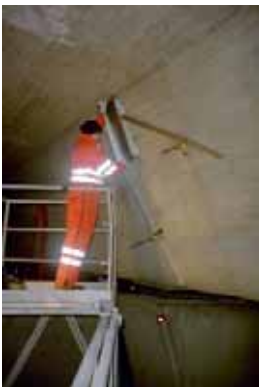
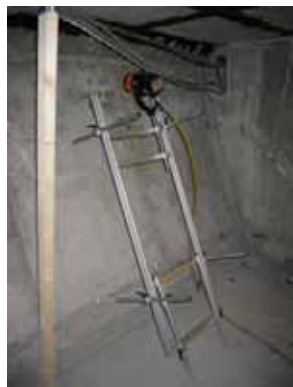
**Fig. 2.4.2:** The isotope in position on the inside (right) and image plates being fixed on the outside (left).

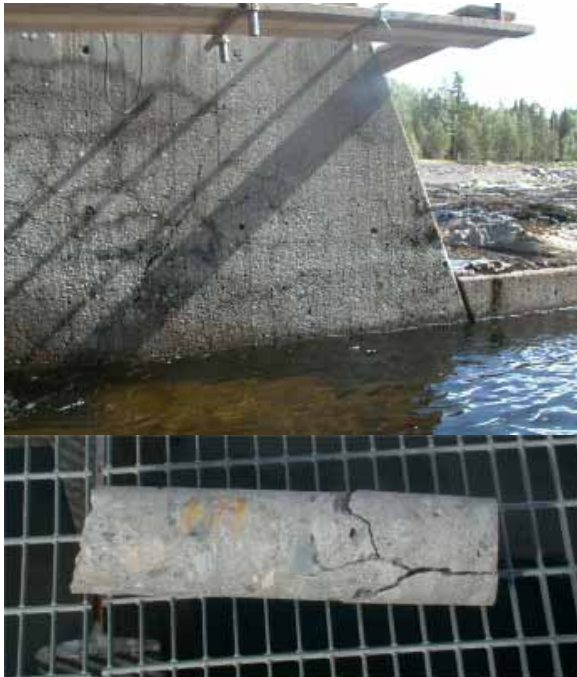
**Fig. 2.5.1:** A dam pillar in the north of Sweden. The concrete is suffering from freezing damage as well as ASR. Tests were made to find out how deep the cracks extended from the surface.

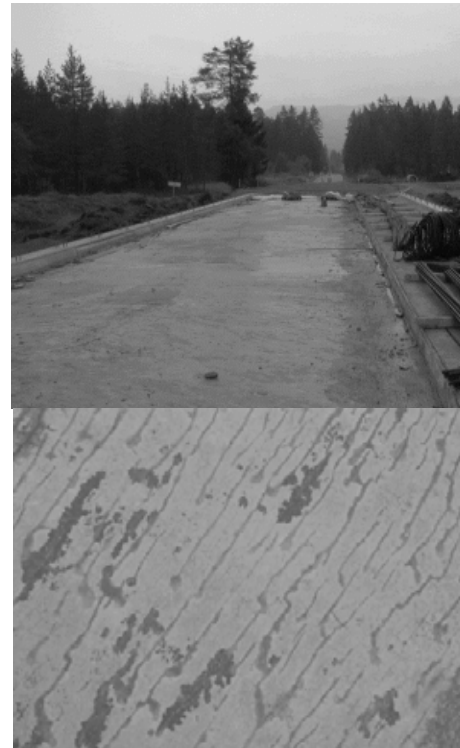
**Fig. 2.5.2:** A new bridge in Norway. Drying-shrinkage cracks appeared after casting the slab. The crack depths were found to be less than the cover thickness to reinforcing.

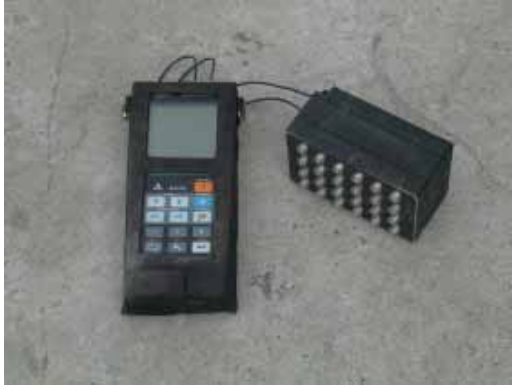
**Fig. 3.2.1:** The U.P.E. unit with transducer array on the right and small field computer on the left. This instrument is powered by four 1.5 V batteries, which normally are sufficient for at least two days of measurement. This unimposing instrument is probably the most advanced and usefull acoustic tool experienced by the authors.

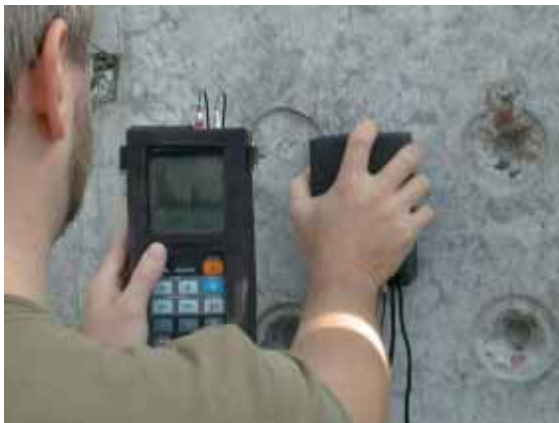
**Fig. 3.2.2:** The transducer is pressed against the concrete and a measurement is completed and stored in a couple of seconds

U.P.E. is based on the propagation and reflection of mechanical waves. This particular instrument uses the shear wave component (as opposed to compression wave). The waves are generated at the concrete surface by an array of transducers that resonate horizontally. The transient\* waves

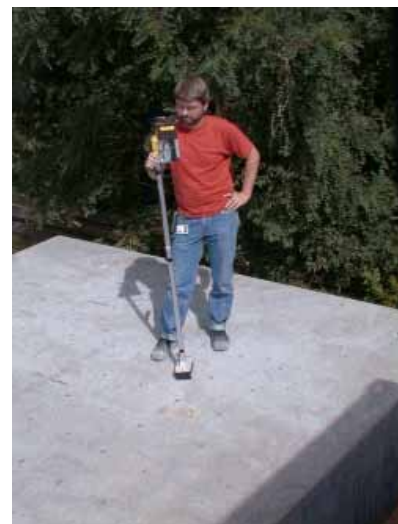
**Fig. 3.2.4:** Testing concrete "the comfortable way" using U.P.E. The equipment is surprisingly light and simple to use yet very capable for detailed testing of quite thick structures.

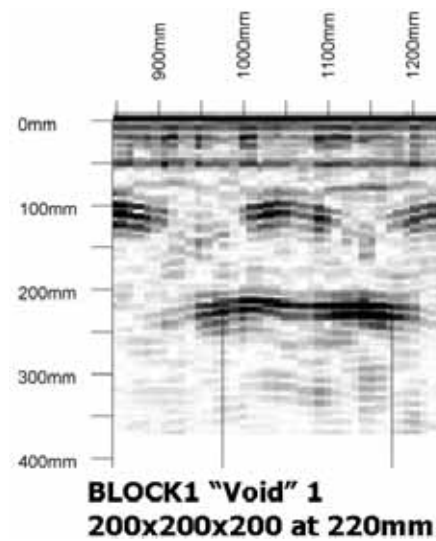
**Fig. 3.2.6:** Artificial void in Block 1. This void at 220 mm can be clearly seen and the size of the void (parallel with the surface) can be estimated. (The thin vertical lines indicate the void edges.)

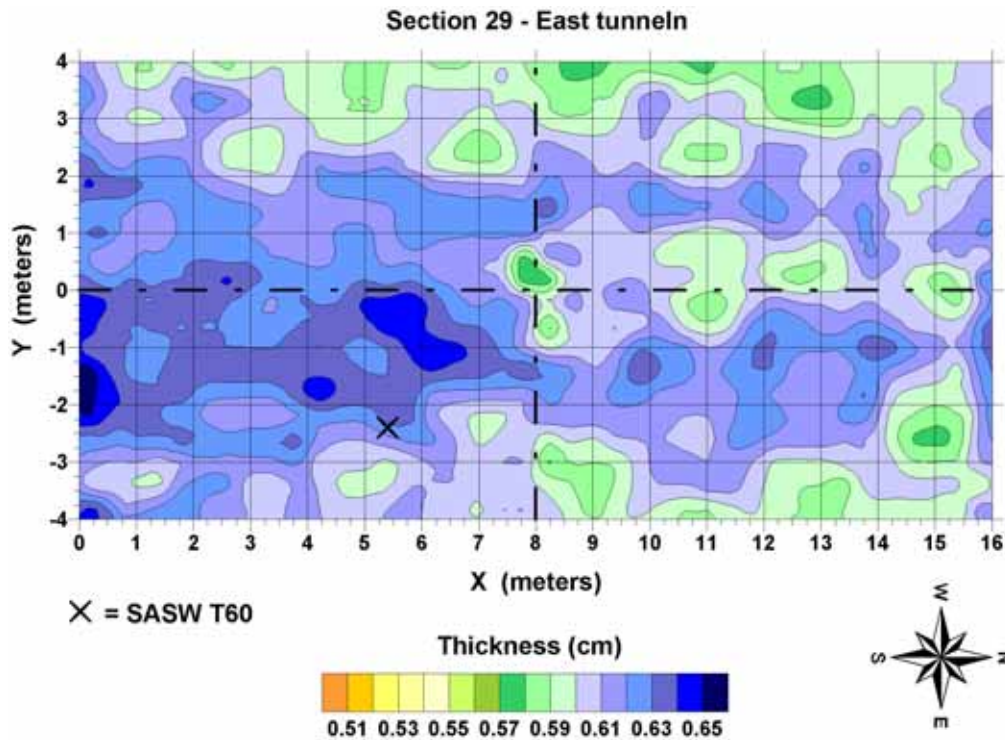
**Fig. 3.2.7:** Result of thickness mapping with the U.P.E.-instrument. The depth/thickness of the concrete is contoured. The concrete in this case has a nominal thickness of 600 mm. The concrete is of high quality (K50) with crushed granite aggregates of max size 25 mm. The concrete is un-reinforced. The area shown in the C-scan above is 128 m<sup>2</sup>. The concrete has been cast against a lower density membrane and it is at the interface between the membrane and the concrete that the reflections occur.

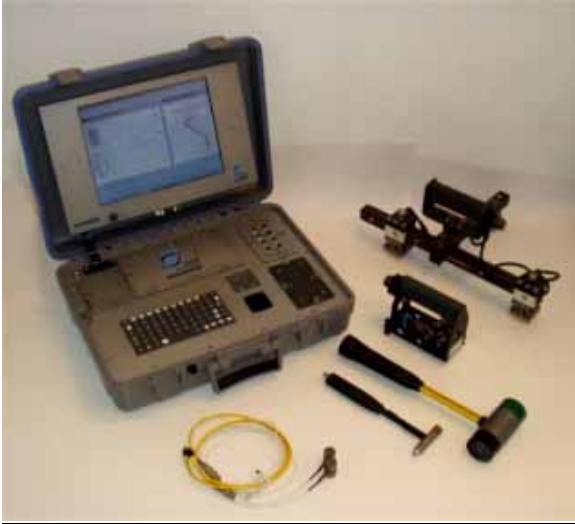
**Fig. 3.3.1:** The impact echo equipment including the field computer and various impactors and transducers (receivers).

By striking the concrete surface with a hammer or similar, compression waves are generated that propagate into the concrete and are reflected from the backside and propagate back to the surface of impact. The reflections back and forth between the surfaces will continue in the form of a standing wave with a frequency,  $f$  dependant on the velocity of the compression wave,  $v_c$  and thickness of the section,  $d$ :

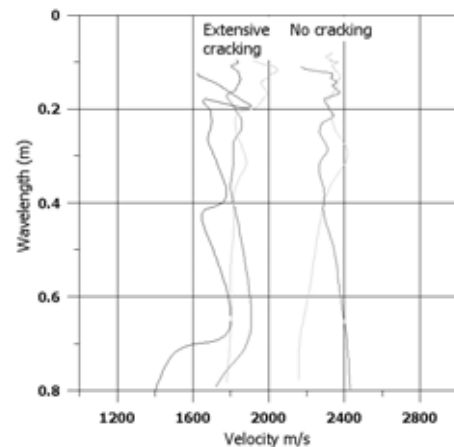
**Fig. 3.4.2:** Data collected with SASW. The dispersion curves are from a concrete wall with visible surface opening cracks.

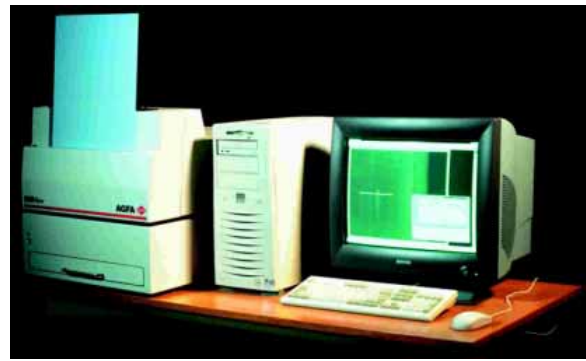
**Fig. 3.5.1:** On the left is the scanner with an inserted image plate and to the right a workstation.

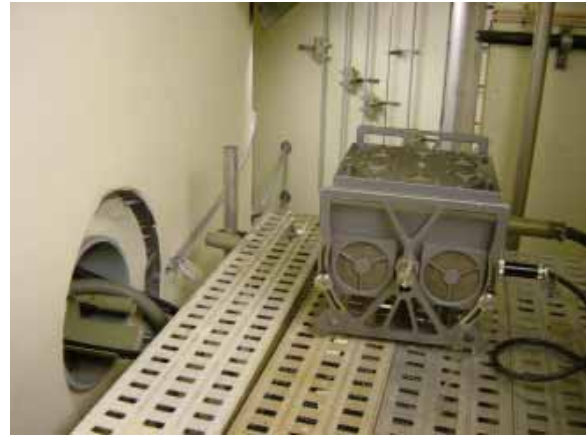
**Fig. 3.5.3:** The 7.5 MeV Betatron Source. In the photo we see the accelerator itself. The equipment is set up to x-ray a wall.

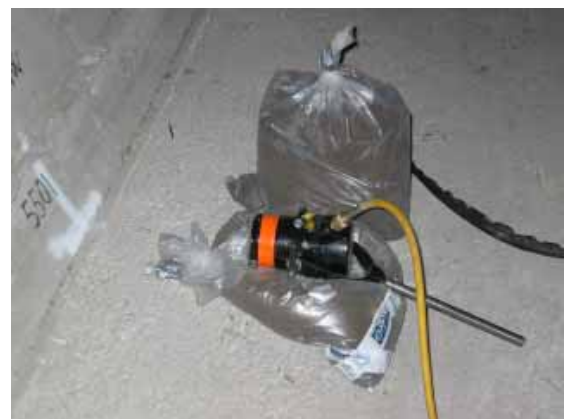
**Fig. 3.5.4:** A cobalt (Isotope) source "Collimator" with additional shielding from sand bags on each side

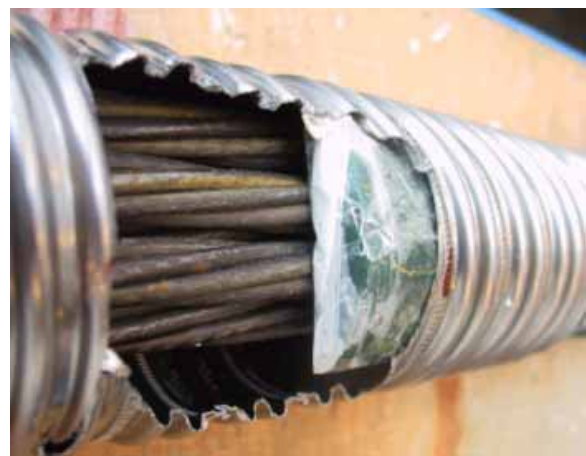
**Fig. 3.5.7:** Cable duct being prepared with air- and water-filled voids. The cable duct has a diameter of 70mm and contains 12 x 12.5 mm vsl cables. It is in other words a heavily reinforced and congested cable duct. The "voids" are placed on the outside of the cables. The duct was then cast in a 30 mm thick concrete beam.

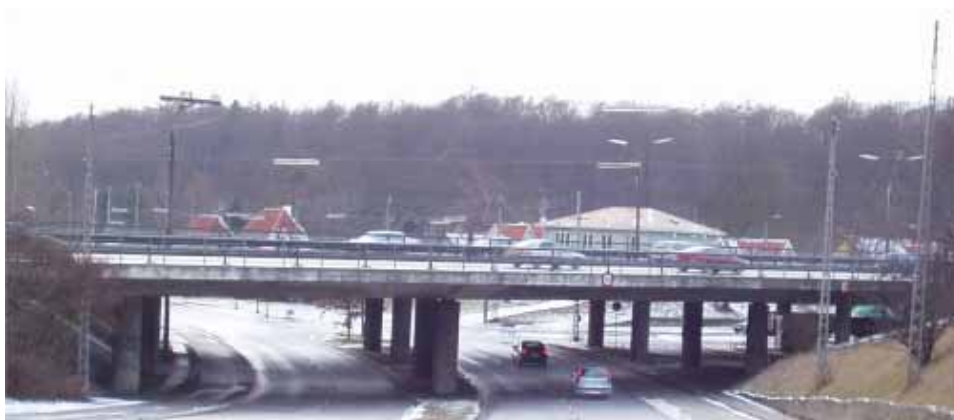
**Fig. 3.5.10:** Skovdiget bridge in Copenhagen. This 30, year old bridge has been suffering from frost damage, asr and reinforcement corrosion. Some of the post-tensioned beams were badly cracked.

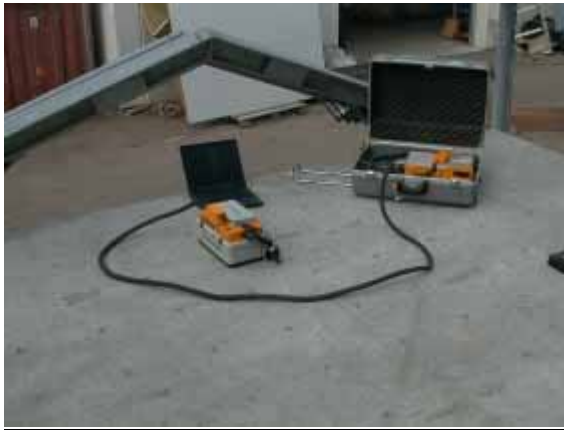
**Fig. 3.6.1:** A GPR system consists of a laptop, a control unit and an antenna. Battery operation is normally used.

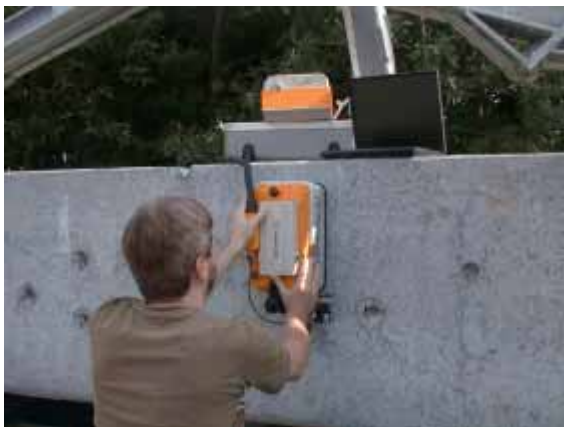
**Fig. 3.6.2:** The antenna is pulled along the surface of the concrete. The measurements are thus made continuously. No contact medium is required between the antenna and the concrete surface.

Electromagnetic methods such as the standard covermeter and radar use electrical induction and electromagnetic wave transmission respectively. The covermeter is a simple tool, which is normally only used to locate rebars close to the concrete surface. The radar equipment is based on the ground penetrating radar but for concrete it usually operates at a much higher frequency. Radar provides us with information on the wave transmission/reflection times and the amount that the wave energy is damped. The strongest asset of

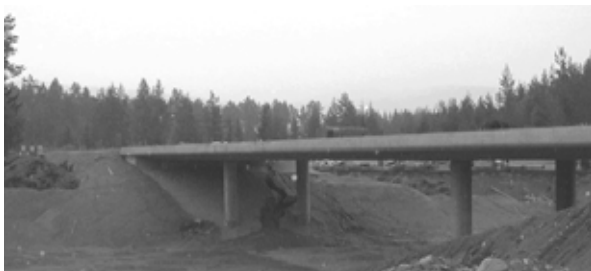
**Fig. 4.2.10:** Newly constructed bridge in Norway. The bridge slab is 850 mm thick and tapered at the edges. Some drying-shrinkage cracks appeared in the top surface. The w/c-ratio of the concrete is 0.4 and the maximum aggregates are 25 mm. The visibility of the back wall (underside of the bridge slab) tells us that the surface-opening cracks are probably shallow and that the concrete is otherwise free from internal damage. See Fig. 4.2.11.

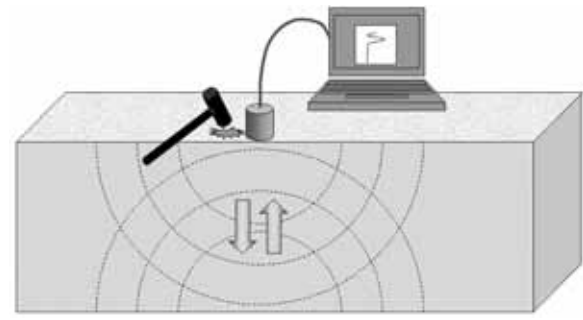
**Fig. 4.2.2.1:** Impact Echo - The concrete is struck with an impactor creating mechanical waves that propagate back and forth between the surfaces. The frequency of this resonance is used to determine thickness, depth to interfaces and P-wave velocity.

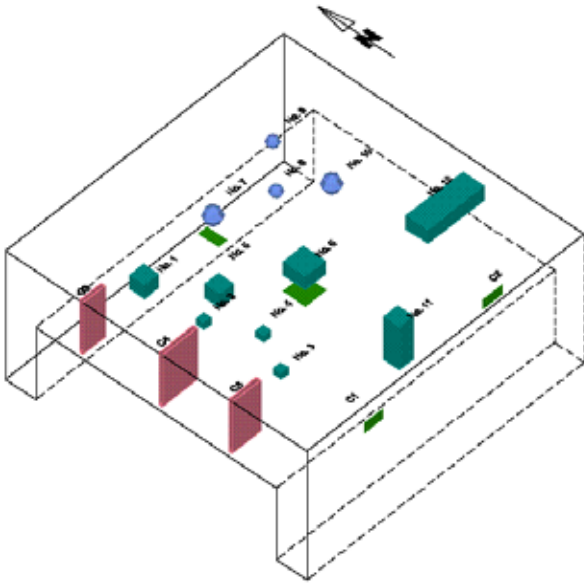
**Fig. 4.3.3:** View of Block 1 including the defects in the form of voids and thin plates to represent cracks.

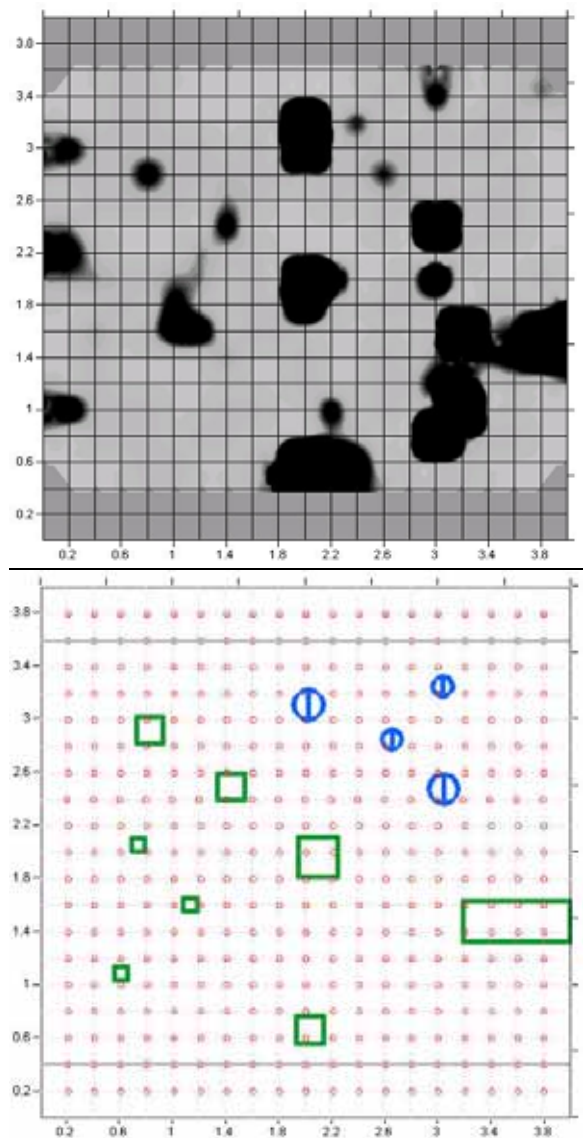
**Fig. 4.3.2.2:** Grid-scan of block no. 1 using U.P.E. The upper diagram shows the result of time-delay calculation for the wave back-wall reflection, with dark areas representing suspect positions. The lower diagram shows the actual position of the voids (this diagram does not include the three voids on the left edge of the block or the large steel plate with attached air voids in the lower right region (detected by upe)). See Appendix 4 for more details of all the defects in this Block.

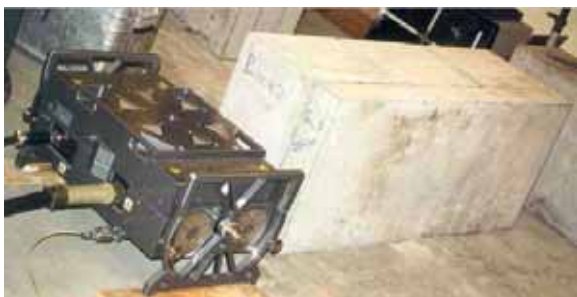
**Fig. 4.3.7.1:** The Betatron accelerator in the laboratory while making tests on 1500 mm thick concrete. A 8 mm thick steel plate has been sandwiched between 1200 mm and 300 mm concrete. Holes in this steel plate can be seen in the radiographic images. See also Appendix 4, Fig. A 4.18.

Tests were made on mock-ups with various void sizes inside an embedded cable duct and concrete. The thickness of the concrete was varied from 300 mm to 1200 mm using a number of other blocks. The fact that the blocks are assembled to make up the required thickness has no bearing on the technique. The smallest (air-filled) void we have investigated is 15 mm square. This was visible in our 1000 mm thick mock-up. Very small voids and even air pores a few mm in size can be clearly seen in some of the images.

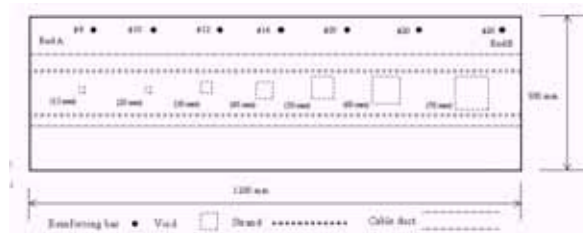
**Fig. 4.3.7.4:** Sketch of the block with encast cable duct and voids (seen from above). The voids are placed centrally in the injection grout and are therefore not in contact with the thin walls of the duct.

The mock-up beam is 300 mm thick and the cable duct is 150 mm in diameter. The duct contains 3 VSL\* cables and has been filled with cement grout. Voids have been made in the grout as shown. The voids are 15, 20, 30, 40, 50, 60 and 70 mm rectangles. The beam is also reinforced as shown with  $\phi$  8, 10, 12, 16 and 20 mm bars.

Images of the block were produced with a 7.5 MeV Betatron. See Fig. 4.3.7.5 (300 mm) and 4.3.7.6 (600 mm) below. The total thickness was increased in stages up to 1200 mm using extra blocks 100 mm and 300 mm thick. Results are presented in the two following figures.

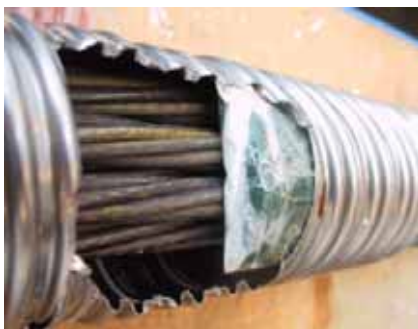
**Fig. 4.3.7.9:** Cable duct being prepared with air- and water-filled voids. The cable duct has a diameter of 70mm and contains 12 x 12.5 mm vsl cables, i.e. a heavily reinforced and congested cable duct. The “voids” are placed around and outside the cables. The duct was then cast in a 300 mm thick concrete beam

The example shown above is perhaps less realistic, as cable ducts are usually quite congested with cables or strands. In the example below an attempt has been made to imitate a congested cable duct.

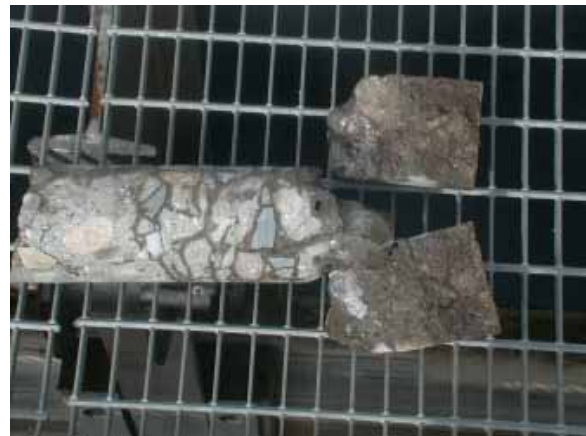
**Fig. 4.6.5.1:** Dam structure northern Sweden. Concrete cracking caused by ASR. The surface cracks are significant – running perpendicular to the concrete surface. The outer 100 mm has separated on drilling out. Internal cracks and porosity can be seen by the dark, moist pattern

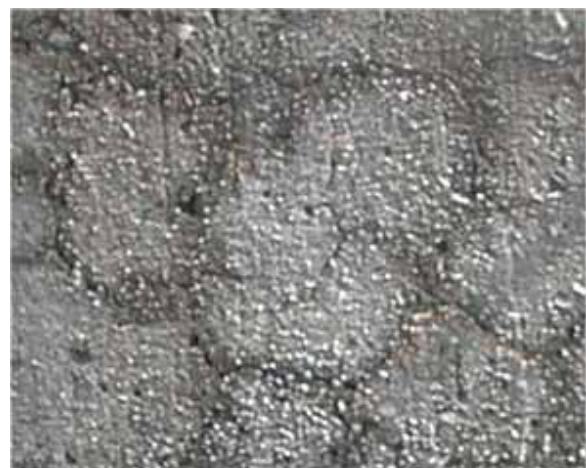
**Fig. 4.6.5.2:** Crack pattern as seen on the concrete surface. The picture covers an area of about 400 mm x 400 mm and was taken near the most severely damaged concrete close to water level.

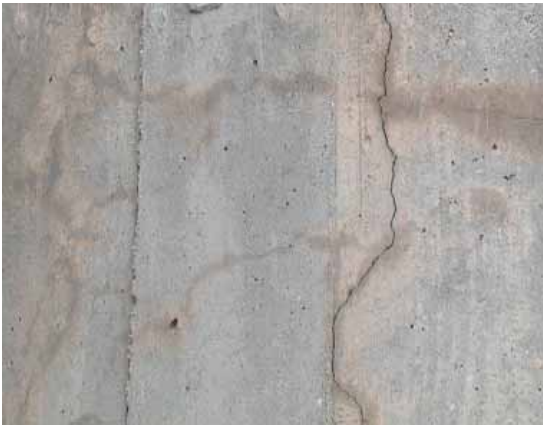
**Fig. 4.6.5.6:** Bridge column with map cracking (shady and moist-like edges suggestive of ASR.) Larger vertical surface open cracks appear at regular intervals around the column, as well as map cracking.

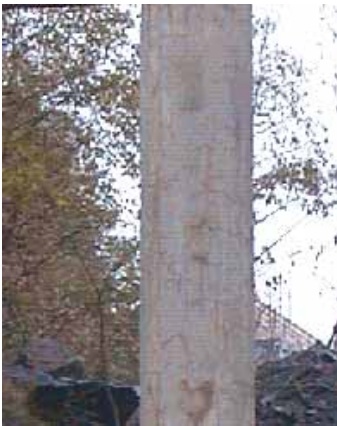
**Fig. 4.6.5.7:** View of the column. The cracking is obvious along the whole length of the column, but most clearly on the side, which is exposed to the prevailing weather (higher moisture levels).

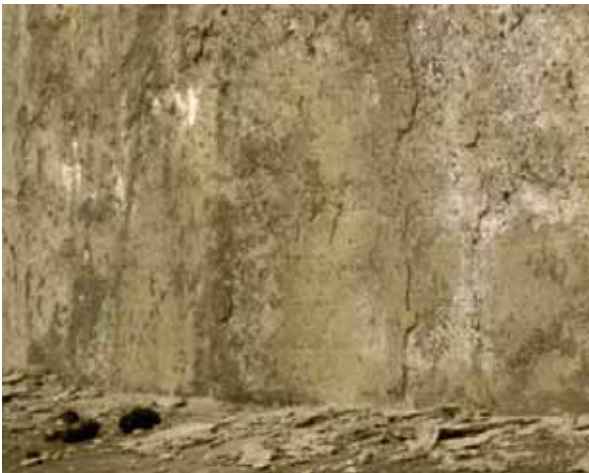
**Fig. 4.6.5.13:** There were obvious signs of frost scaling also.

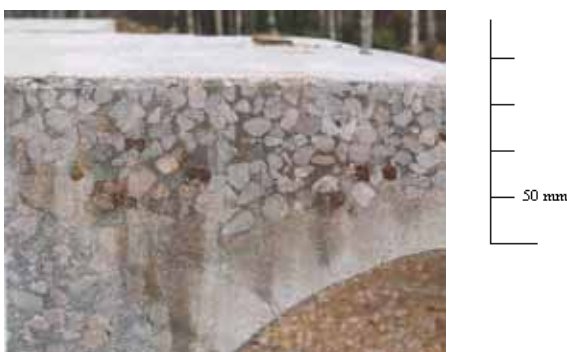
**Fig. 4.6.5.19:** The mock-up used for the repair trial has been cut in sections revealing the condition of the repair along the section tested. It can be seen that the first 150 mm is reasonably well formed with both aggregates and binder. There is however a layer of grout without aggregates, which corresponds with the “weak” layer suggested by SASW.

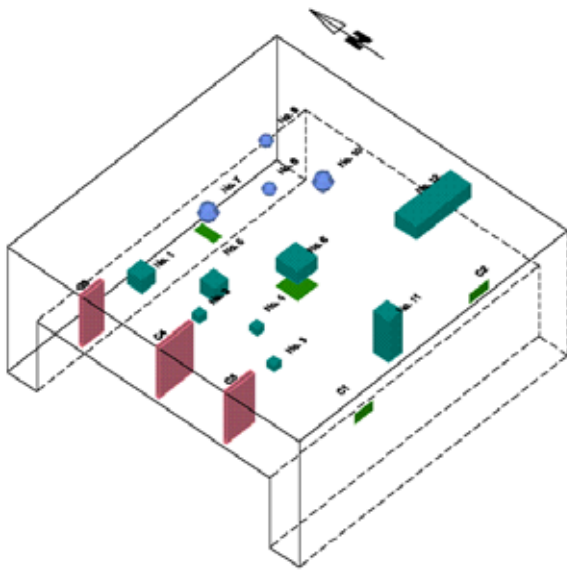
**Fig. A.1.1:** View of Block 1 including the defects in the form of voids and thin plates to represent cracks.

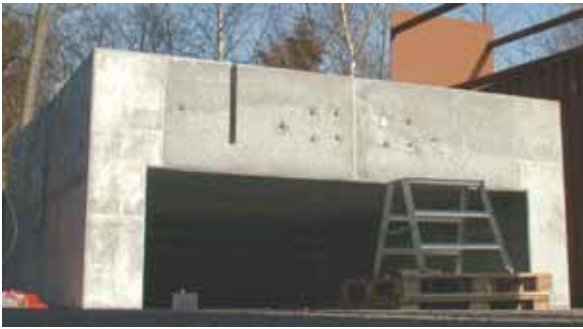
**Fig. A.1.2:** View of Block 1 from NW. In the photo one of the three large “cracks” is seen as well as several LOK (pullout) test scars.

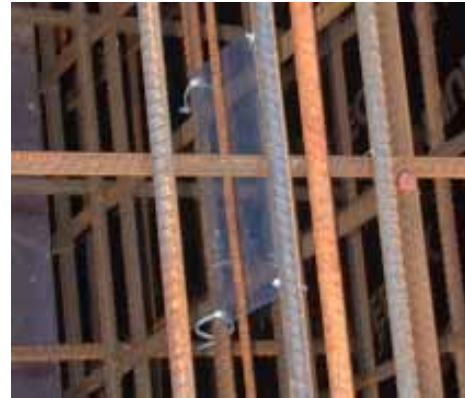
**Fig. A.1.4:** South face of Block 1 with thin plastic sheet securely fixed to the reinforcing. Notice that a thin bar has been fixed behind the sheet to prevent movement or bending.

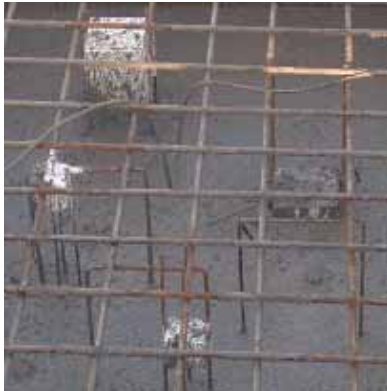
**Fig. A.1.3:** Block 1 during casting with square voids fixed in place. In the upper part of the picture we see two 200 mm cubes at 220 mm and 490 mm depth respectively.

Cubic and spherical voids of various sizes were imitated using polystyrene blocks and hollow plastic spheres. These were fixed securely in the formwork using welded bars and stirrups, to guarantee that they did not move during casting.

In addition to the voids, some thin plastic sheets were installed as shown in Photo 3. These were used so that the response could be compared with 3-dimensional voids.

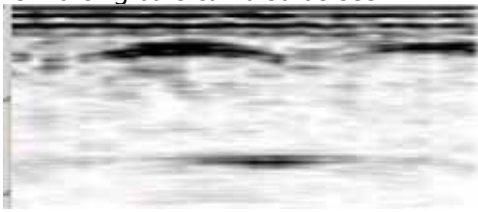
**Fig. A.4.14:** B-scan across Void no. 5 at a depth of 490 mm. The frequency and settings are similar to above. Both the void and reinforcing bars can be clearly seen. (Compare this with Fig. A.4.12 (d))

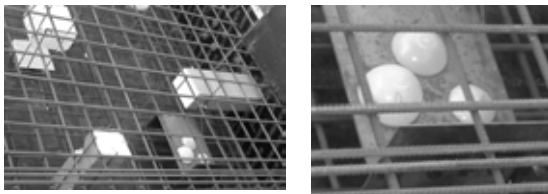
**Fig. A.4.17:** The steel plate cast in Block 1 (260 mm from the underside). In the left-hand figure the artificial voids can be seen on top of the plate. The steel plate is 8 mm thick. Some semi-spheres made of plastic have been glued to the top of the plate to represent voids inside the concrete adjacent to the (back of) plate. Scans were made along the underside of the slab in line with the two voids nearest the edge (closest to the camera in the photo above).

In some situations, it can be interesting to look for air voids around and behind a steel plate cast in concrete. Of course, poor bond or a small air gap between the steel and concrete will have the same effect as a void. UPE cannot distinguish between the two. As can be seen in the following example however, UPE does provide a means of detecting voids behind the steel plate and of measuring their size (parallel to the plate). It could of course be used to determine the type of contact/bond between concrete and steel.
