Life Cycle Behaviour of Concrete Bridges

Laboratory test and probabilistic evaluation

Luleå University of Technology
Department of Civil and Environmental Engineering
Division of Structural Engineering

Licentiate Thesis 2006:59

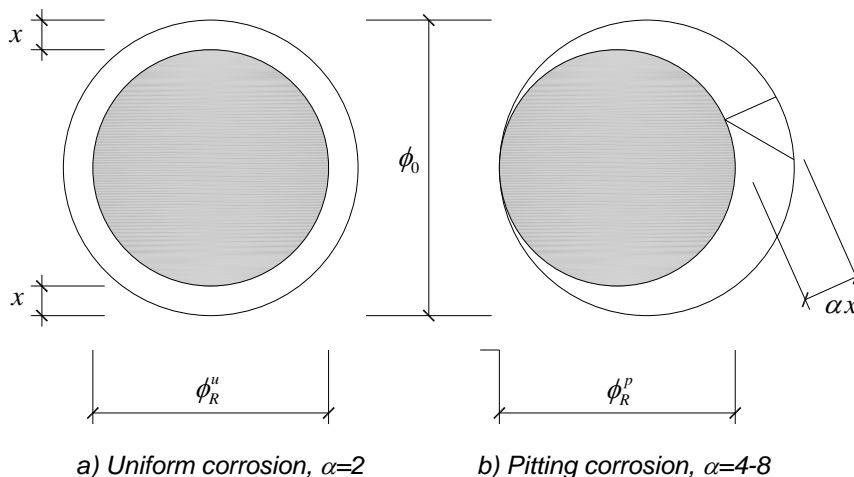
Figure 2-2. Residual reinforcing bar section for a) Uniform corrosion and b) Pitting. Sand, 2001.

Here, Sand (2001) has given the example that only one rebar is attacked by pitting and the remaining rebars are attacked by uniform corrosion.

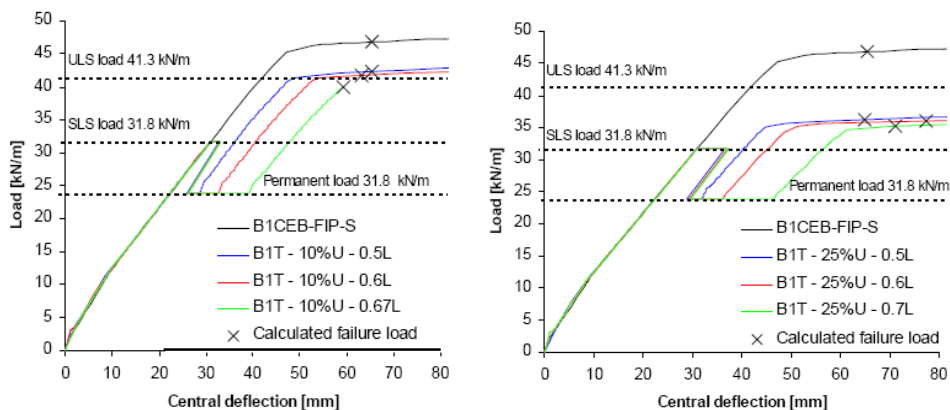
Figure 2-7. Calculated load vs. central displacement curves for beams. Left: with 10% mass loss due to corrosion. Right: 25% mass loss due to corrosion. Graphs from Sand (2001).

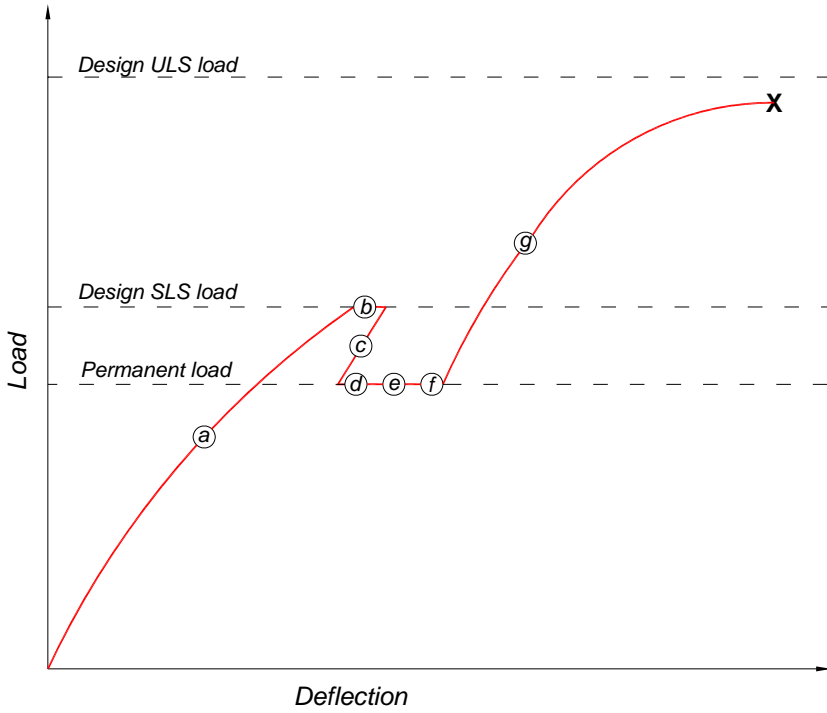
Figure 2-8. Graphical description of general beam behaviour during the repair process (Sand, 2001).

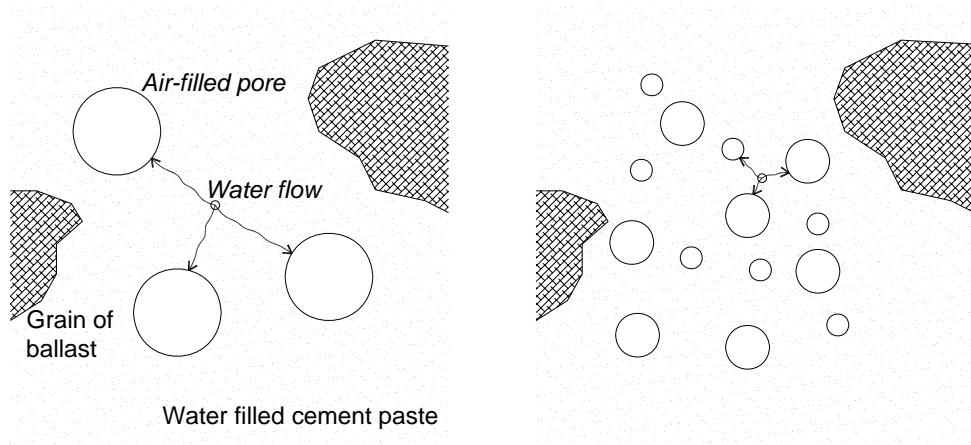
Figure 3-1. Principle of air-pore mixture. Left (without extra pores): Few large pores, long distance between pores. Right (with extra pores): Many small pores, short distance between pores. Based on Fagerlund, 1992.

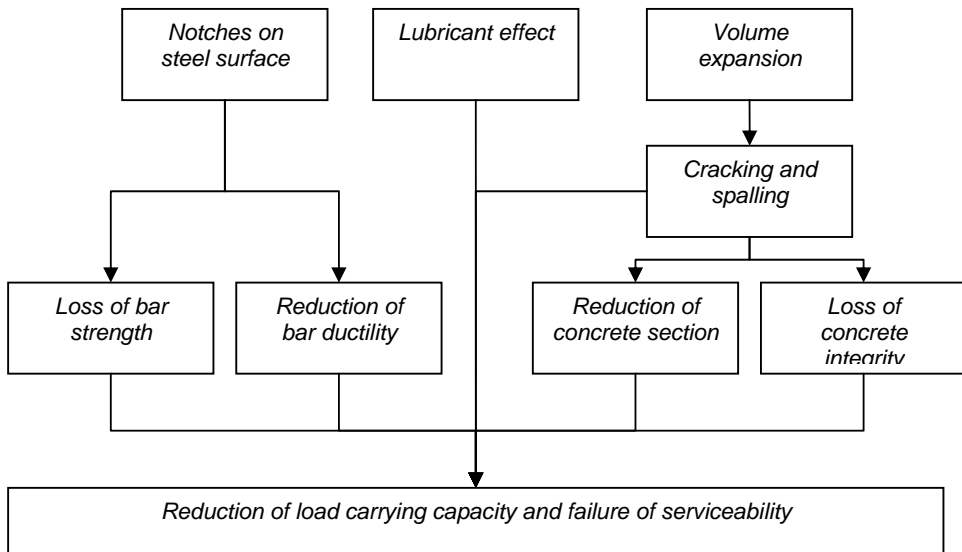
Figure 3-3. Effects of steel corrosion on concrete structures. After Tamer & Soudki, 2005.

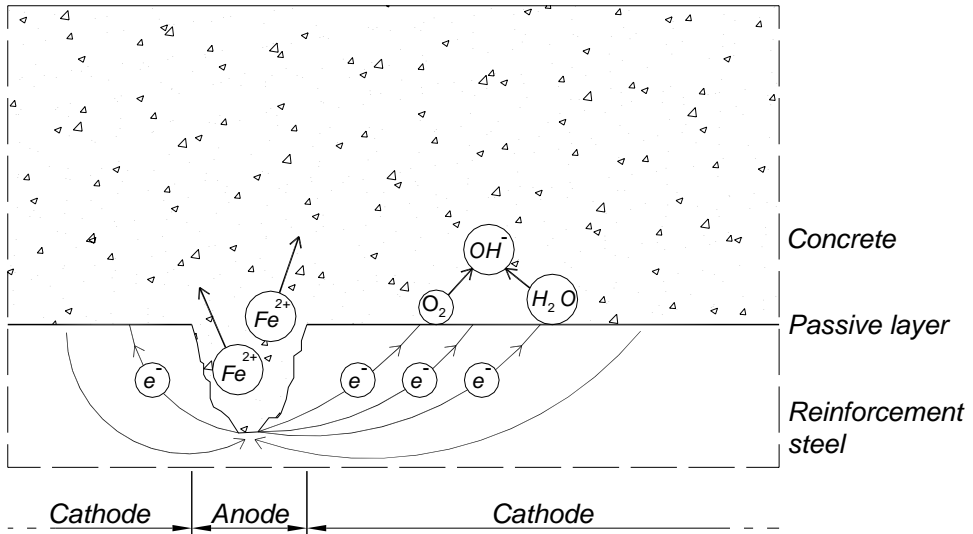
Figure 3-4. Diagram of a corrosion cell in moist concrete.

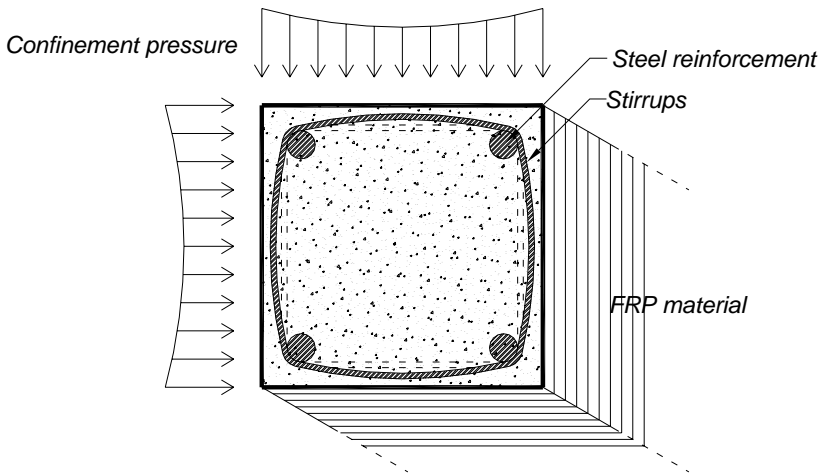
Figure 3-7. Diagram of confinement by wrapping the concrete member with CFRP material.

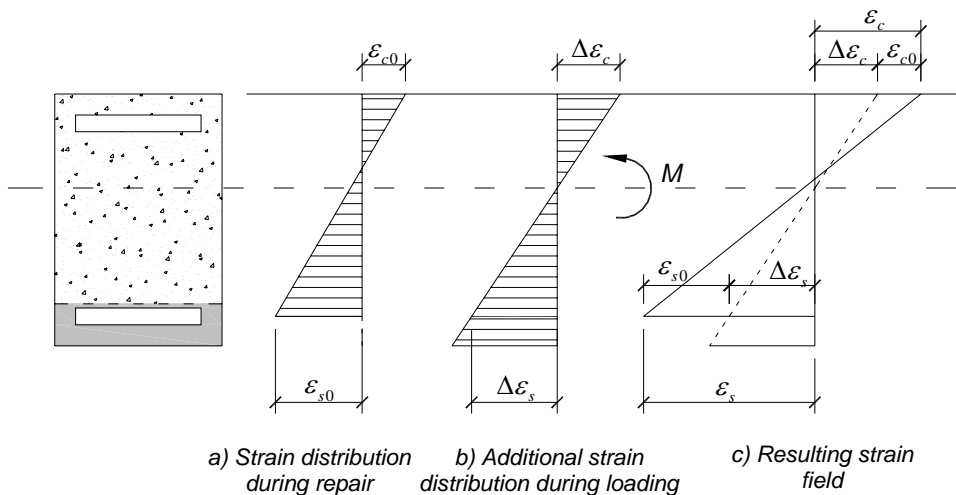
Figure 3-10. Diagram of how to take consideration to strain field created during the repair procedure.

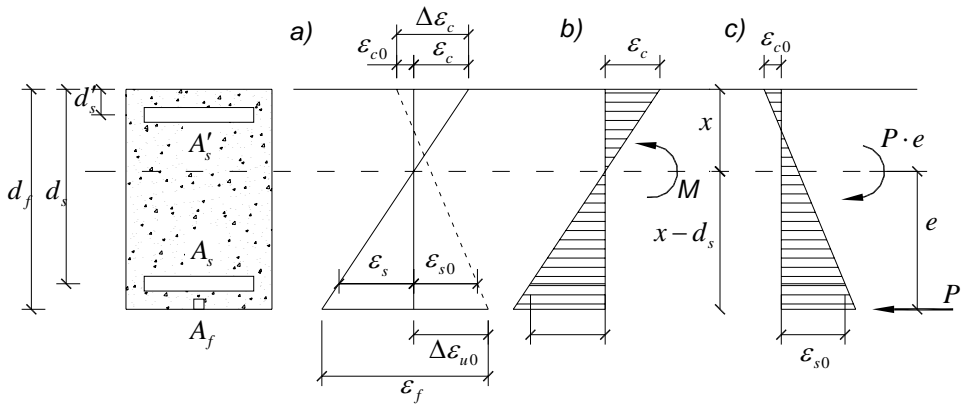
Figure 3-13. a) Strain distribution in the loaded beam cross-section, where the CFRP is pre-stressed, is achieved by super-positioning of b) and c). b) Strain distribution when applying a bending moment on the non-strengthened cross-section. c) Gives the initial strain field when applying a pre-stressed strengthening material.

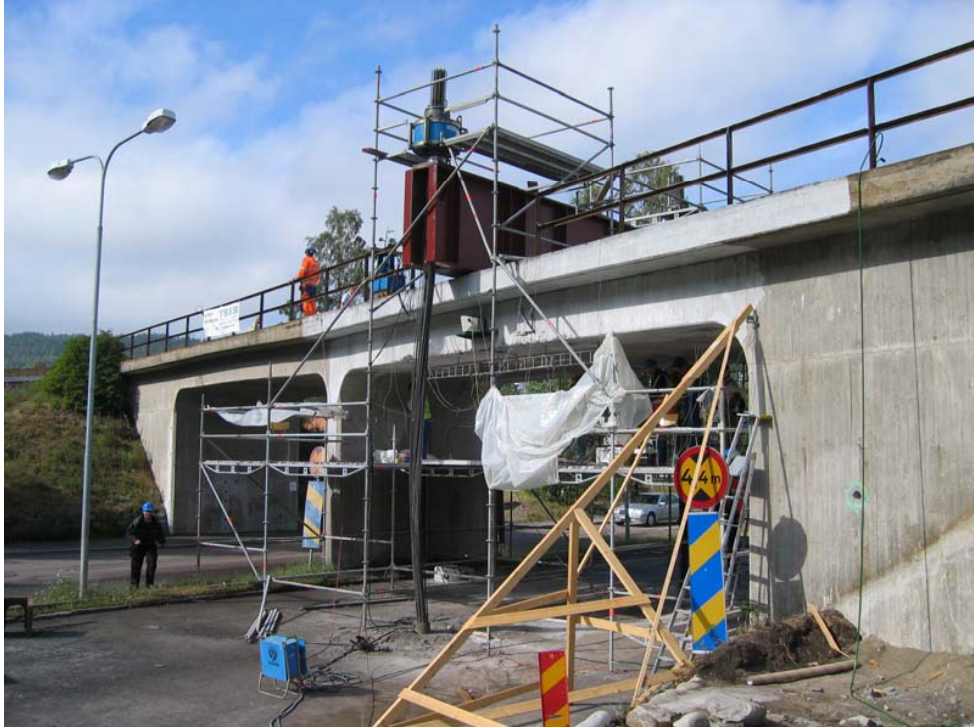
Figure 3-22. Ö-vik bridge in Sweden during failure test in the summer of 2006.

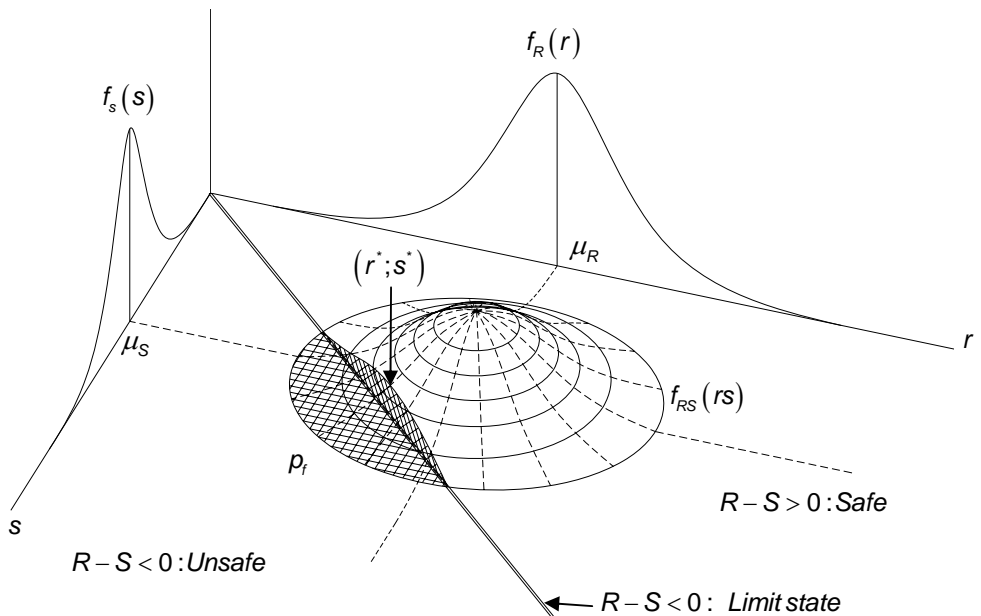
Figure 4-2. The 3-D view of two random joint density function $f_{RS}(rs)$.

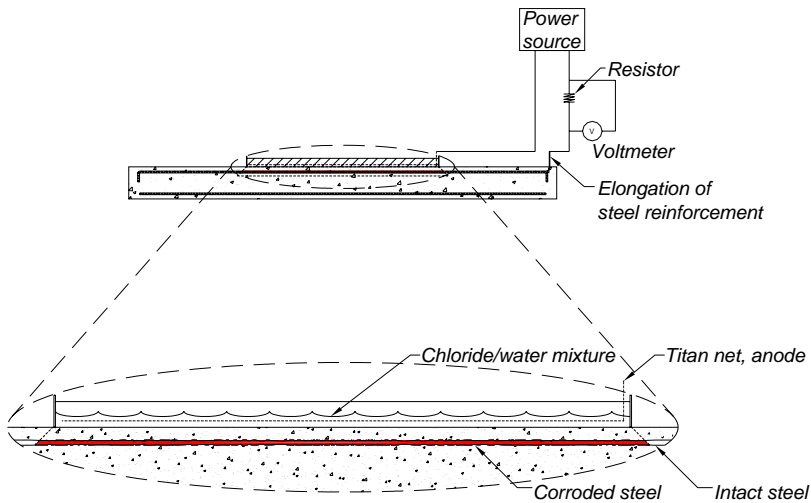
Figure 5-3. Schematic diagram for accelerated corrosion setup.

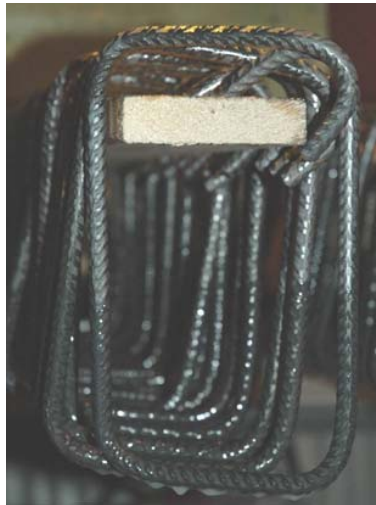
Figure 5-4. Stirrups were protected against corrosion with a coating of epoxy adhesive. Here they are seen when left to harden.

Ordinary longitudinal steel reinforcement was used. There was no electrical connection between transverse and longitudinal reinforcement since the stirrups were protected by epoxy. For this purpose StoBPE Lim 417 (A+B) was used. Each stirrup was dipped down into a bucket of adhesive to form the coating for corrosion protection. The protective layer reached 100 mm up along the part of the stirrup that was supposed to be near the tensile steel reinforcement as can be seen in Figure 5-4. The adhesive was left to harden for five days at an average temperature of 16 °C and a relative humidity of around 70%. The beams were finally cast. The concrete quality was equivalent to Swedish standard concrete; C28/32, which correspond to a compressive strength of about 40 MPa. Material testing showed however that the actual compressive strength was higher. Material properties are presented in section 5.5.

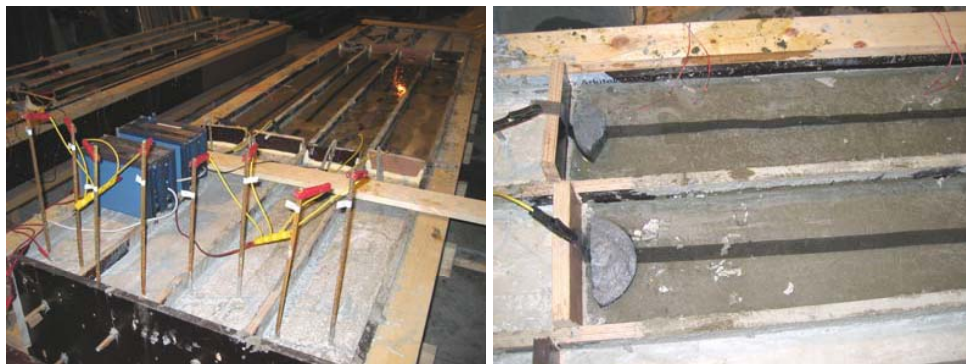
Figure 5-5. Left: Full view of initiation setup. Right: The anodic titan net placed in the water bath on top of concrete beam.

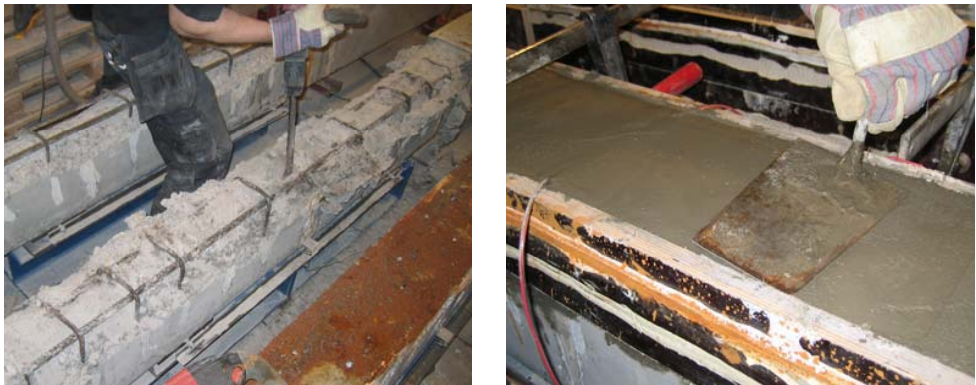
Figure 5-6. Left: Cover concrete was removed using jack hammer. Right: The cavity was refilled with repair mortar.

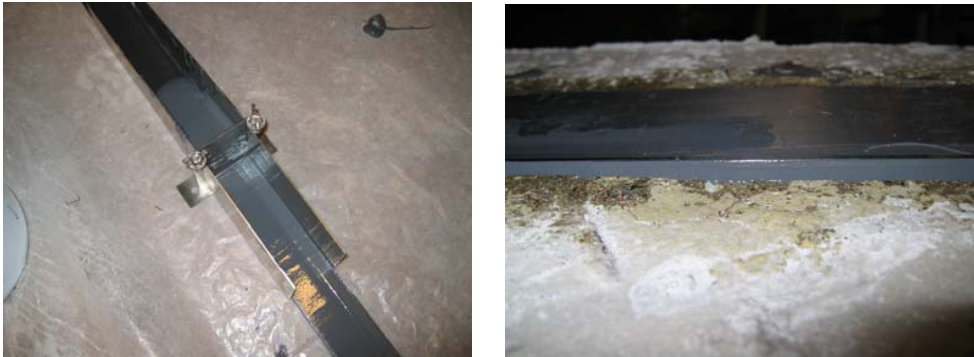
Figure 5-7. Left: Adhesive tool to apply the right amount of adhesive to the plates. Right: Concrete surface, adhesive layer and CFRP plate.

The peel-ply on the CFRP plates was first removed and then the adhesive applied using a special tool to obtain the correct amount of adhesive on the plates – i.e. an average thickness layer of 2 mm, this tool is shown more clearly in the left part of Figure 5-7. The temperature during the strengthening work was 21 °C and the humidity approximately 45%. After these preparations, the CFRP plates were placed on the beams, as can be seen in the right part of Figure 5-7.

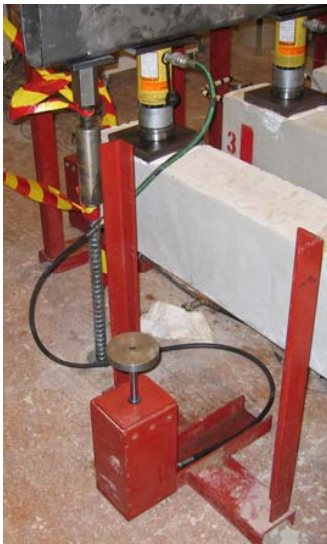
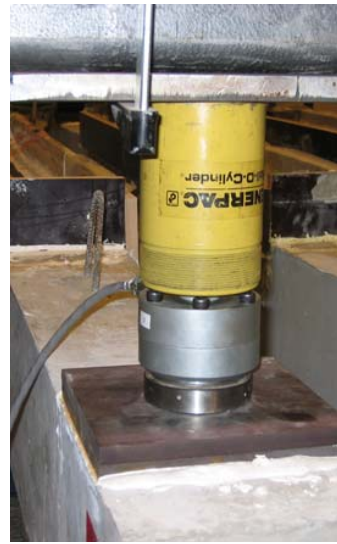
Figure 5-13. Left: The applied load is placed on the small piston. Right: The resulting load is created through a hydraulic cylinder.

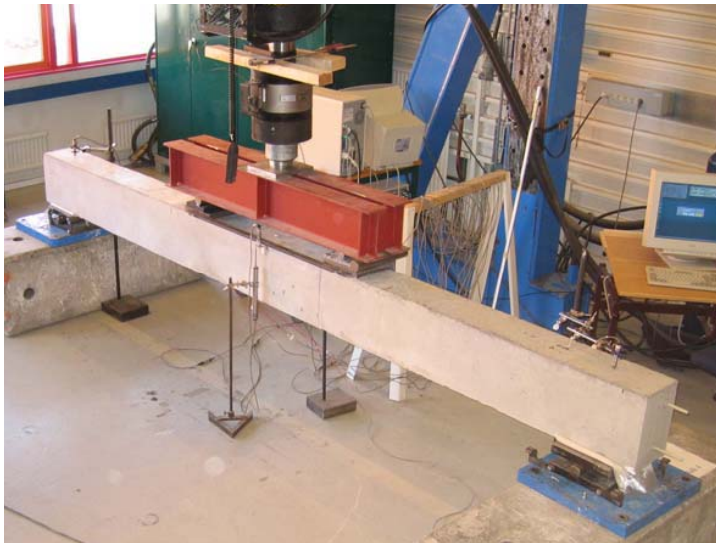
Figure 5-15. Picture taken on test setup during failure test.

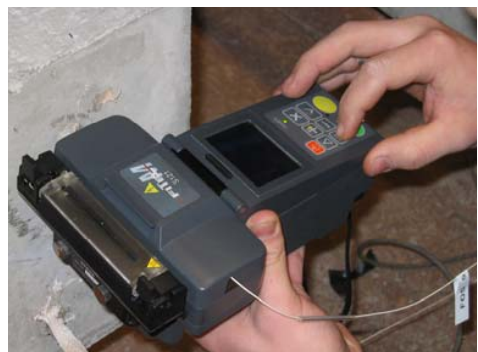
Figure 5-19. Left: Cross sectional view of optical fibre. Right: Splicing tool used to mend broken fibre.

The optical fibre used consists of a fibre core surrounded by cladding and finally a layer of coating. The diameter of the optical fibre is about 250 micrometer, see left part of Figure 5-19. The fibre is especially sensitive to shear forces, so it is normally also protected by another plastic coating for easy handling. If the fibre accidentally breaks, it is possible to mend it using a splicing tool, see right part of Figure 5-19.

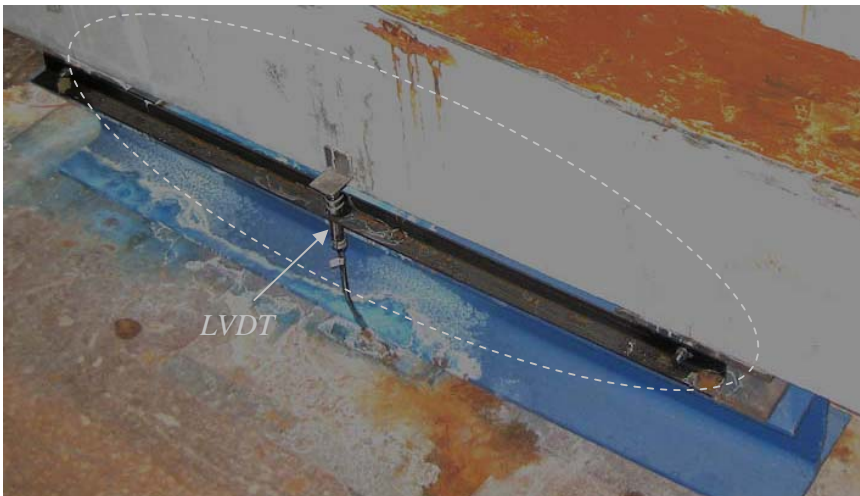
Figure 5-23. Curvature measurement setup using LVDT during corrosion stage.

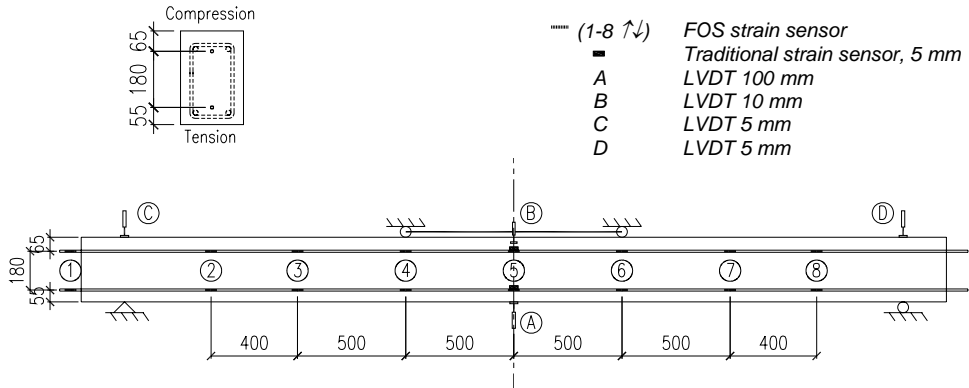
Figure 5-24. Monitoring setup for the reference beams and the corroded beams.

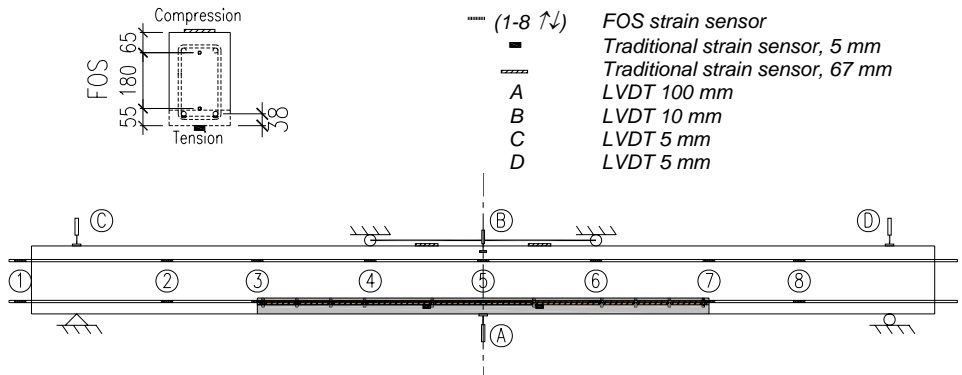
Figure 5-25. Monitoring setup for beams where the cover concrete was removed, repaired and strengthened.

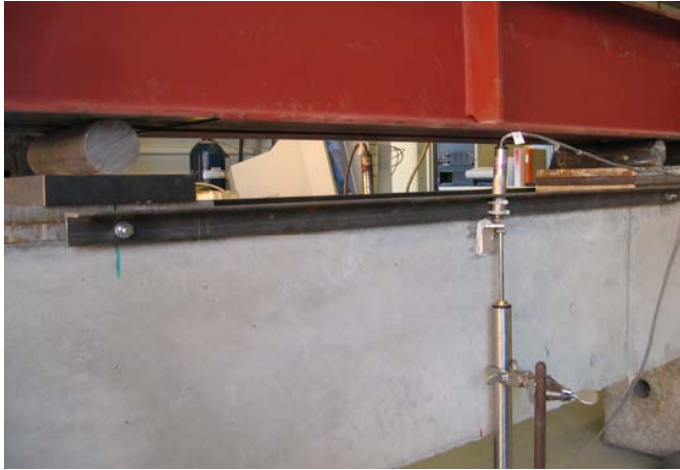
Figure 5-26. Curvature measurement setup using the 10 mm LVDT mounted on a steel profile reaching in between the loading points. Mid-point deflection is measured using a 100 mm LVDT.

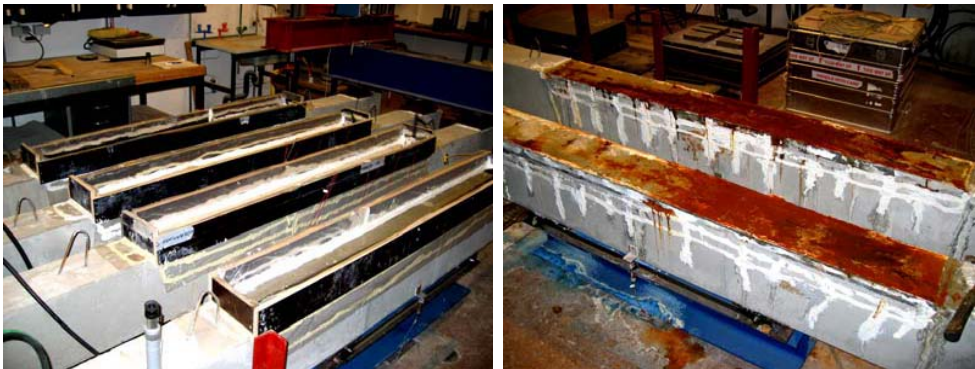
Figure 6-1. Left: Ponds holding chloride water placed onto beams. Right: External look of beams after finished corrosion stage.

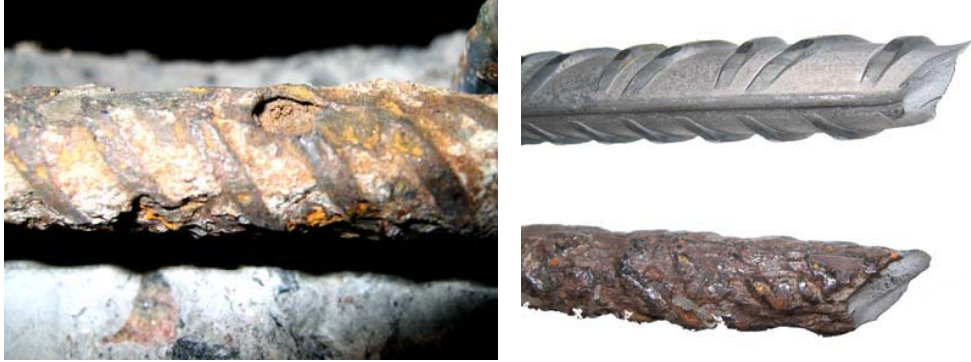
Figure 6-2. Left: Both evenly distributed corrosion as well as pitting corrosion was observed on corroded steel reinforcement bars. Right: Failure surface for corroded and undamaged steel reinforcing bars after material test.

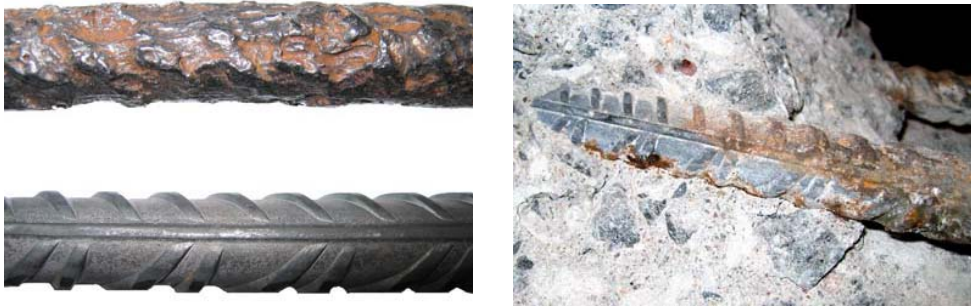
Figure 6-3. Left: Corroded and undamaged steel reinforcement. Right: The interface between the corroded and the undamaged steel section.

The significant degree of corrosion of the steel reinforcement made the bars look quite deteriorated. It is also worth mentioning that a distinct interface between the corroded and the non-corroded sections in the right part of Figure 6-3 could be noticed on the steel bars. This proves that it is possible to damage selected regions with this method.

It is obvious that the bond between steel and concrete is decreased when visually comparing corroded and undamaged steel bars as in the left part of Figure 6-3. Almost all signs of the ridges are erased on the corroded bars.

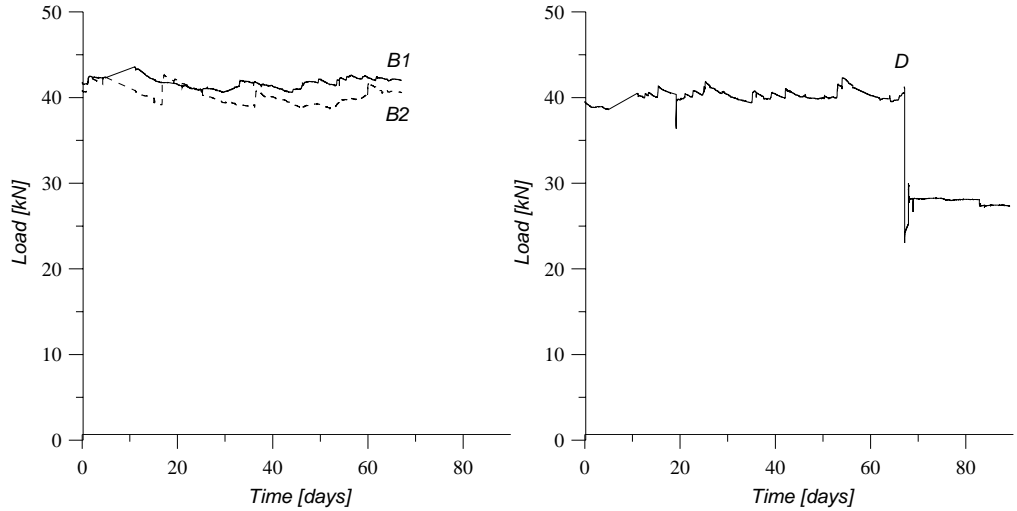
Figure 6-4. Left: Applied load during corrosion stage for the corroded beams B1 and B2. Right: Applied load during the corrosion phase and the time for removal of concrete for beam D, where cover concrete was removed.

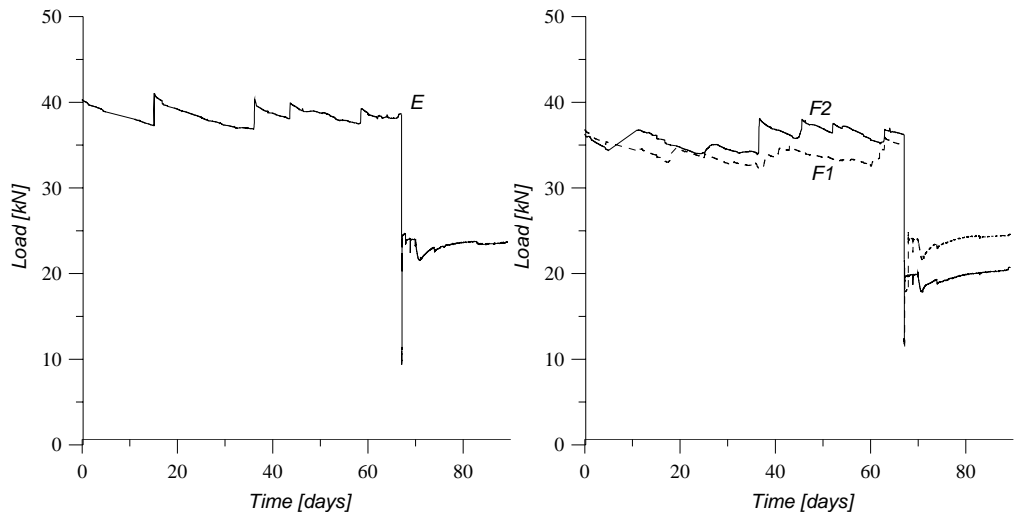
Figure 6-5. Left: Applied load during the corrosion and repair phase for the repaired beam, E. Right: Applied load during the corrosion phase and the rehabilitation phase for the repaired and strengthened beams, F1 and F2.

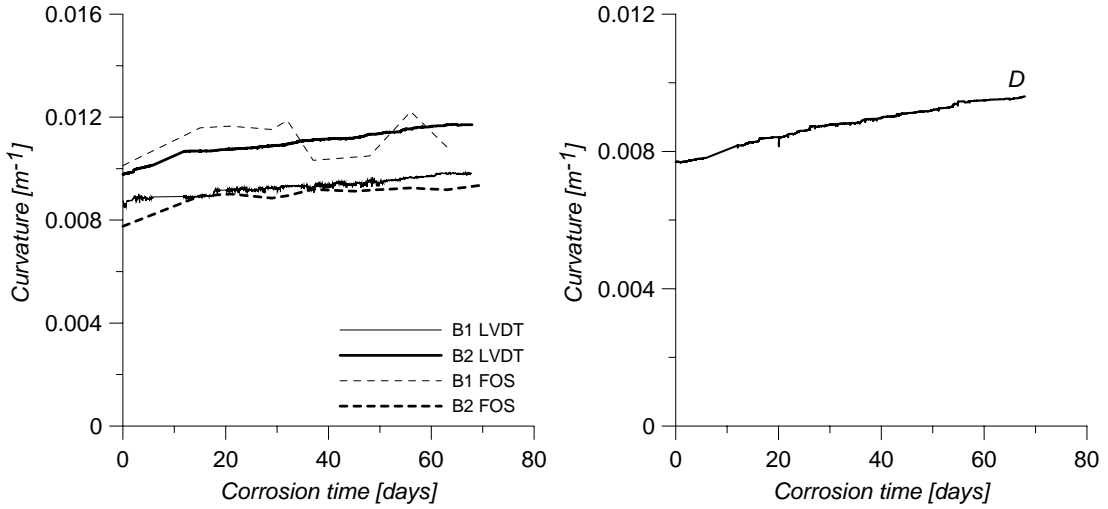
Figure 6-10. Left: Curvature of beam specimen *B1* and *B2* during the corrosion phase using the LVDT as well as the FOS setup. Right: Curvature of beam specimen *D* during corrosion phase using the LVDT setup.

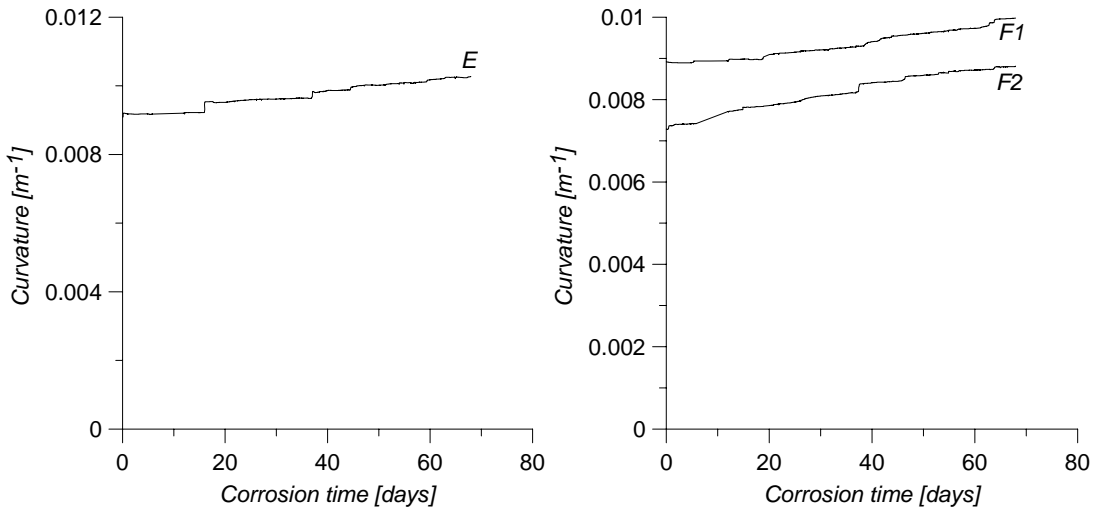
Figure 6-11. Left: Curvature of beam specimen *E* during the corrosion phase using the LVDT setup. Right: Curvature of beam specimen *F1* and *F2* during corrosion phase using the LVDT setup.

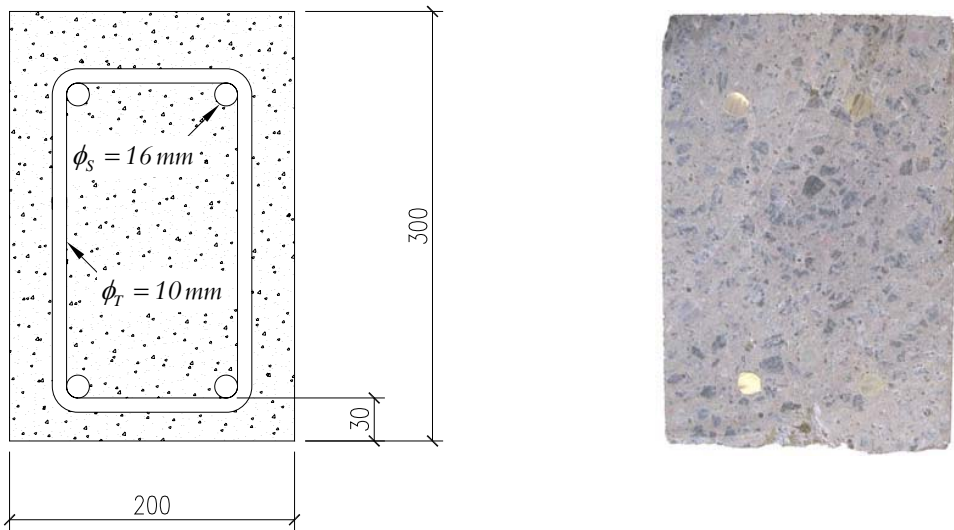
Figure 6-12. Left: Cross sectional view of intact beam. Right: Cross section of real intact beam.

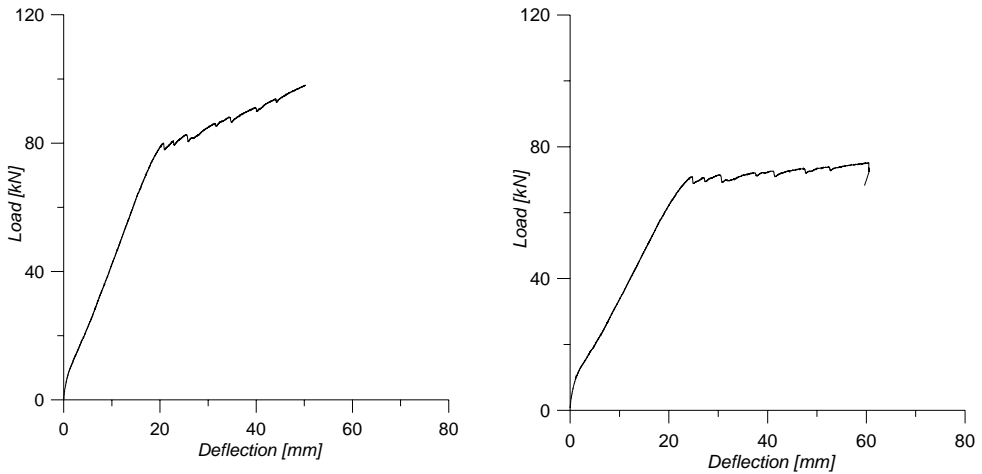
Figure 6-14. Load vs. deflection relation for intact beam.

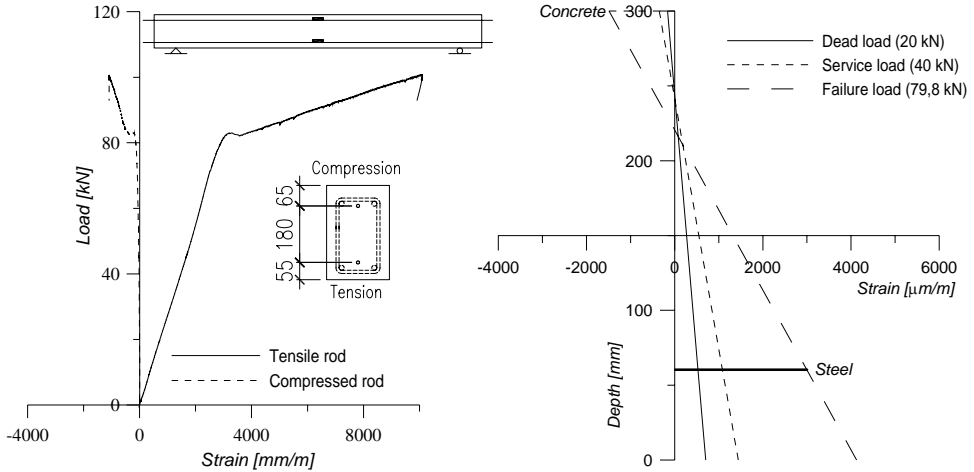
Figure 6-15. Left: Strain in tensile and compressed glass fibre rod. Right: Strain distribution, ϵ_x , through the beam thickness in mid-span.

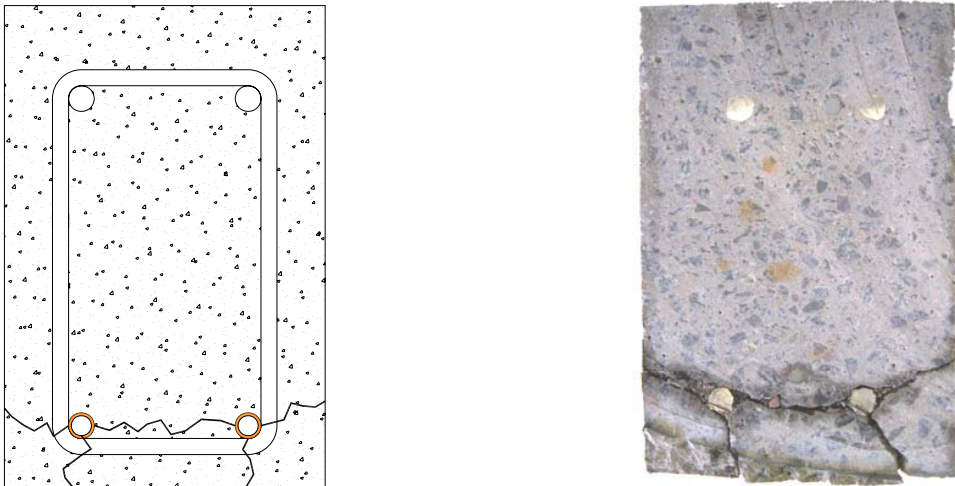
Figure 6-18. Left: Schematic diagram of corroded beam cross section. Right: Actual corroded beam cross section.

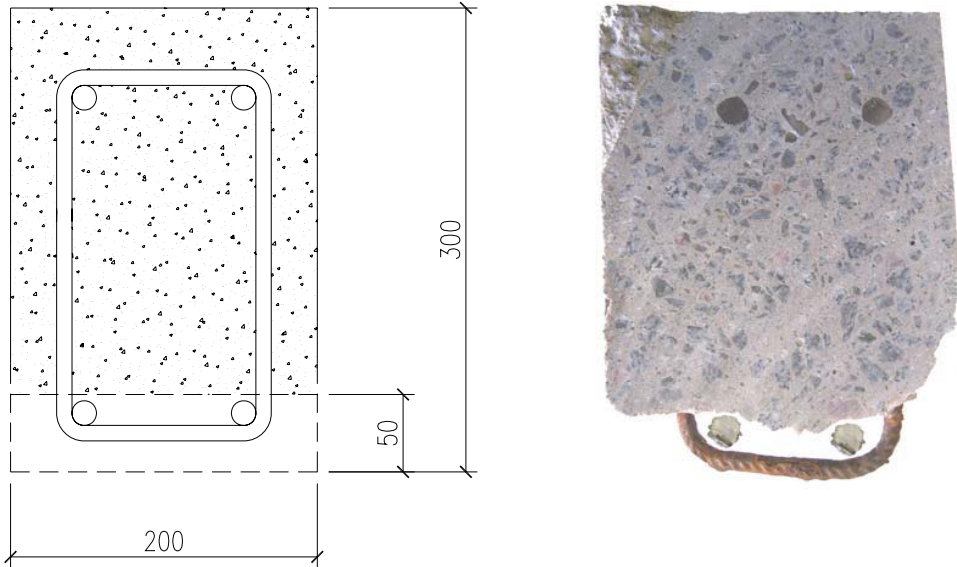
Figure 6-19. Left: A sketch of the cross section of the beam where concrete to a depth of 70 mm was removed. Right: Cross section of real beam where concrete was removed.

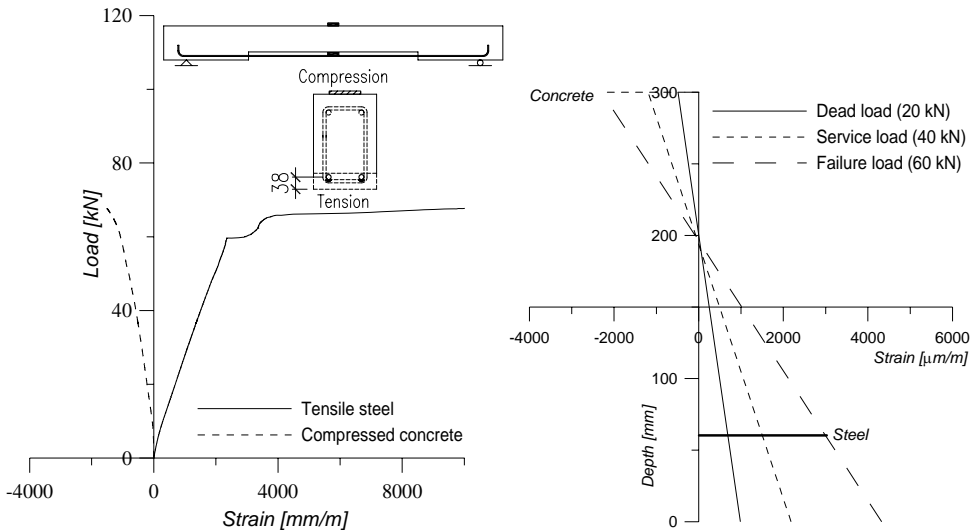
Figure 6-22. Left: Strain readings on tensile steel reinforcement and compressed concrete on beam where cover concrete is removed. Right: Strain distribution between tensile steel reinforcement and compressed concrete surface.

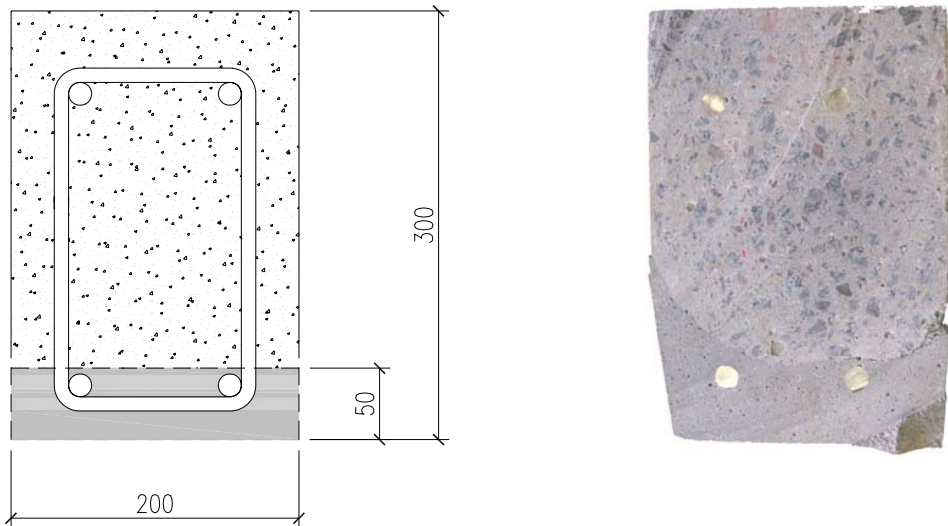
Figure 6-24. Left: Schematic of cross section of repaired beam. Right: Cross section of real repaired beam.

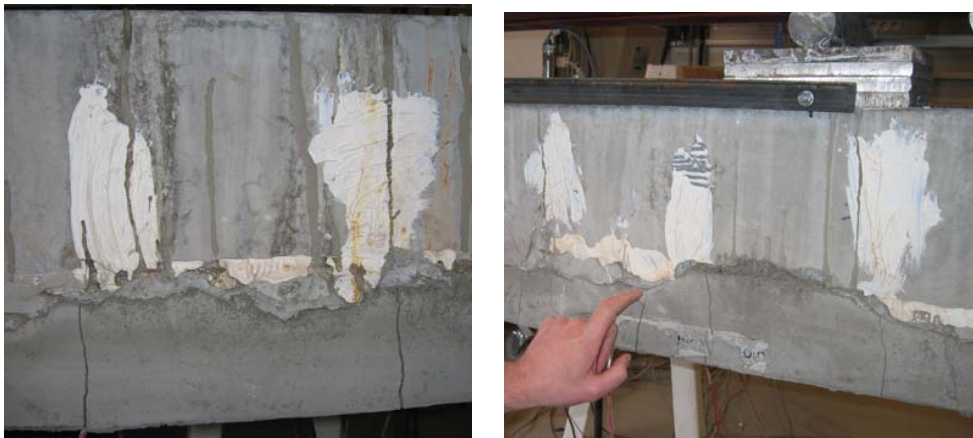
Figure 6-26. Large cracks formed in the repair mortar during failure test.

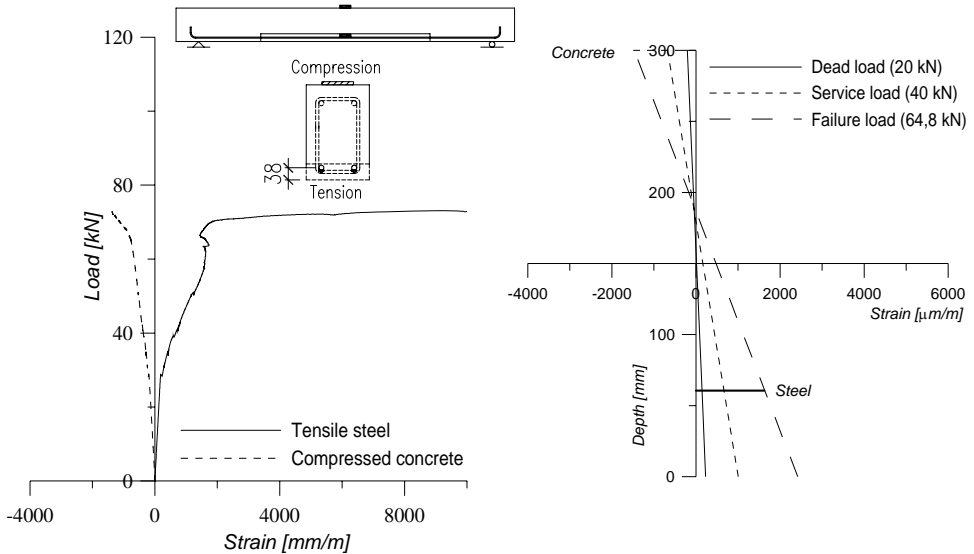
Figure 6-28. Left: Strain readings on tensile reinforcement and compressed concrete on repaired beam . Right: Strain distribution for repaired beam at dead load, service load and failure load.

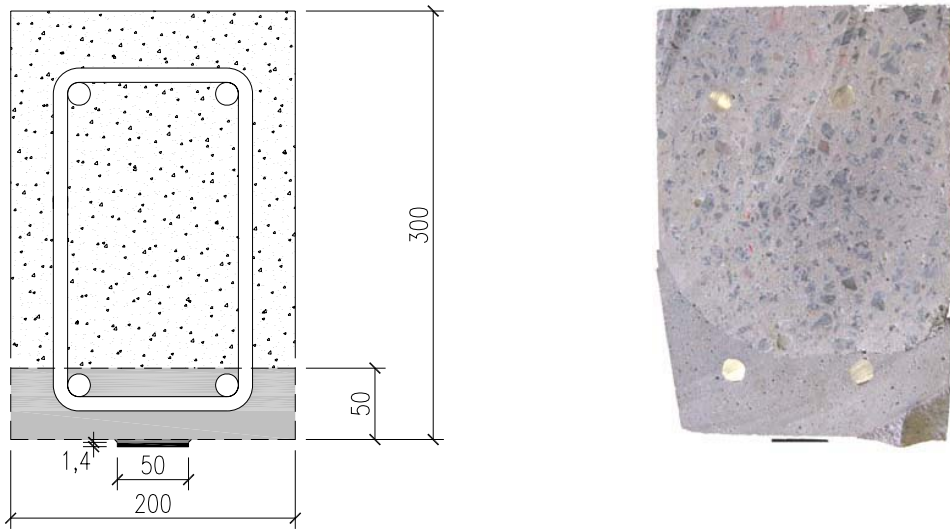
Figure 6-29. Left: Schematic of repaired and strengthened beam cross section. Right: Real cross section of repaired and strengthened beam.

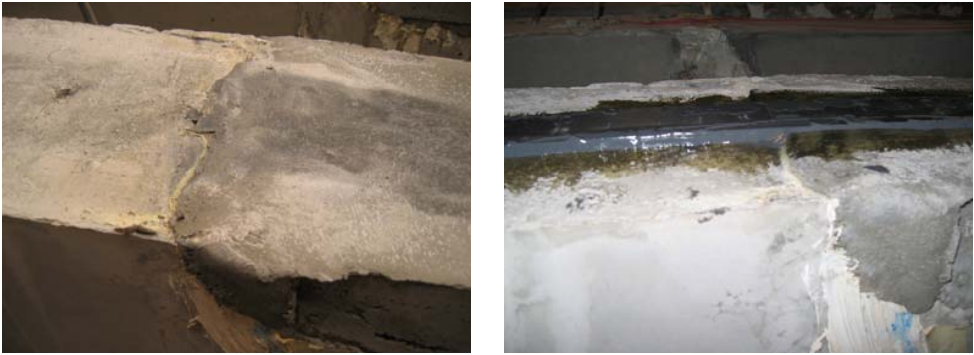
Figure 6-30. Left: Interface between original concrete and repair mortar. Right: CFRP plate bonded to the repaired beam.

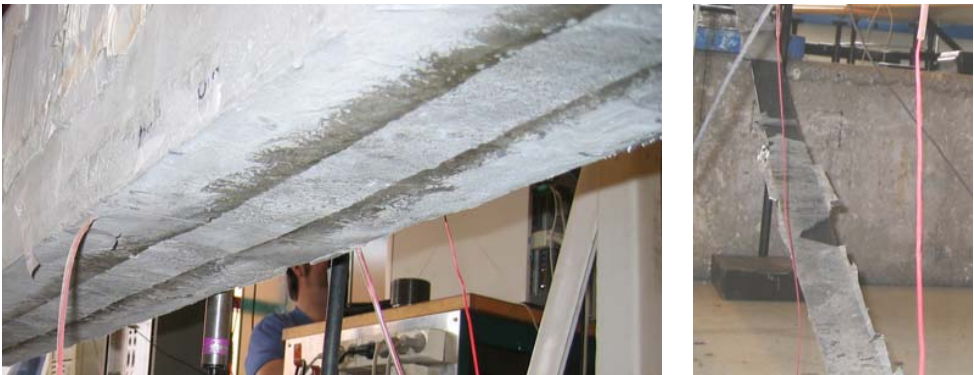
Figure 6-31. Left: The failure occurred in the interface between adhesive and concrete. Right: Only epoxy and primer was left on the CFRP plate after debonding.

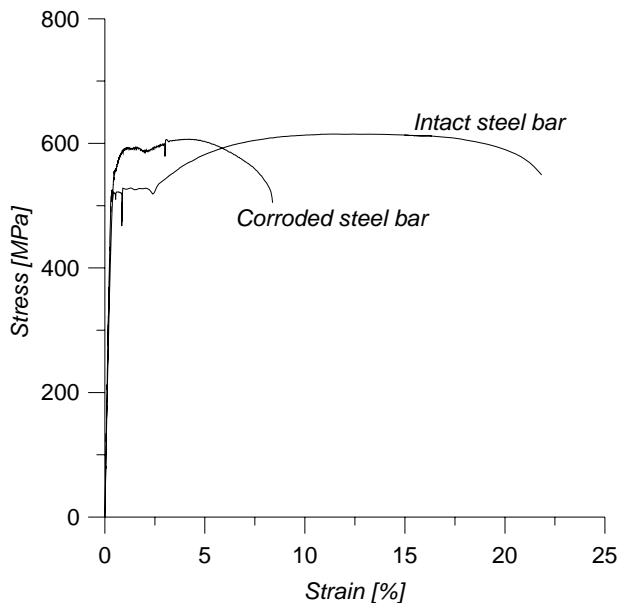
Figure 7-1. Stress vs. strain diagram for intact steel bar and corroded steel bar. Reduction of ductility of corroded steel bar is obvious.

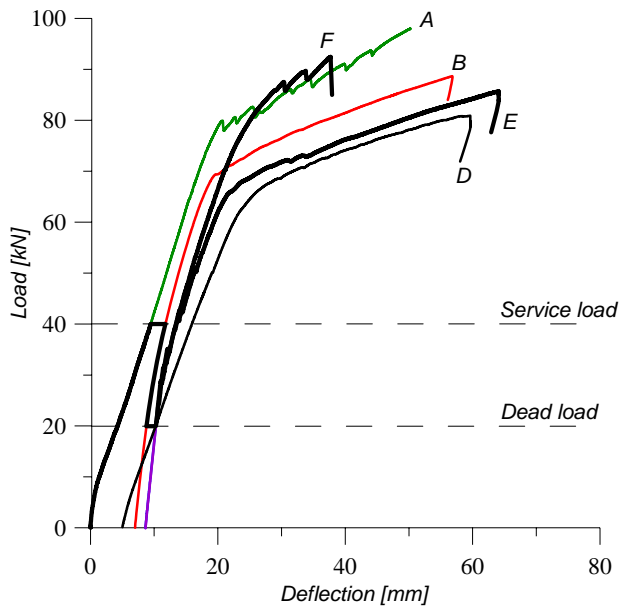
Figure 7-4. Life cycle behaviour is indicated by the bold black line.

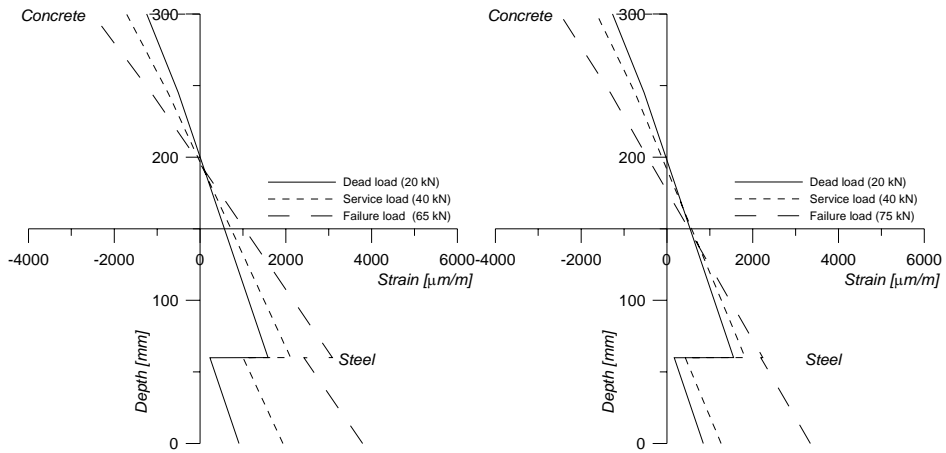
Figure 7-7. Actual strain field at different load levels for the repaired beam specimen, E, (left) and the repaired & strengthened (right) beams, F.

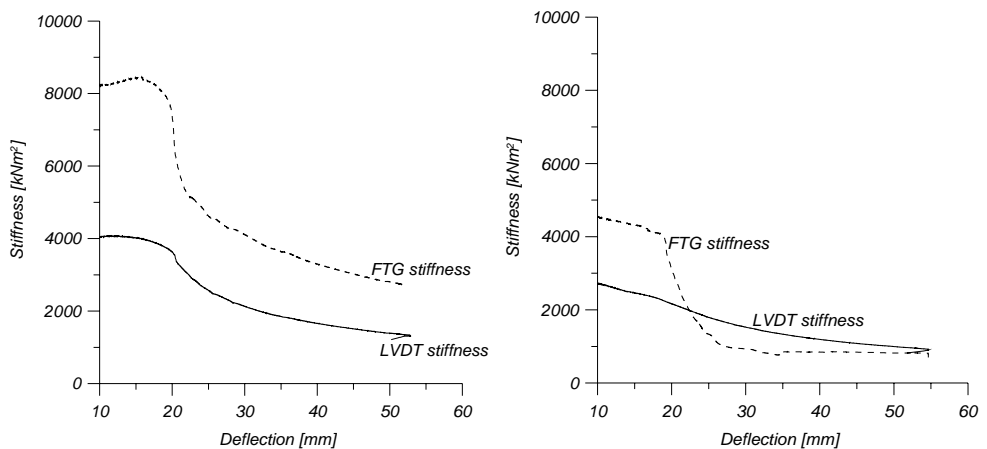
Figure 7-8. Left: Stiffness of reference beam during failure test. Right: Stiffness of beam where cover concrete was removed during failure test.

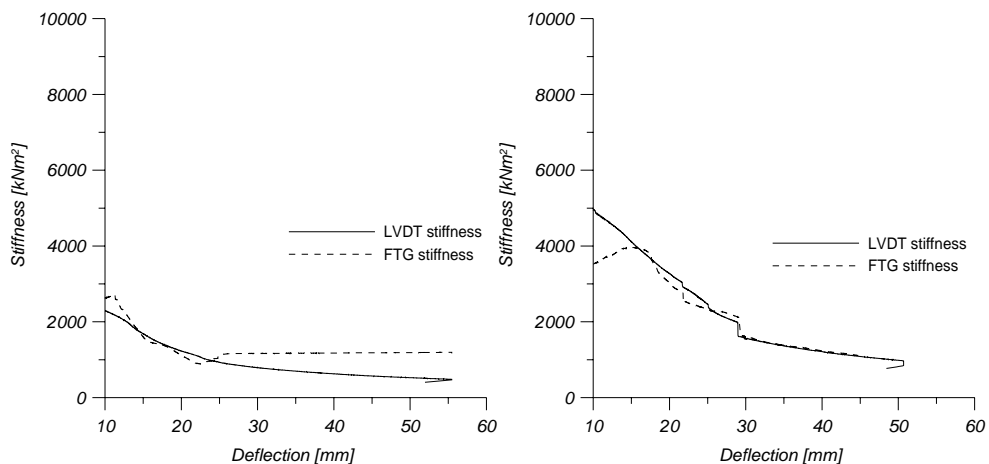
Figure 7-9. Left: Stiffness of repaired beam during failure test. Right: Stiffness of repaired and strengthened beam during failure test.
