Life Cycle Behaviour of Concrete Bridges

Laboratory test and probabilistic evaluation

Luleå University of Technology
Department of Civil and Environmental Engineering
Division of Structural Engineering

Licentiate Thesis 2006:59

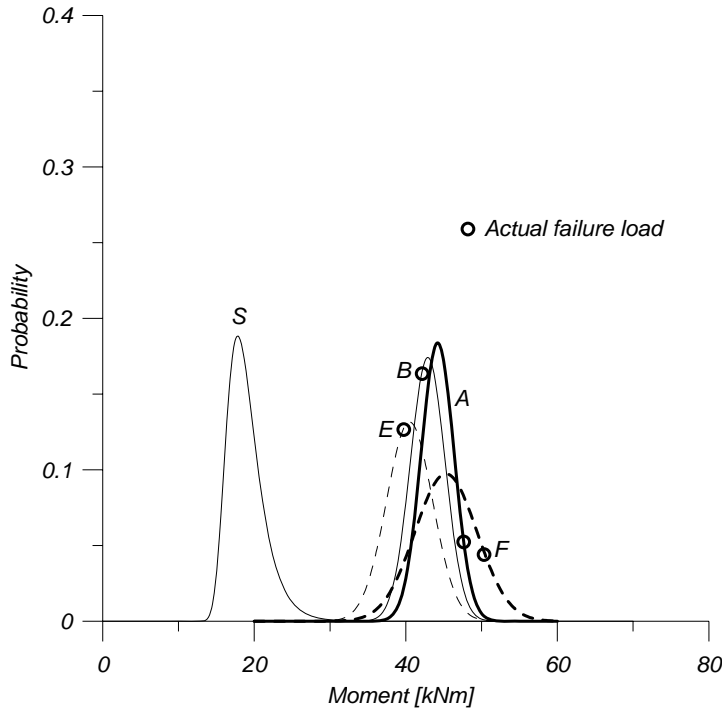
Figure 8-5. Load carrying capacity probability distribution plots for intact, corroded, repaired and repaired & strengthened beams, together with the load effect distribution.

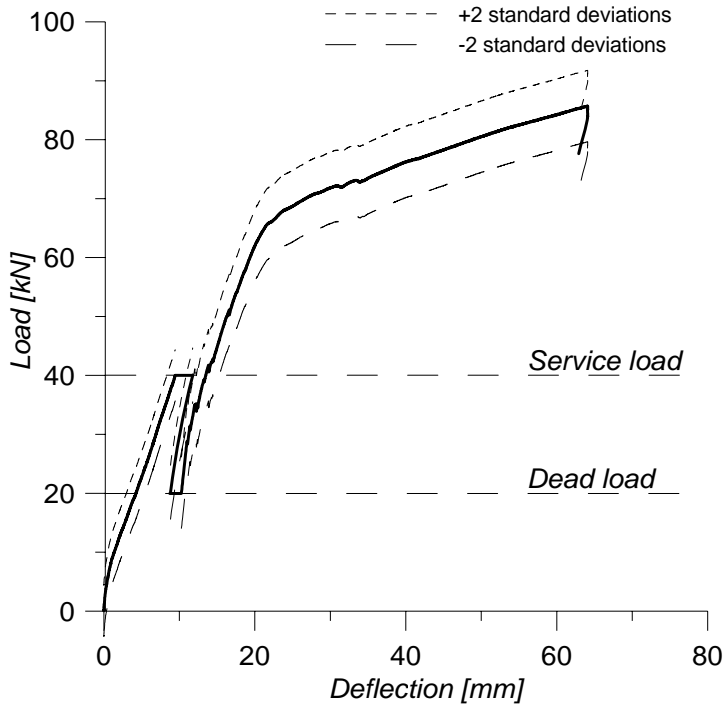
Figure 8-6. Dotted lines give the 95% confidence interval from the actual load vs. deflection behaviour during the life cycle.

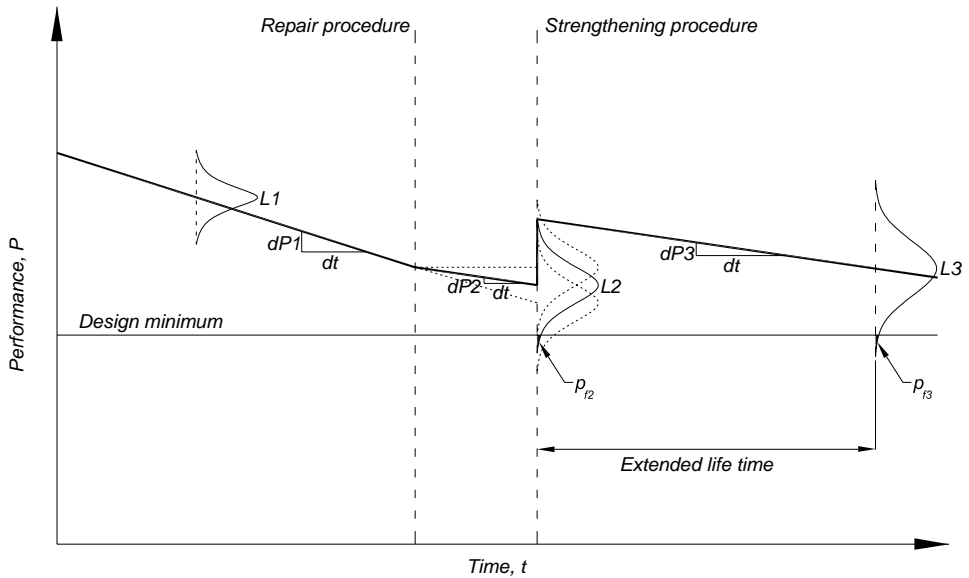
Figure 9-1. Diagram over the structural life described by performance, P .

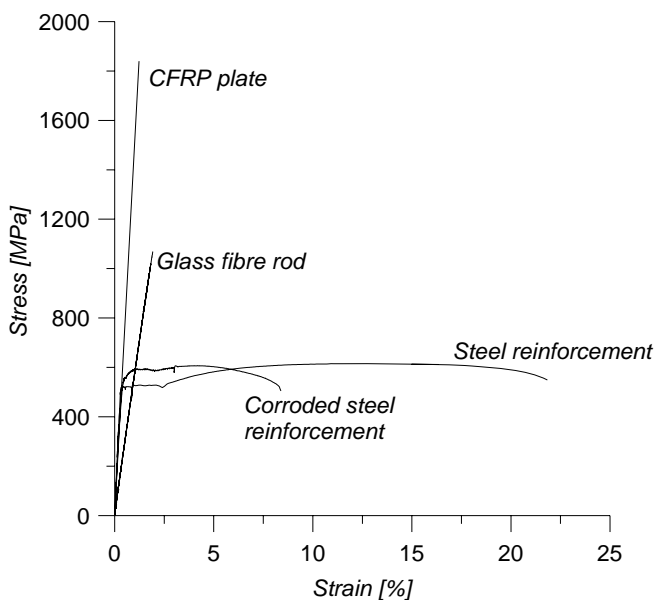
Figure A2. Comparison between stress versus strain curves for non-corroded Ks600 $\phi 16$ mm steel bar specimen used for tensile bending reinforcement, corroded steel reinforcement, glass fibre rod and CFRP plate.

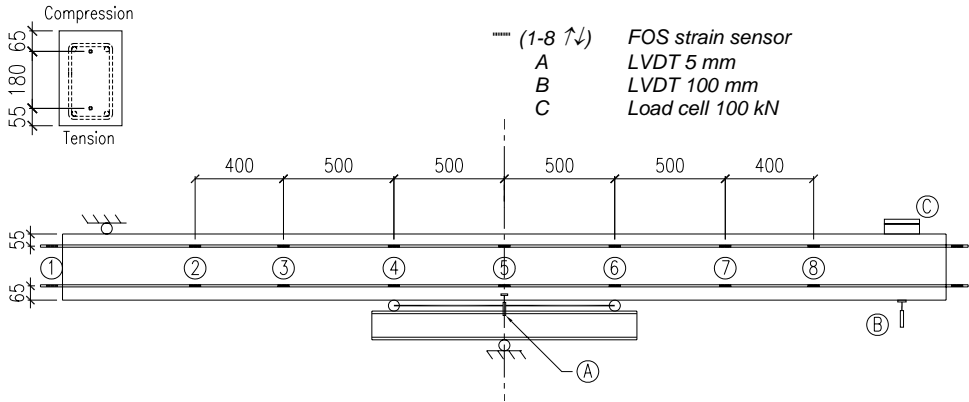
Figure A5. Sensor locations and sensor type on the intact beam specimen during corrosion stage. FOS are located along the glass fibre rods.

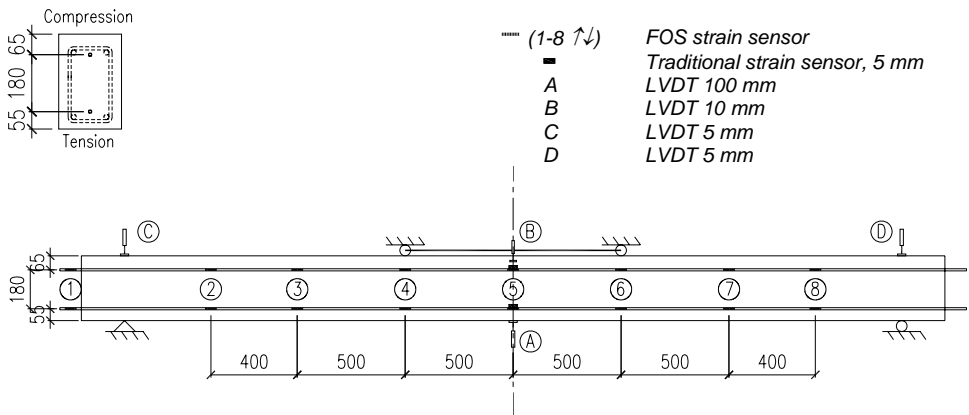
Figure A6. Sensor locations and sensor type on the intact beam specimen. FOS and traditional strain sensors are located along the glass fibre rods.

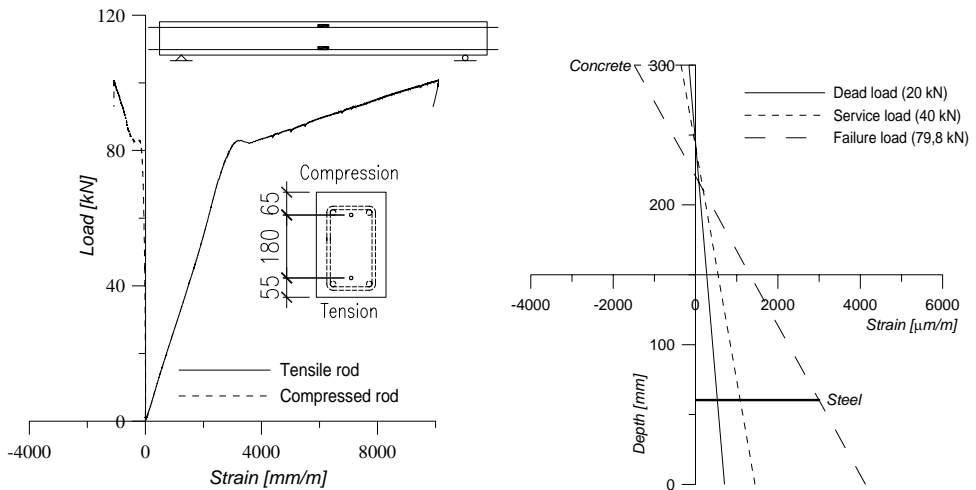
Figure A8. Left: Strain readings on tensile and compressed glass fibre rod. Right: Mid-span strain distribution between tensile steel reinforcement and compressed concrete surface.

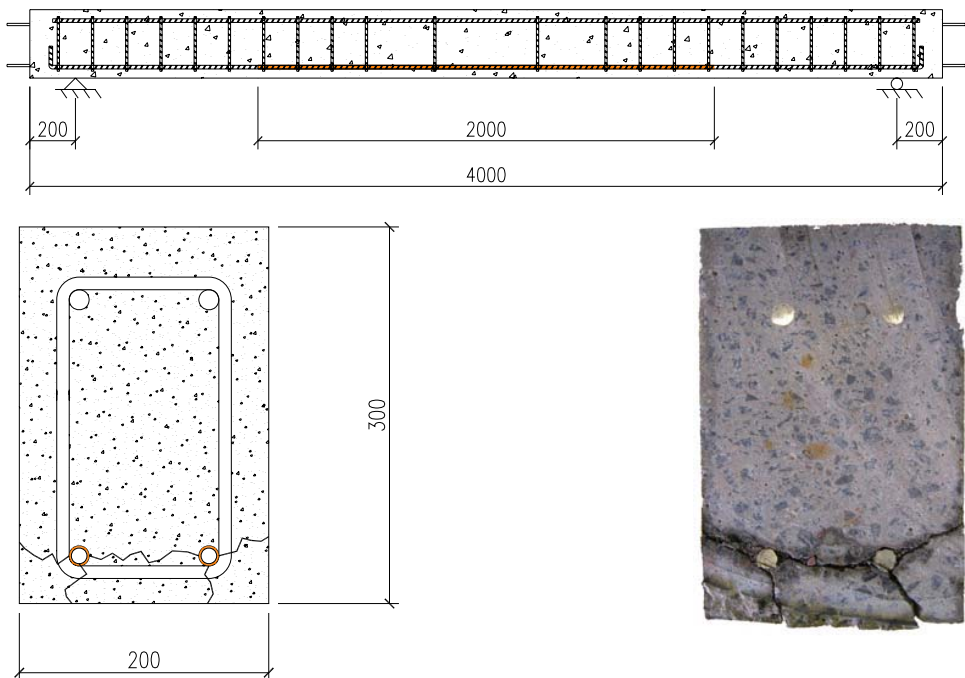
Figure A9. Top: Beam specimen measurements and steel reinforcement layout. Bottom left: Cross sectional view of corroded beam. Bottom right: Cross section of real corroded beam.

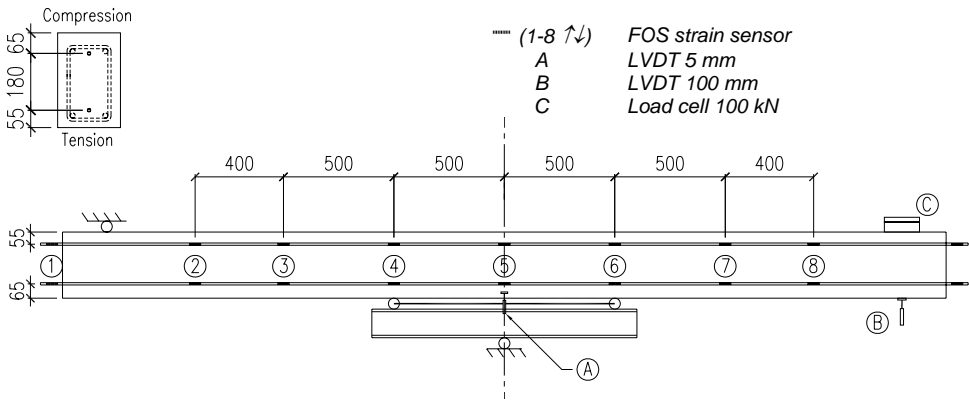
Figure A11. Sensor locations and sensor type on the intact beam specimen during corrosion stage. FOS are located along the glass fibre rods.

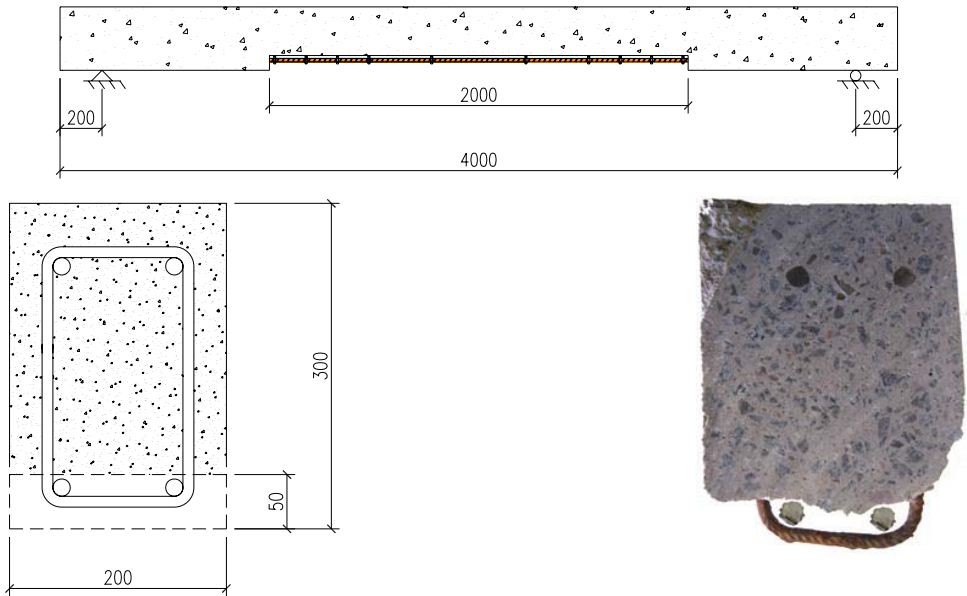
Figure A14. Top: Beam specimen measurements and steel reinforcement layout. Bottom left: Cross sectional view of beam where cover concrete was removed. Bottom right: Cross section of real beam where cover concrete was removed.

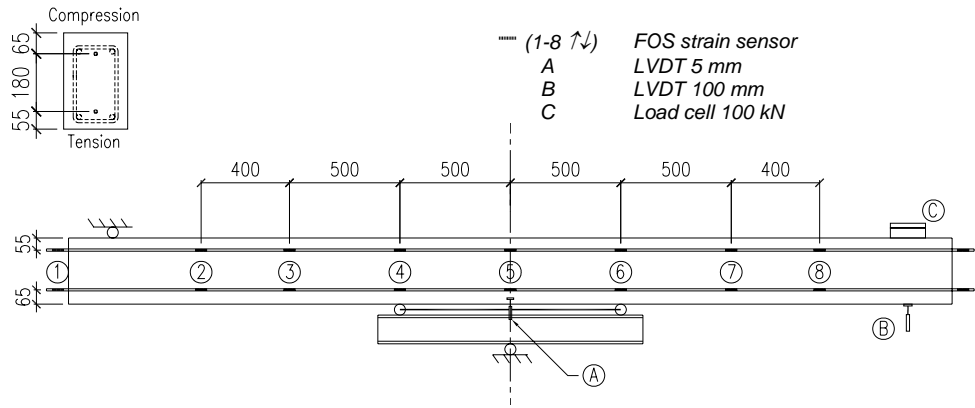
Figure A16. Sensor locations and sensor type on the intact beam specimen during corrosion stage. FOS are located along the glass fibre rods.

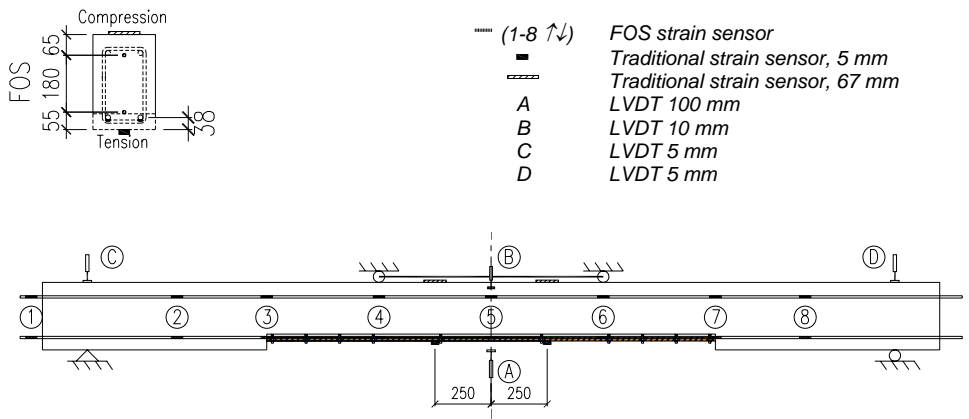
Figure A17. Sensor locations and sensor type on the beam where cover concrete was removed. FOS are located along the glass fibre rods. Traditional strain gauges are located on the concrete surface and onto tensile steel reinforcement.

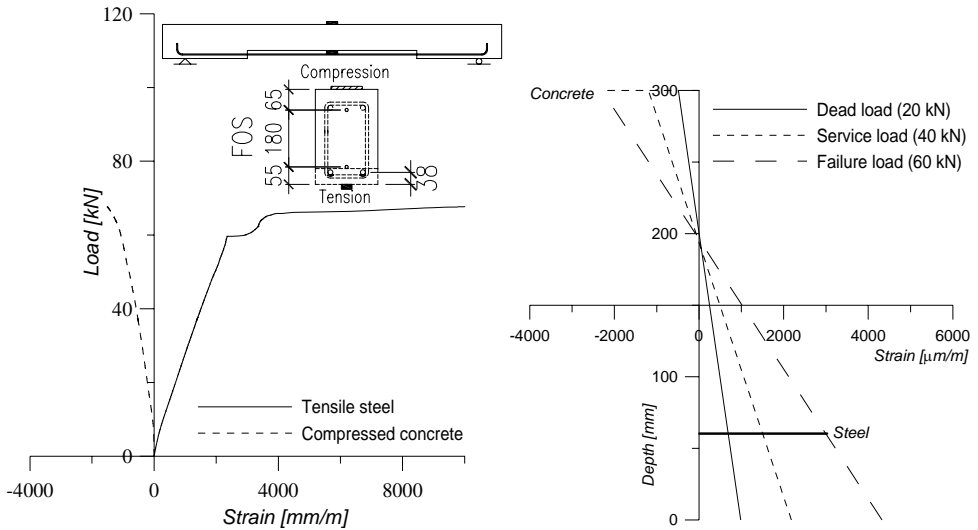
Figure A19. Left: Strain readings on tensile steel reinforcement and compressed concrete on beam where cover concrete is removed. Right: Strain distribution between tensile steel reinforcement and compressed concrete surface.

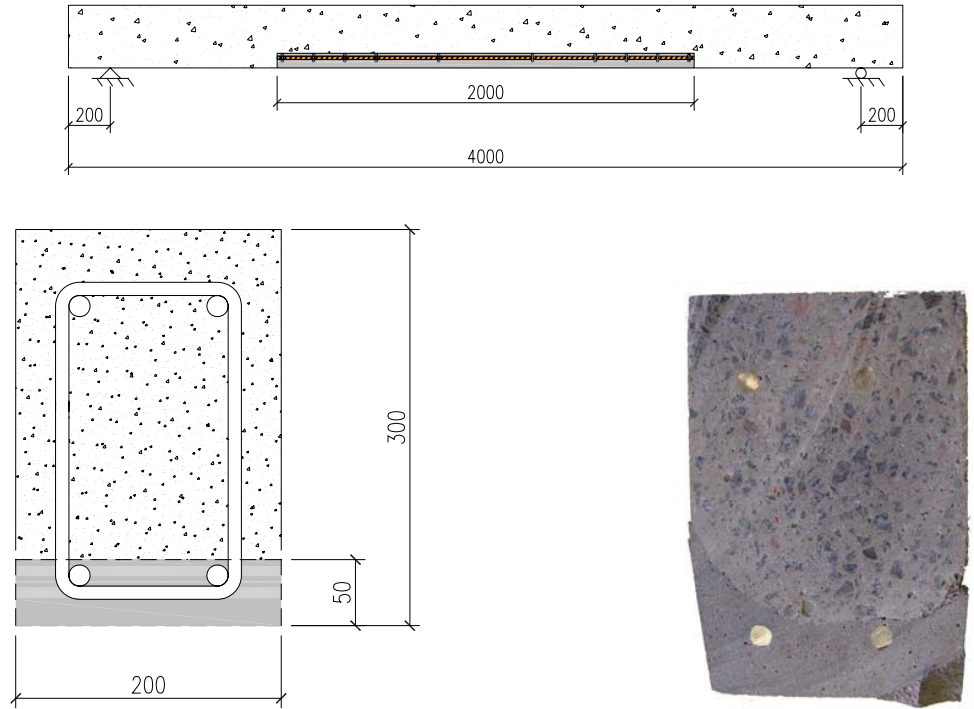
Figure A20. Top: Beam specimen measurements and steel reinforcement layout. Bottom left: Cross sectional view of repaired beam. Bottom right: Cross section of real repaired beam.

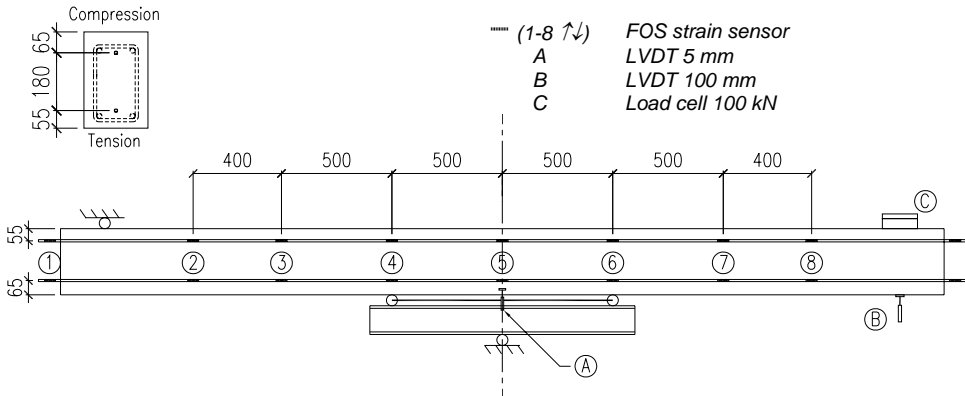
Figure A22. Sensor locations and sensor type on the intact beam specimen during corrosion stage. FOS are located along the glass fibre rods.

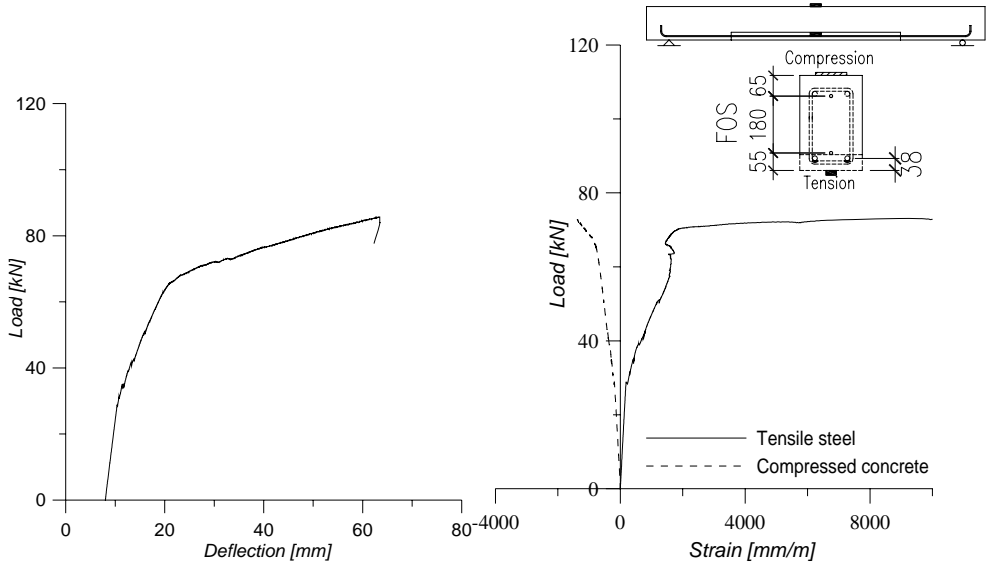
Figure A24. Left: Load vs. deflection relation for repaired beam. Right: Strain readings on tensile reinforcement and compressed concrete on repaired beam.

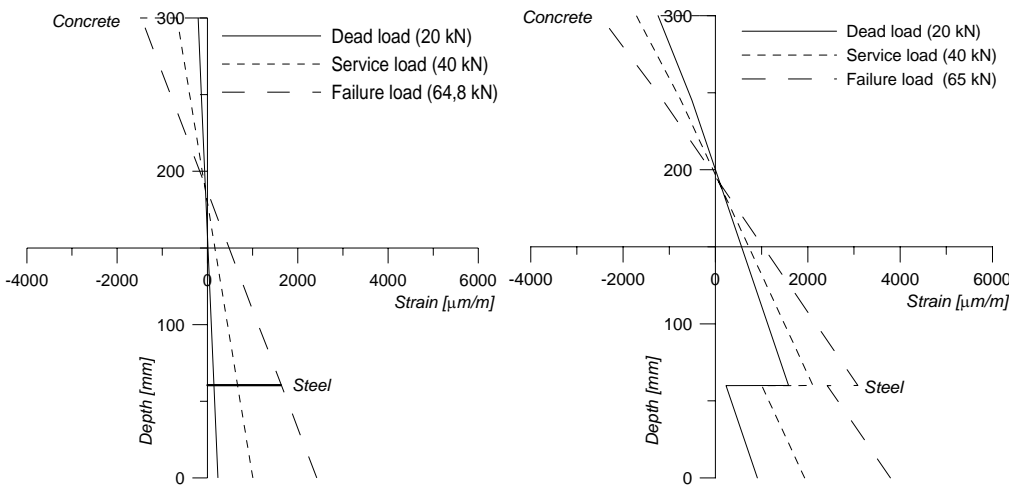
Figure A25. Left: Strain distribution for repaired beam at dead load, service load and failure load without taking the initial strain field into consideration. Right: Strain distribution when taking the initial strain field into consideration.

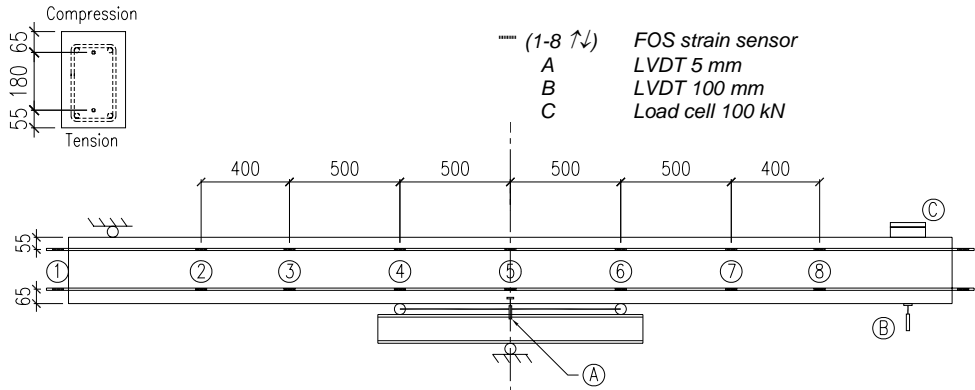
Figure A28. Sensor locations and sensor type on the intact beam specimen during corrosion stage. FOS are located along the glass fibre rods.

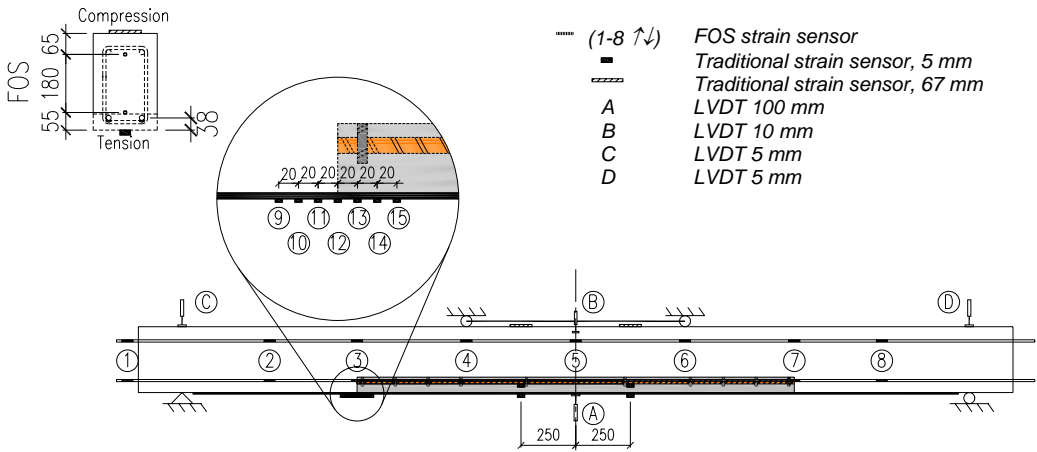
Figure A29. Sensor locations and sensor type on the repaired and strengthened beam specimen. Fibre optical sensors are located along the glass fibre rods. The traditional strain sensors are located on the tensile steel reinforcement and on the surface of the compressed concrete.

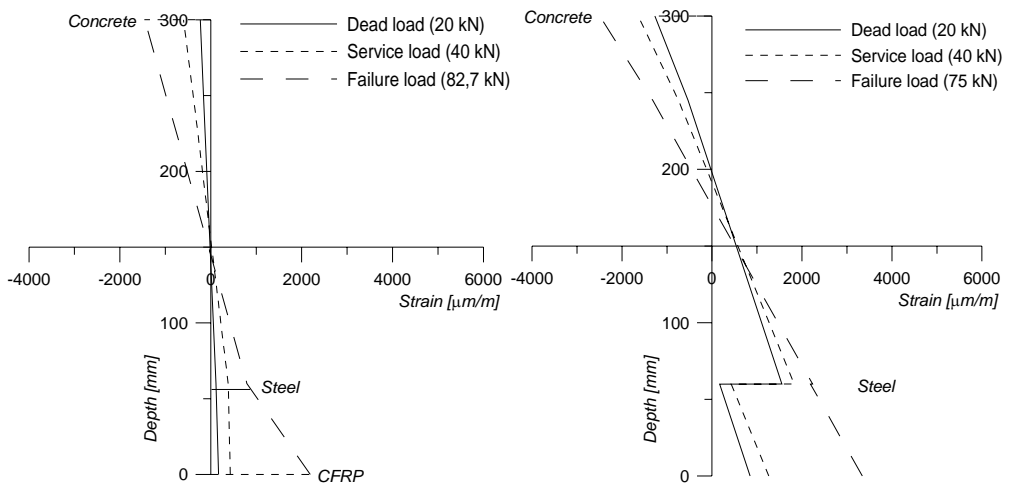
Figure A31. Left: Strain distribution in the repaired and strengthened cross section, without taking the initial strain field into consideration. Right: Strain distribution when taking the initial strain field into consideration.

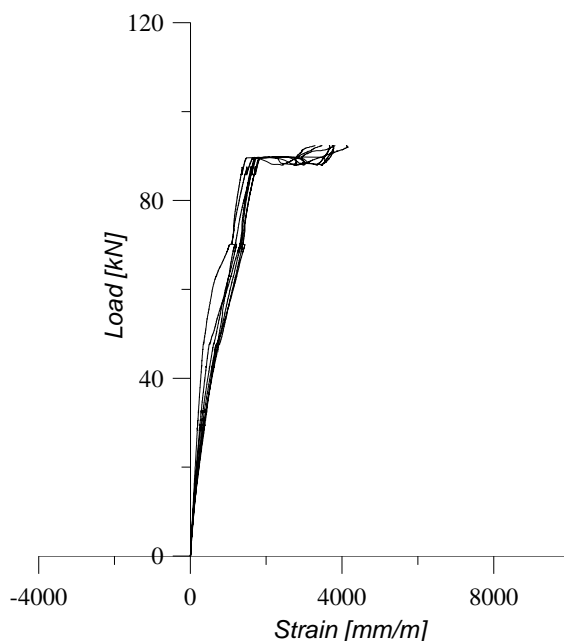
Figure A32. Strain readings from sensors 9 through 14 placed above and near the interface between concrete and repair mortar.
