Chloride Transport and Reinforcement Corrosion in the Vicinity of the Transition Zone between Substrate and Repair Concrete

TRITA-BKN, Bulletin 89, 2006
ISSN 1103-4270
ISRN KTH/BKN/R--89--SE

Licentiate Thesis

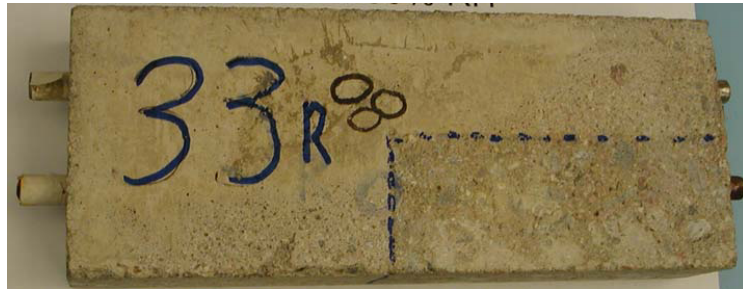
Figure 2. One repaired and reinforced concrete specimen in this investigation. The rectangle to the right is the repair concrete and the rest is the substrate concrete.

In 1992 several reinforced concrete specimens, see Figure 2, were cast simulating concrete repair systems. The w/c-ratio in the substrate concrete was 0.50 and 0.70 when the specimens were cast according to reports. The concrete was mixed in a 25 liters concrete mixer and thus it may have been difficult to achieve the required homogeneous w/c-ratio or homogeneous chloride distribution. The w/c-ratio of the repair concrete at the casting time is not known but oral communication reports a w/c-ratio of 0.40 or 0.45. Based on practice of making concrete repairs in 1992, a probable w/c-ratio between 0.4 and 0.5 may be assumed. Each specimen was cast with a major substrate concrete part and some weeks after with one minor part with repair concrete. Specimens were cast with 1 and 4 % chlorides per cement weight. The specimens were then exposed to different environments (outdoors and indoors in 80 % RH, 85-90 % RH and 95 % RH). Unrepaired reinforced specimens were also cast as a reference to the repaired specimens in all environments.

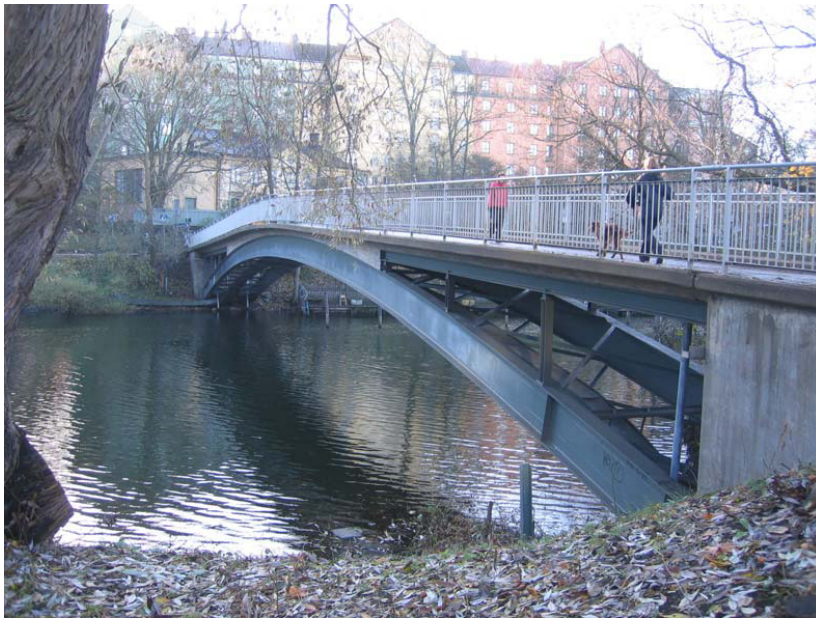
Figure 3. *Pålunds bridge*

Pålsund bridge is an arch bridge in one span (total length 62 m and span 52.5 m), see Figure 3, in the centre of Stockholm. It was built in 1947 across a narrow part of the lake *Mälaren* between *Söder Mälarstrand* and the island *Långholmen*. The bridge is narrow and highly

trafficked by cars and trucks. In winter time the bridge is treated with deicing agents. In 1992 the asphalt overlay was removed and the concrete bridge deck was blasted with water jet and about 20-30 mm concrete was removed [43]. A 50 mm thick fibre reinforced overlay concrete was cast on the top of the substrate concrete according to documents, see Figure 4. Totally 60 kg steel fibre was intermixed per m^3 concrete. In 1994, the whole concrete part of the bridge was hydrophobed by applying some kind of impregnation, probably some kind of silane/siloxane, to reduce the ingress of chlorides, water and moisture. The function of the concrete layer is a wearing surface.

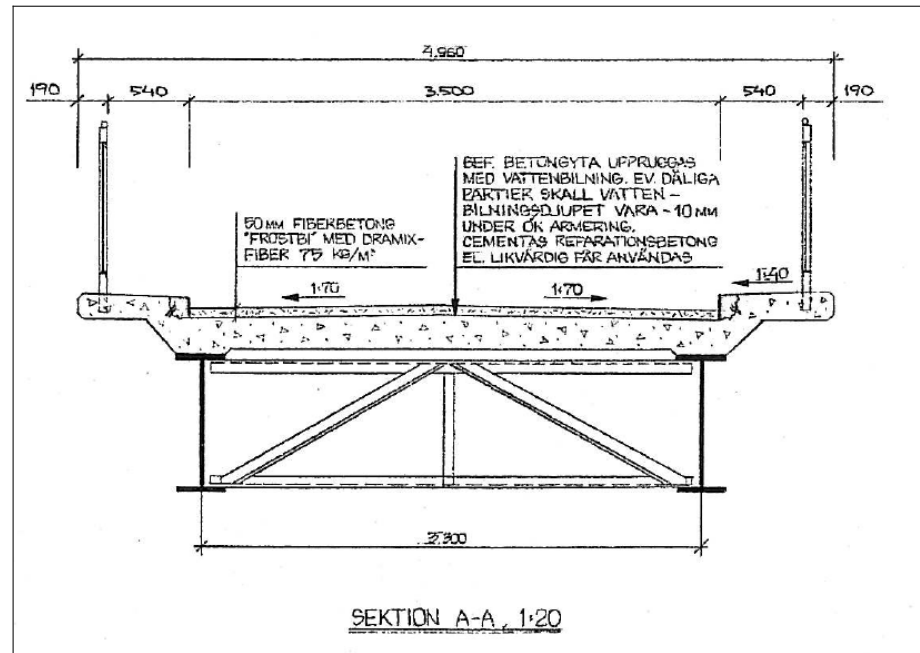
Figure 4. Principal sketch for the repair of the overlay of the bridge

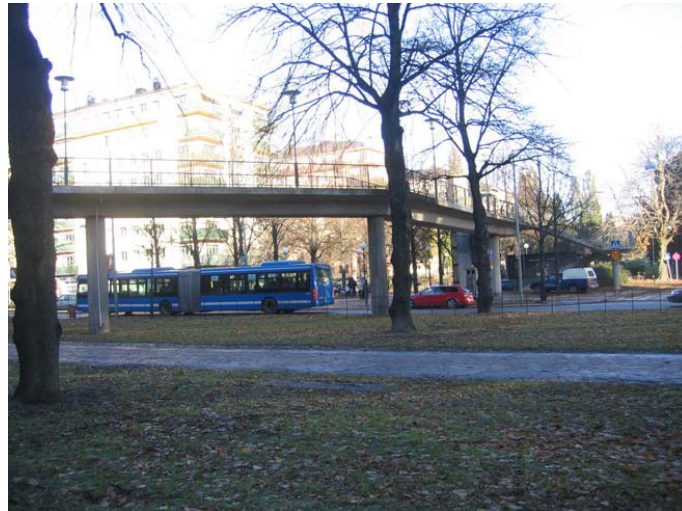
Figure 5. Pedestrian bridge across *Valhallavägen* at *Fältöversten*.

The second object was a pedestrian concrete bridge with stairs built in 1974 across *Valhallavägen* in the centre of Stockholm, see Figure 5. Damages on the stairs were observed already in the early 90's, see Figure 6, probably caused by salt-frost actions and reinforcement corrosion. The stairs have been treated with deicing agents in the winter time.

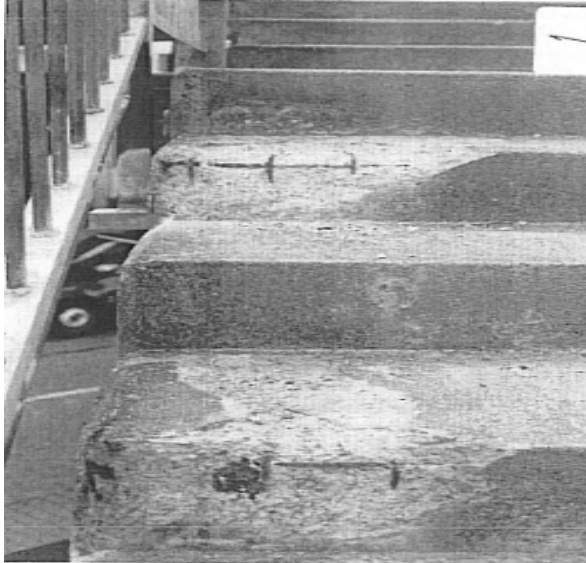
Figure 6. Damaged stairs at Fältöversten, 1998.

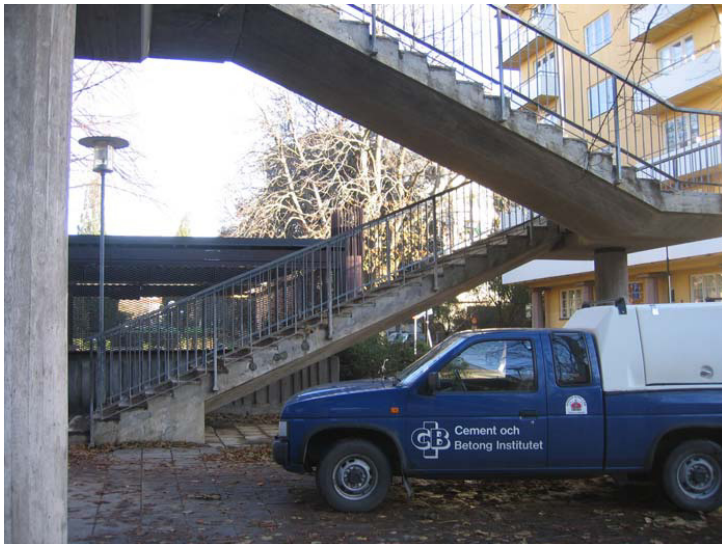
Figure 7. Stairs to the pedestrian bridge across *Valhallavägen* at Fältöversten

In the year of 2000 the top of the concrete stairs was repaired. The existing granulate concrete and the damaged structural concrete were removed. At the edges of the stair steps the removing of concrete was done with a handheld equipment to avoid too big losses of concrete and the rest of the stairs was blasted with water jet. New concrete was cast with 80 mm cover to the reinforcement according to the documents. After the casting granite steps were placed on the top in a mortar. Finally the concrete stairs were impregnated. The stairs can be seen in profile in Figure 7.

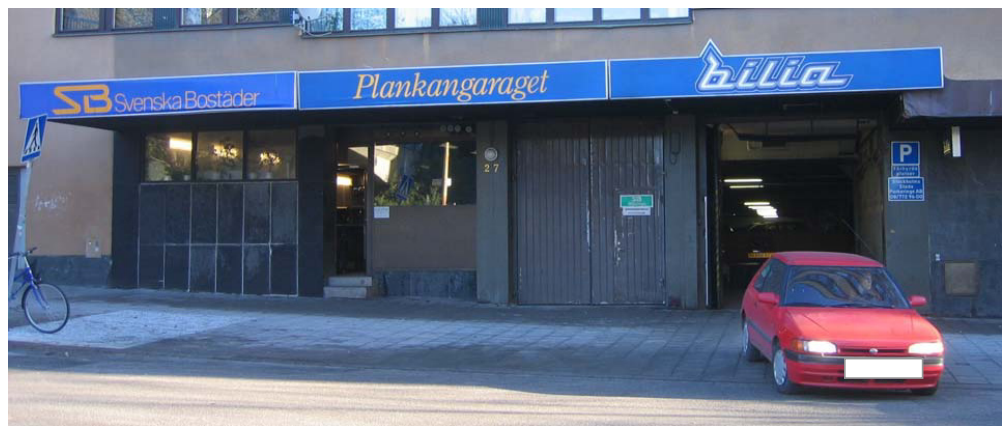
Figure 8. The entrance to the carpark *Plankan*.

In the middle of the 60's the parking structure called *Plankan* was built in the southern part of Stockholm centre, see Figure 8. The parking structure consists of two parking levels and a total area of about 5000 m². The floor structure is totally 300 mm thick. The top of the floor structure has no concrete overlay or water protecting membrane. The cars are driving directly on the structural concrete. Traffic during the years has brought deicing salts into the parking structure. CBI has carried out an assessment of the parking structure in 2006 and during that investigation [49] it was found that premixed chlorides have probably been used as an accelerator during the casting in the 60's. Damages caused by chloride initiated reinforcement corrosion on the top of the concrete floor have been patch repaired between years 1994 and 1998. After 1998 several new damaged areas have raised and even some of the patch repairs are damaged.

In all these three structures concrete cores, Ø 50-100 mm, were drilled out across and along the transition zone between repair concretes and substrate concretes. The cores and reinforcement, if any, were ocularly examined and after that material was sawn out at different distances from the transition zone. The sawn material was analysed regarding the chloride content (weight-% per cement weight) with an ion selective electrode. The chloride contents were then arranged to chloride profiles across the transition zone to investigate if any chlorides had been moving from the substrate concrete and into the repair concrete.

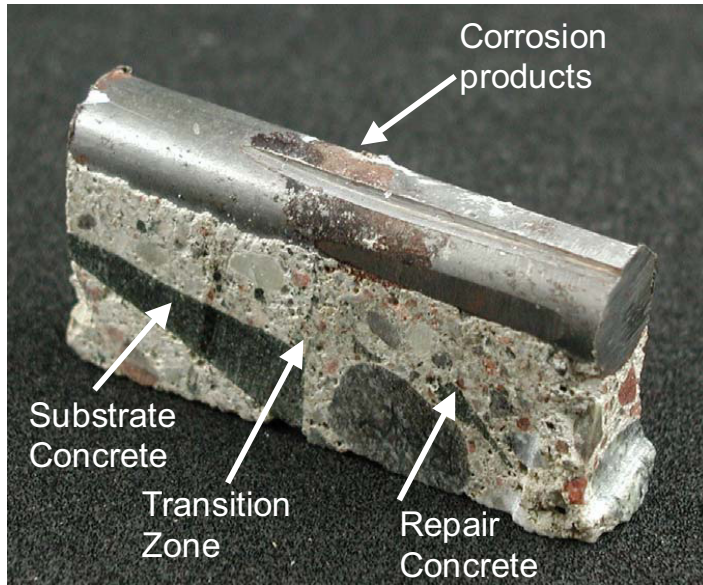
Figure 9. Specimen slice with rebar attached to the concrete.

From the specimens, 10 mm thick slices, see Figure 9, were cut with a precision saw. To prevent the chlorides to be washed out during the sawing process no cooling water was used. The cuts were directed so the transition zone between the substrate and repair concrete was located in the middle of the slices and 25 mm of concrete on both sides of the transition zone was included.

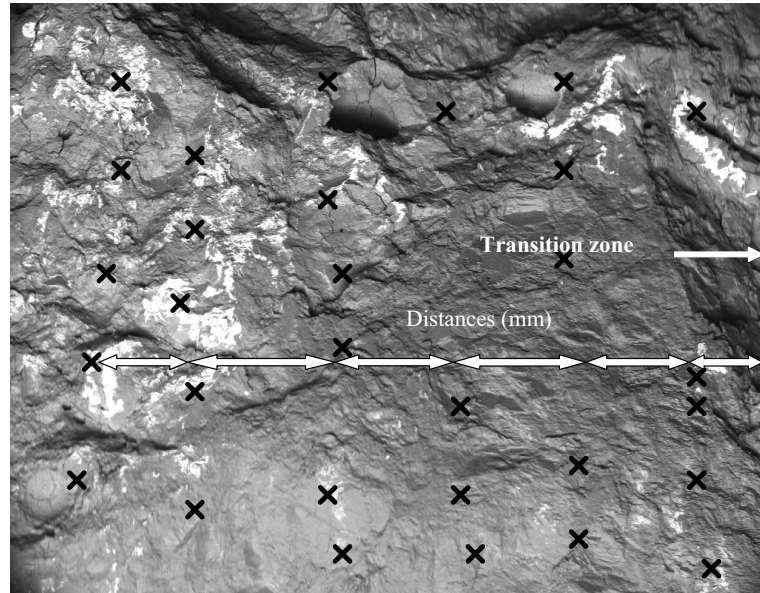
Figure 10. SEM-image over an analysed area. Total length of the sample in this image is 6.5 mm.

Subsequently, the slices were fractured perpendicularly to the transition zone. This preparation technique is believed to produce the least altered surfaces for the purpose of chemical analysis. The amounts of chloride in the samples for all specimens were analysed using a Scanning Electron Microscope (SEM) equipped with Energy Dispersive Spectrometer (EDS). The EDS detector detects most of the X-ray spectrum generated from the probe surface when the accelerated electrons from the microscope hit the analysed surface [44]. The SEM-EDS-analyses were carried out on fractured surfaces and the analytical results are presented as wt % of chloride per cement weight. The EDS instrument detects the total chloride content in the cement paste, the sum of the free chlorides and the bound chlorides. All the SEM-EDS-analyses were carried out in the cement paste and the beam was focused to point analyses. As the chlorides are not uniformly distributed in the cement paste on the micro scale, at least five SEM-EDS-analyses were done at every distance from the transition zone. Pictures were taken at different distances, see example in Figure 10, and the analysed points were marked and the distance from the transition zone was measured. Mean values at each distance were calculated and chloride profiles were made, see example in Figure 11. In the profile the transition zone is defining the origo, the distance into the substrate concrete is negative and the distance is positive into the repair concrete. Distances are given in millimetres (mm). In some of the specimens it was not possible to make chloride SEM-EDS-analysis all the 25 mm in each material because of aggregate interference. A similar method has been used by [45] to determine the chloride profile and the diffusion coefficient.

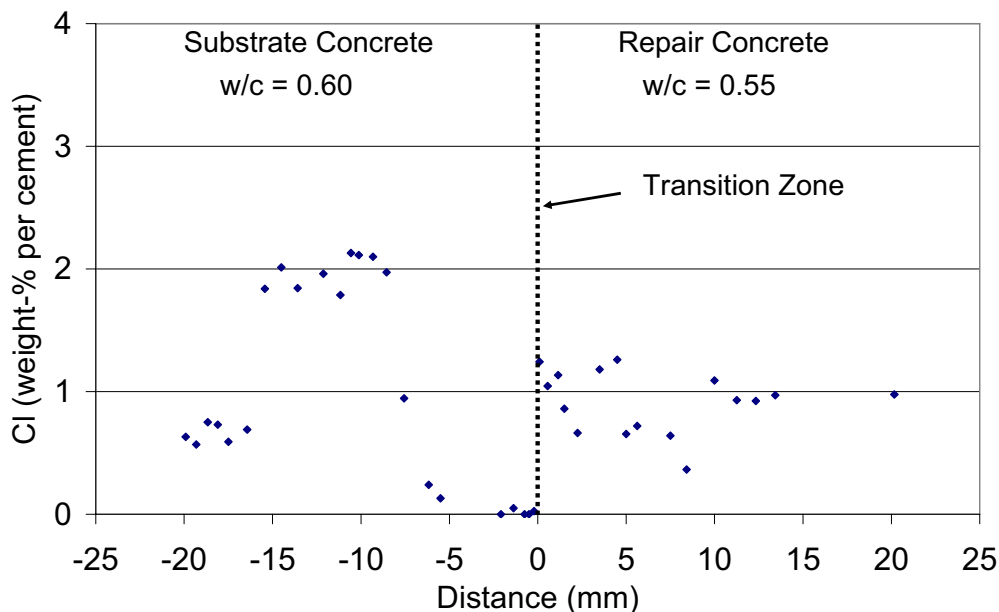
Figure 12. Chloride profile in a specimen with 1 wt % chlorides premixed in the substrate concrete, exposed outdoors.

In the laboratory specimens it was seen that the premixed chlorides have been transported into the repair concrete during the 13 years of exposure. In Figure 12 an established chloride profile is shown for a specimen with initially 1 wt % chlorides in the substrate concrete exposed outdoors. The chlorides have moved more than 20 mm into the repair concrete and the concentration at this distance is the same as the initial content in the substrate concrete.

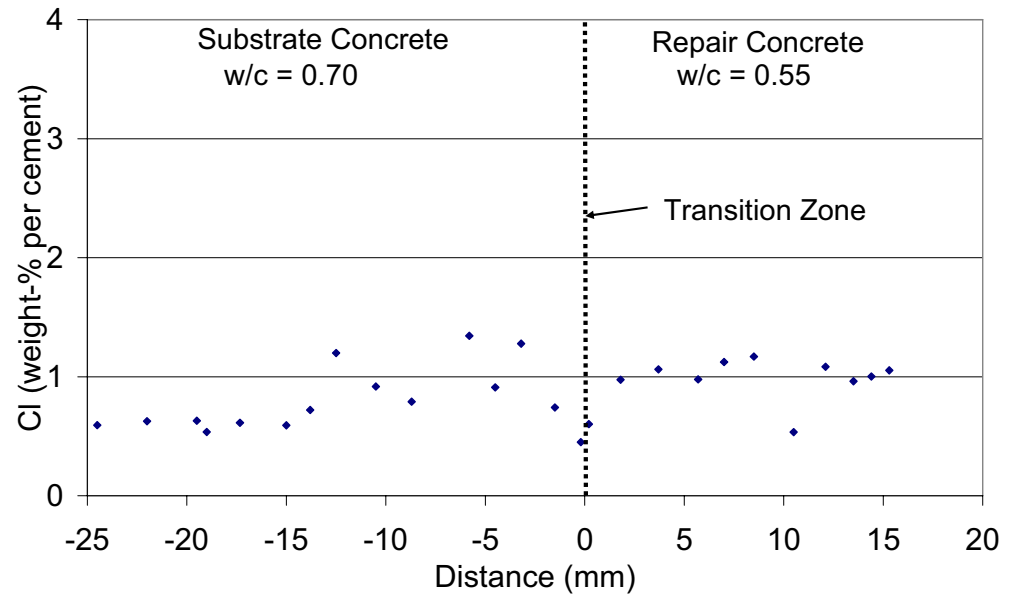
Figure 13. Chloride profile in a specimen with 1 wt % chlorides premixed in the substrate concrete, stored 13 years in relative humidity of 80 %.

The profiles for the specimens stored in 80 % relative humidity during the 13 years have the same appearance, for example see Figure 13.

In Figure 13 another general observation can be seen. The chloride concentration in the first millimetres of the substrate concrete just near the transition zone was very low. For the specimens stored in the field this zone is comparable with the depth of carbonated concrete. It seems that the carbonation front has forced the chlorides into the substrate concrete and behind the carbonated concrete there are accumulated chlorides, the carbonation depths can be seen in Appendix 1, Table 1. Behind this zone the chloride level went down to a background value in most of the profiles. It would have been interesting to extend these analyses up to 50 mm distance from the transition zone. This was not possible because of the sizes of the samples were too small. If the chloride transport into the repair concrete occurred before the carbonation or if the chlorides still can move through the carbonated zone is not investigated and fully understood. The same phenomenon with carbonation front and chloride content has been seen and explained earlier by Tuutii [32]. This is further discussed in Section 5.4.2 and Paper III. In the specimens stored in 80 % relative humidity the carbonation depths are larger, see Table 3, and it is not the same clear relation to the chloride profiles. The higher carbonation is due to a environment in the chamber compared to outdoors and the carbonation rate is higher in a concrete with 80 % relative humidity. The maximum for the carbonation rate occurs at 65-70 % relative humidity [25].

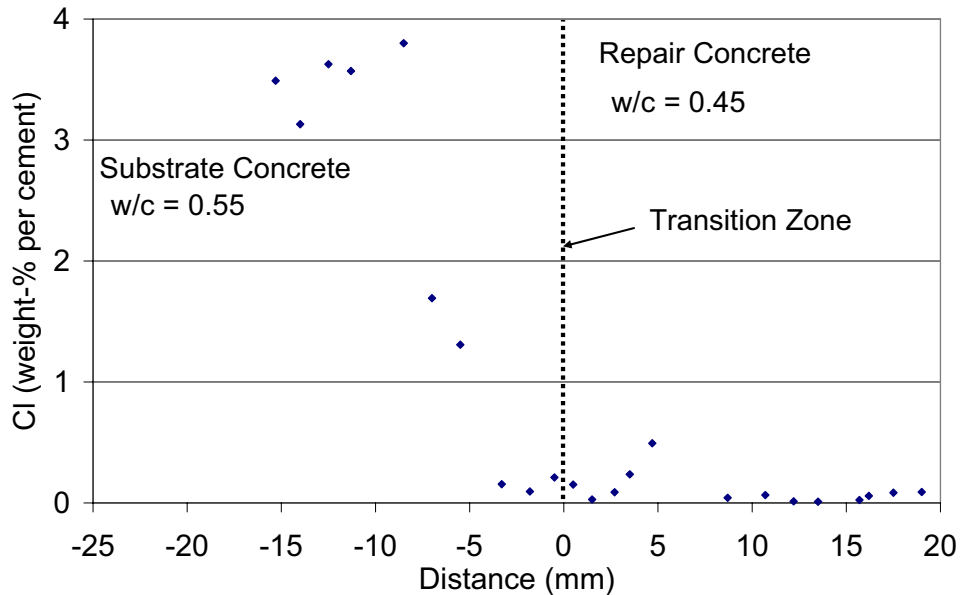
Figure 14. Low chloride transport across the transition zone when the equivalent w/c -ratio is 0.45 in the repair concrete.

This chloride transport has occurred in all the laboratory specimens with two exceptions. These two had an equivalent w/c-ratio 0.45, see example in Figure 14, but the equivalent w/c-ratio in the substrate concrete differed between these two specimens from 0.40 to 0.55. The other six specimens had an equivalent w/c-ratio ≥ 0.50 in their repair concretes.

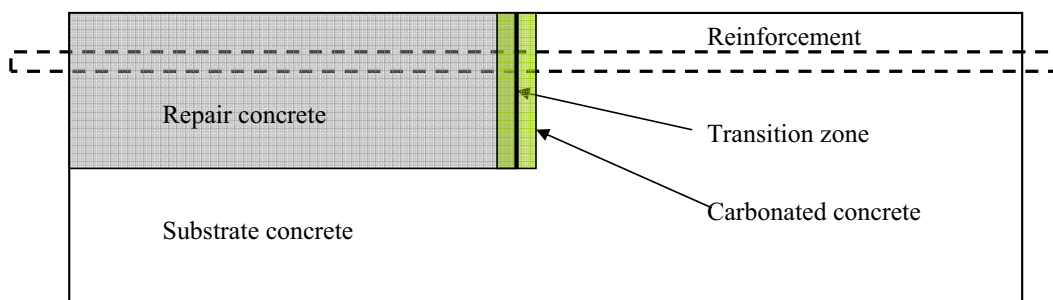
Figure 15. Schematic figure for specimen with carbonation in the transition zone.

Carbonation was observed in the transition for the specimens in the laboratory specimens. A principal sketch can be seen in Figure 15.

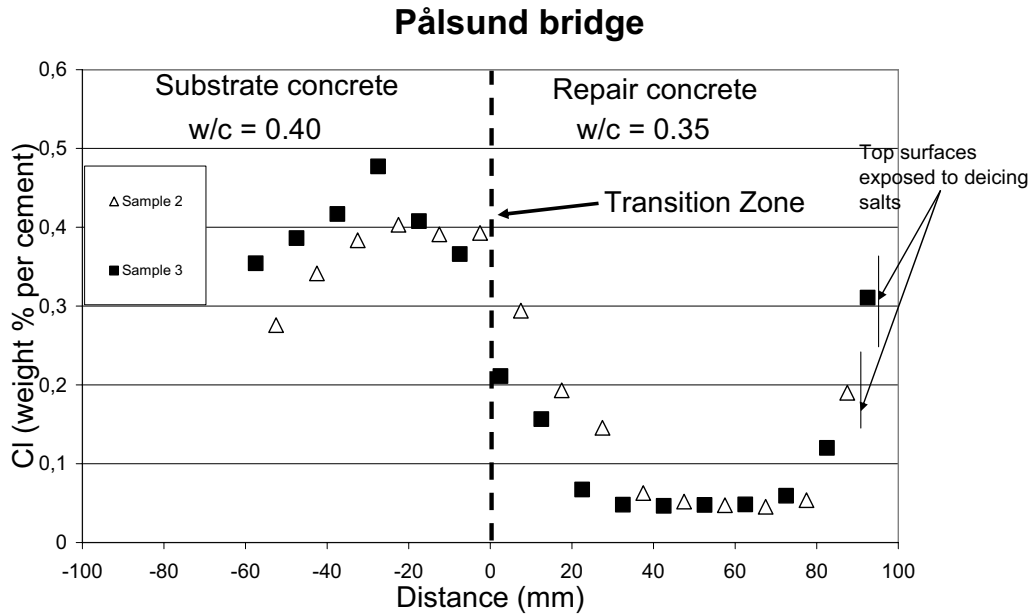
Figure 16. Chloride profile across transition zone in two field samples from a concrete repair.

In the field study chloride transport was observed across the transition when the substrate concrete was contaminated with chlorides, see Figure 16. In field samples it was also observed that some chlorides have penetrated the top of the concrete overlay but it was clear that a dense concrete overlay reduces the chloride ingress. This is discussed further in Paper IV.

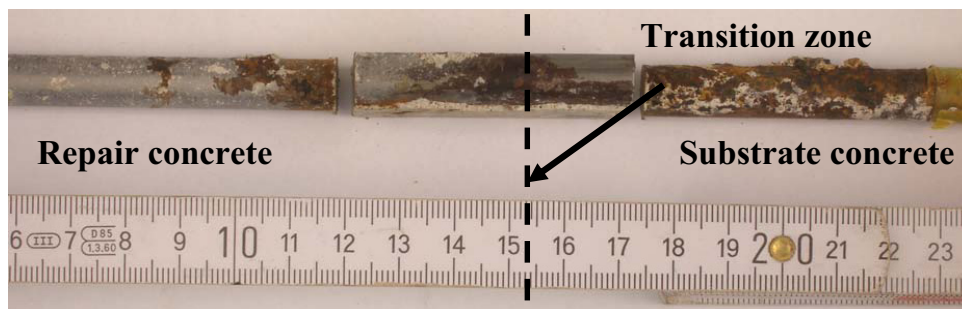
Figure 17. Reinforcement corrosion in separated large areas. Corrosion appears in this specimen in both the materials and in the transition zone.

All eight specimens in the laboratory study had more or less corroded reinforcement. In three of the field specimens and four of the specimens exposed to 80 % RH rebars were corroded in the transition zone, see example in Figure 17. All the specimens were corroded in the substrate concrete

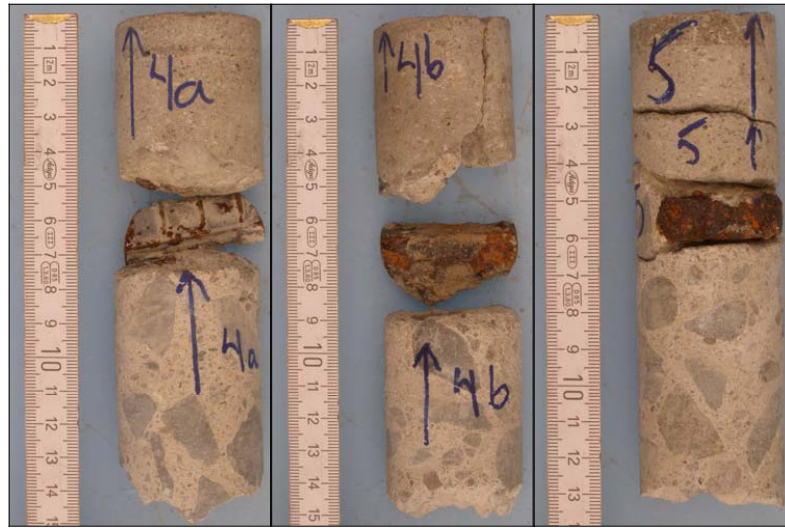
Figure 18. Concrete samples from patch repairs in parking structure *Plankan* with corroded reinforcement in the transition zone.

In two of the investigated field structures reinforcement corrosion was found in the transition zone. In the parking structure, see Figure 18, all the concrete cores were broken during the drilling process and in several of them corroded reinforcement was found in the transition zone.

The expansive corrosion products in the repairs in the parking structure are caused by the high levels of chlorides near the transition zone, between 0.7 and 2.0 weight % chlorides per cement weight.

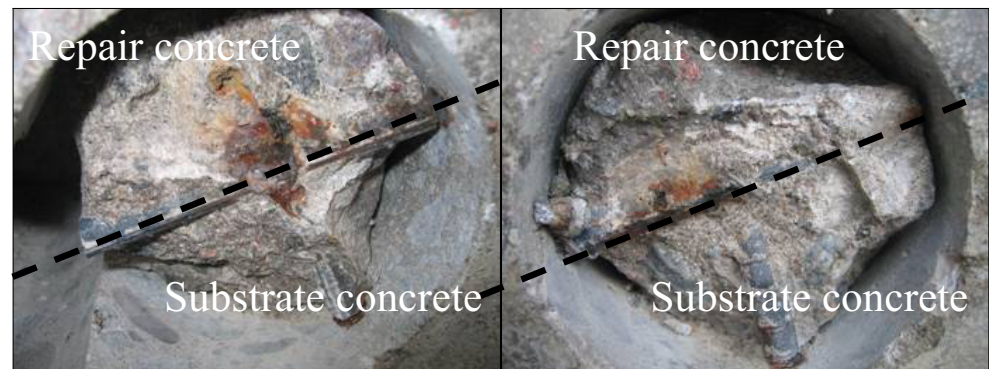
Figure 19. Reinforcement corrosion in the transition zone in the pedestrian stairs. The dotted lines indicate the location of the theoretical transition zone

Reinforcement corrosion was also found in the transition zone between the substrate concrete and the repair concrete in the pedestrian bridge, see Figure 19.

The only difference between the substrate concrete and the repair concrete is to be found in the mix design. It is obvious that some kind of electrochemical phenomenon has occurred. In this case it seems that reinforcement corrosion can occur in the transition zone between two different concretes without chlorides present or carbonation in any of the two materials. In this study just a few samples and observations are carried out. Further analyses regarding chloride content and concrete composition etc. would be valuable. Another possible explanation could be galvanic corrosion if the reinforcement is connected to a more noble

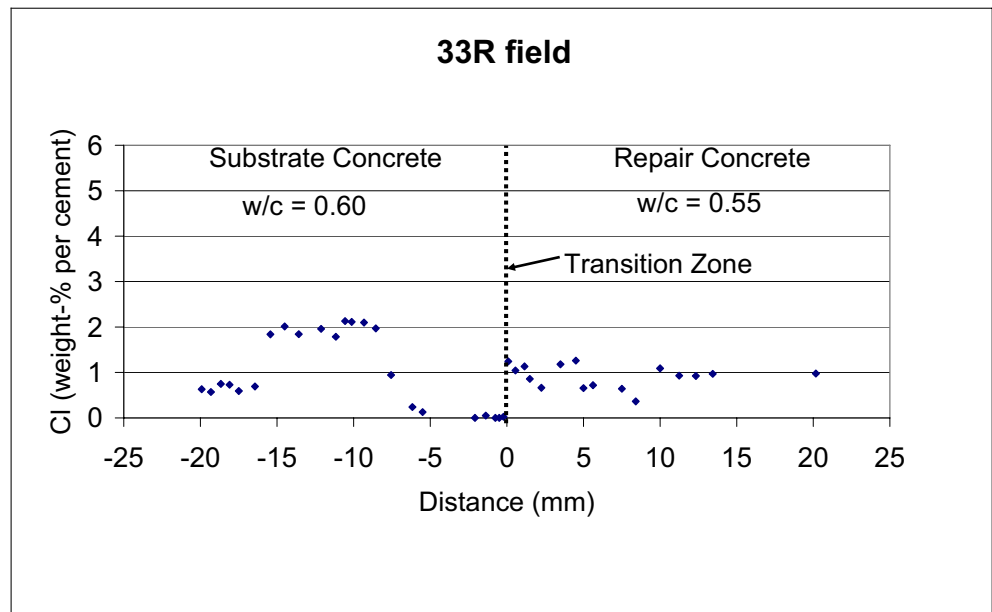
Figure 1. Chloride profile across the transition zone in 33R field, SEM-EDS-analysis.

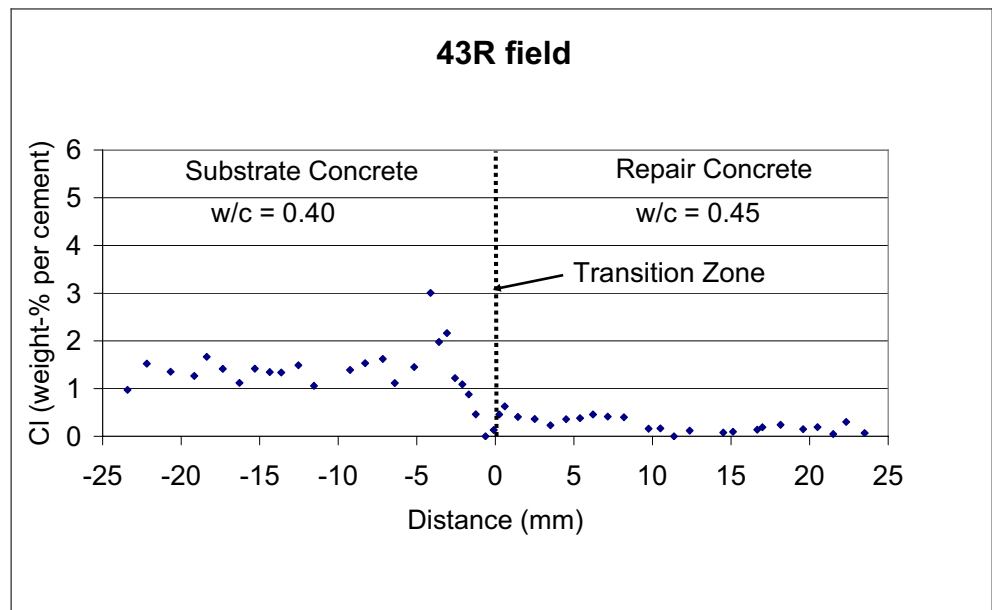
Figure 2. Chloride profile across the transition zone in 43R field, SEM-EDS-analysis.

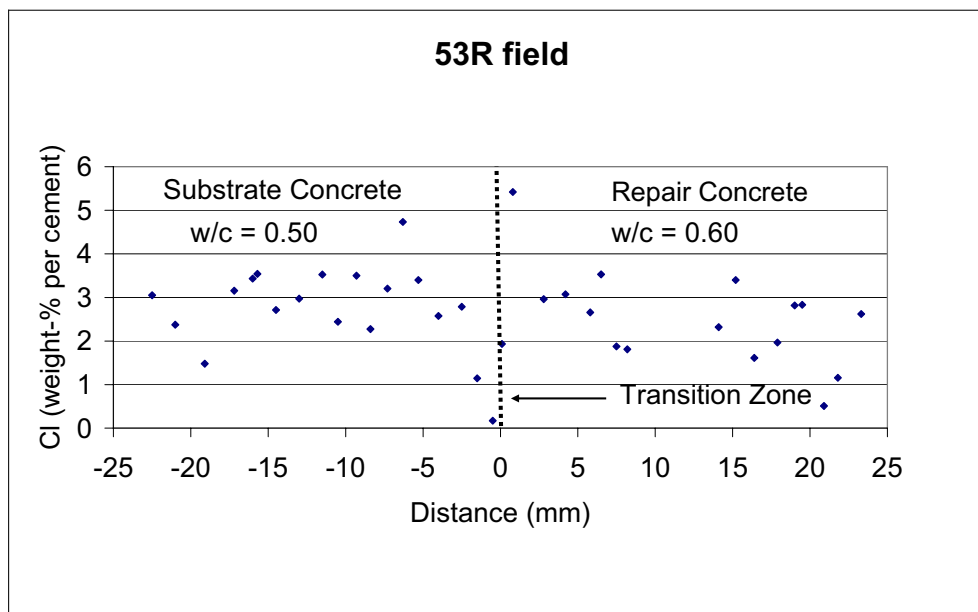
Figure 3. Chloride profile across the transition zone in 53R field, SEM-EDS-analysis.

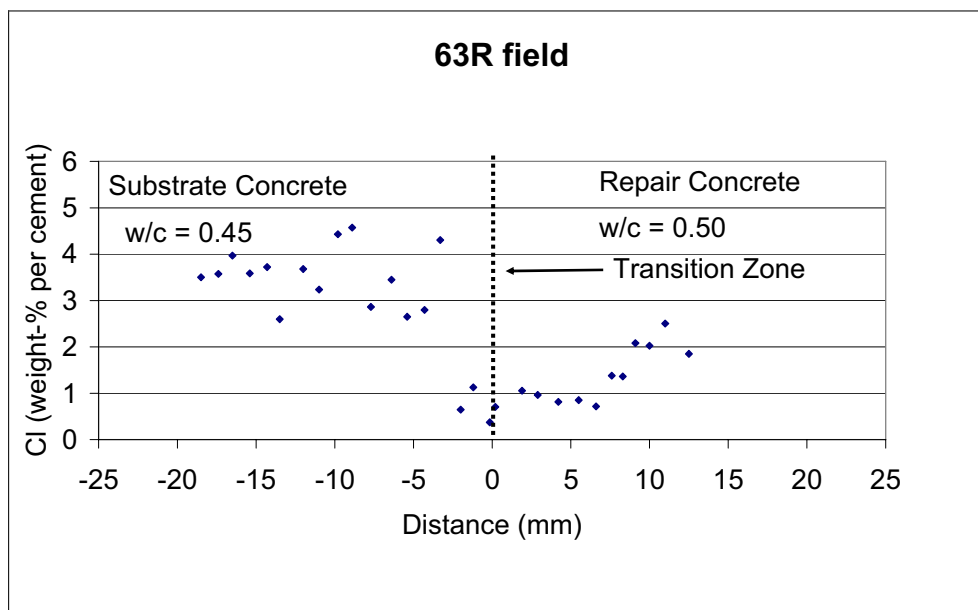
Figure 4. Chloride profile across the transition zone in 63R field, SEM-EDS-analysis.

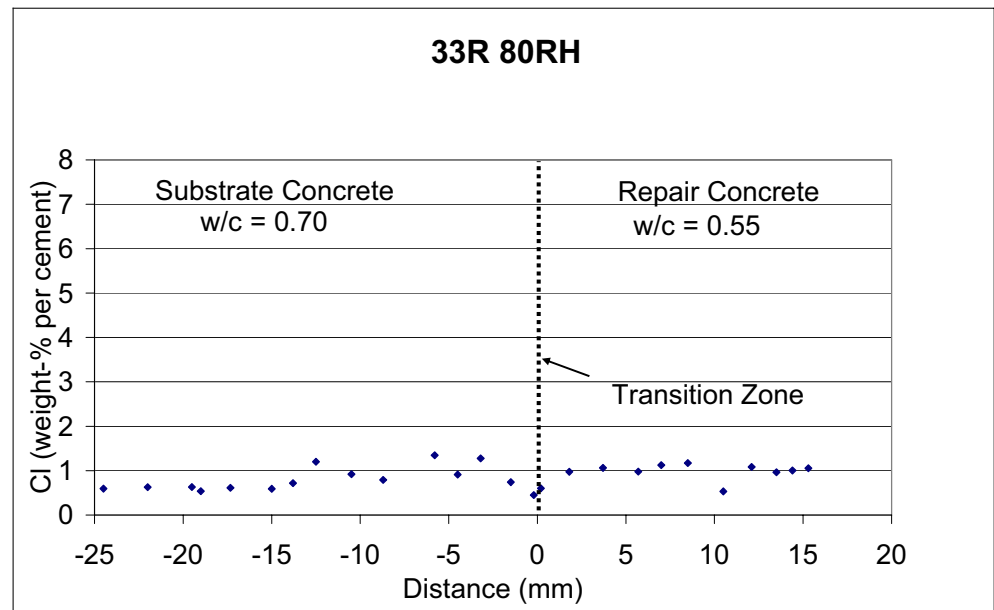
Figure 5. Chloride profile across the transition zone in 33R 80 % RH, SEM-EDS-analysis.

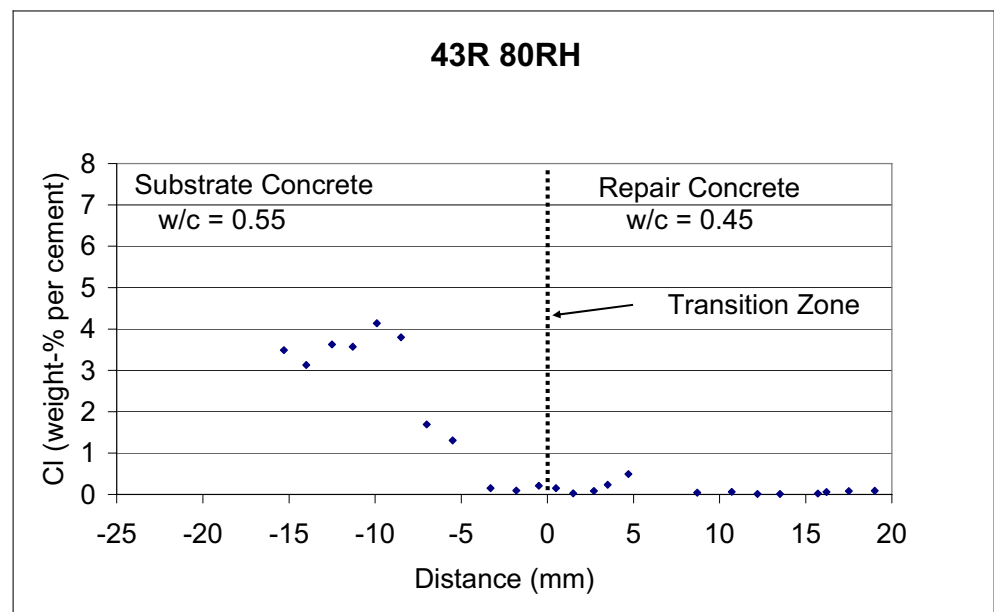
Figure 6. Chloride profile across the transition zone in 43R 80 % RH, EDS-analysis.

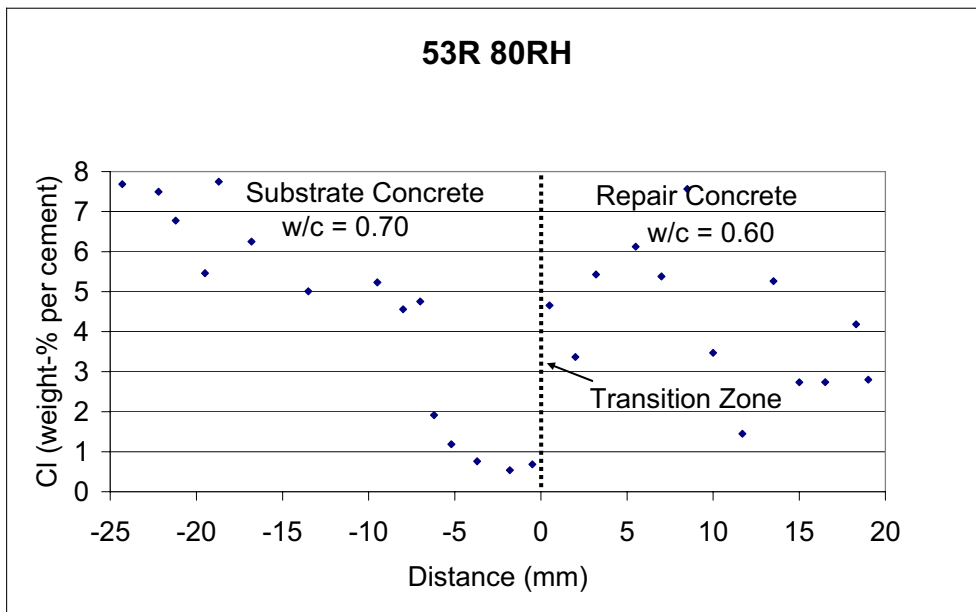
Figure 7. Chloride profile across the transition zone in 53R 80 % RH, EDS-analysis.

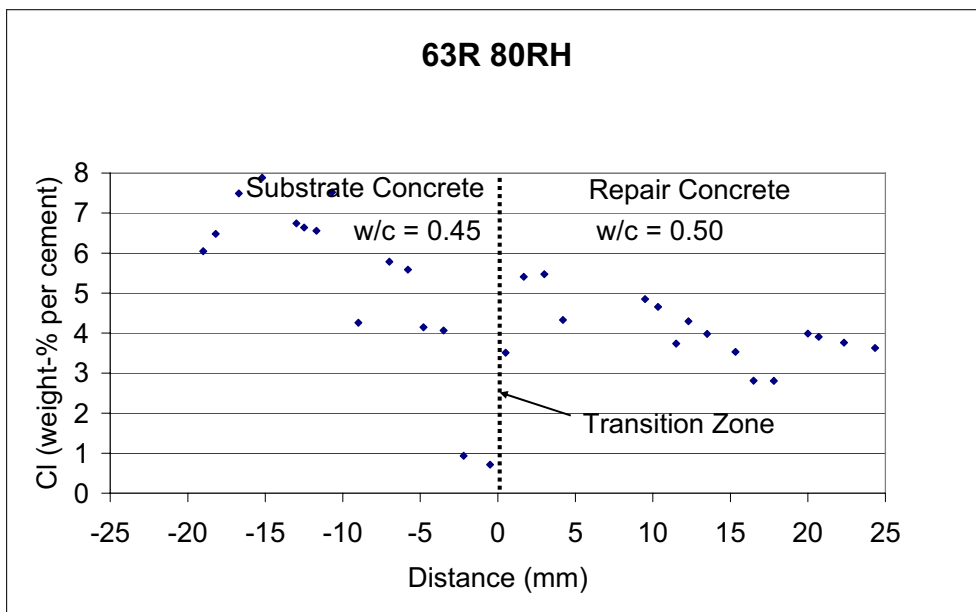
Figure 8. Chloride profile across the transition zone in 63R 80 % RH, EDS-analysis.

63R 80RH Substrate w/c = 0.45 Cl = 4.0 wt % Repair w/c = 0.50	63R 80RH has chloride content lower than 1 wt % in the first 3 mm into the substrate concrete. In the repair concrete the highest concentration are found near the transition zone, 5.5 wt %. Deeper into the repair concrete the chloride contents decrease to 3.5 wt % at 25 mm. See figure 8.	5-10 mm distance from the transition zone was carbonated. 2 mm from the transition zone was carbonated into the repair concrete.	Corrosion in the transition zone and the main part of this corroded zone was 10 mm into the repair concrete. No further corrosion was observed in the repair concrete. In the substrate concrete there was an uncorroded area between 10 and 20 mm distance from the transition zone. The reinforcement is totally corroded from 20 mm distance from the transition zone and all through the substrate concrete. See figure 16.

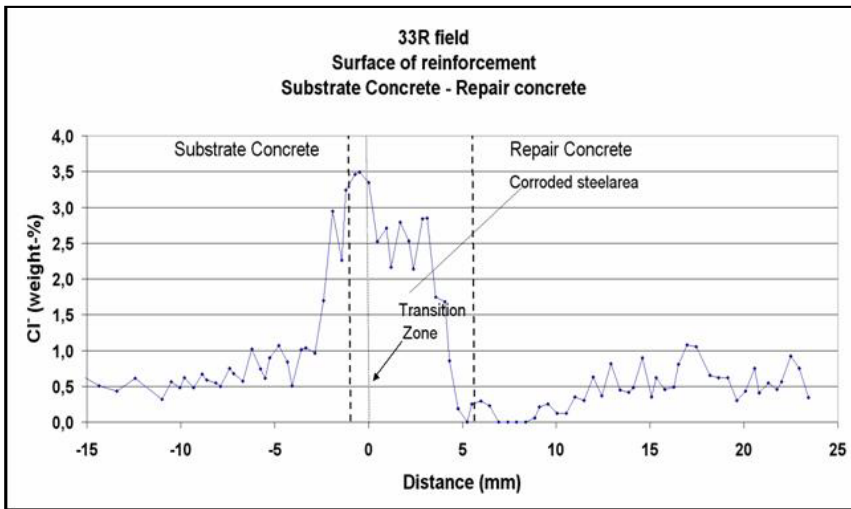
Figure 17. Chloride profile along the surface of reinforcement in 33R field, EDS-analysis.

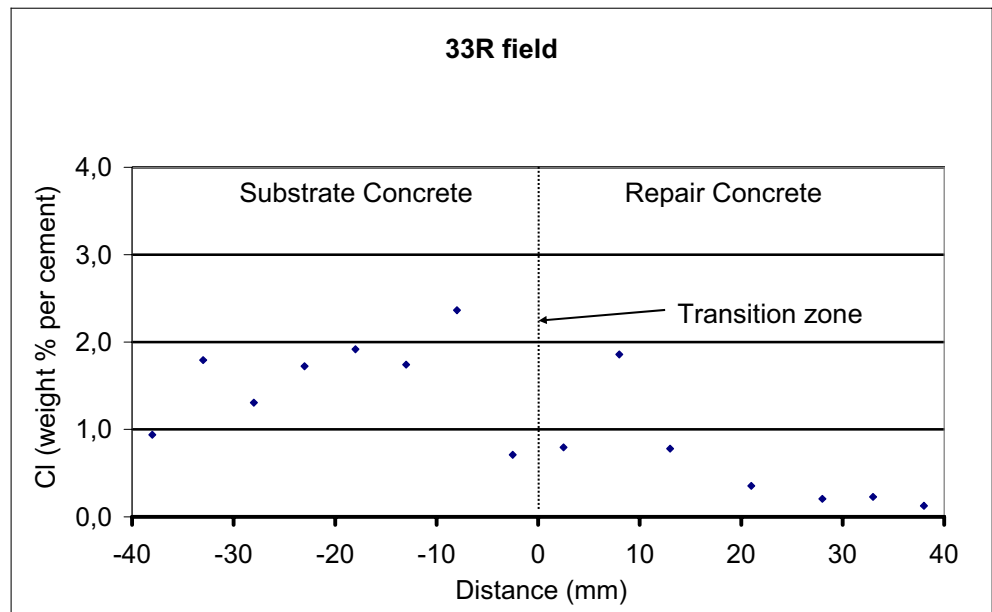
Figure 18. Chloride profile for 33R field analysed with an ion selective electrode method.

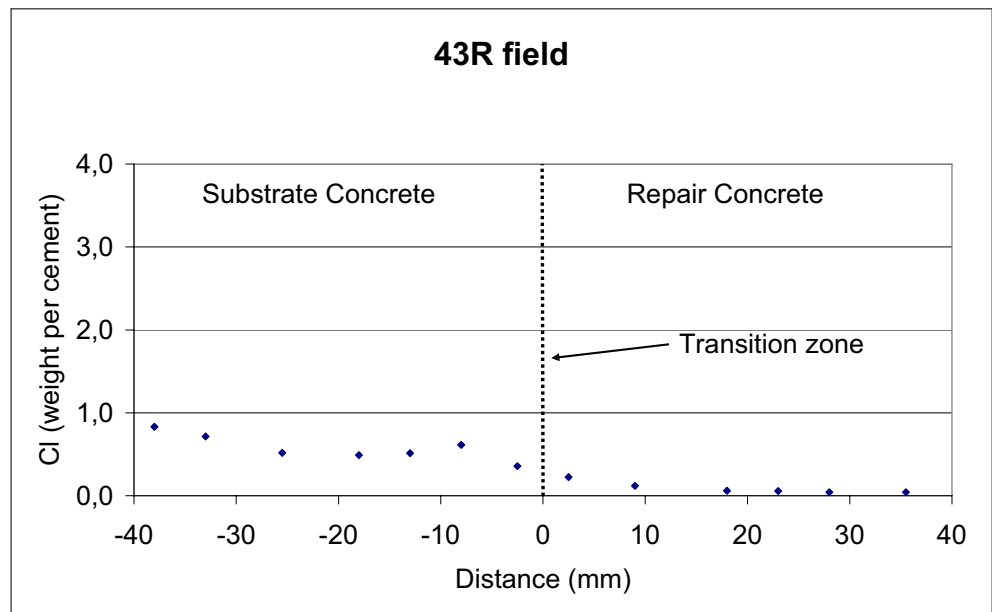
Figure 19. Chloride profile for 43R field analysed with an ion selective electrode method.

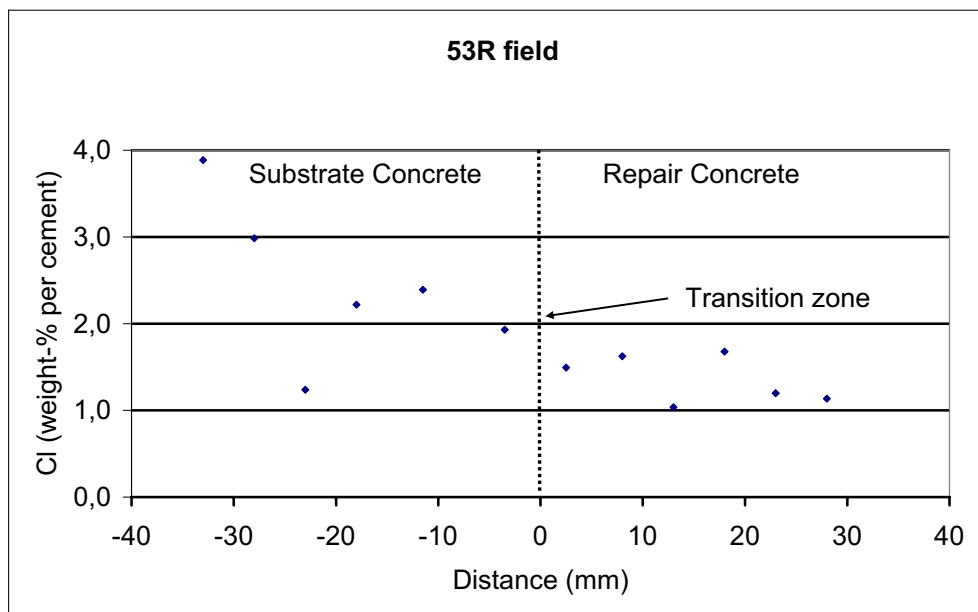
Figure 20. Chloride profile for 53R field analysed with an ion selective electrode method.

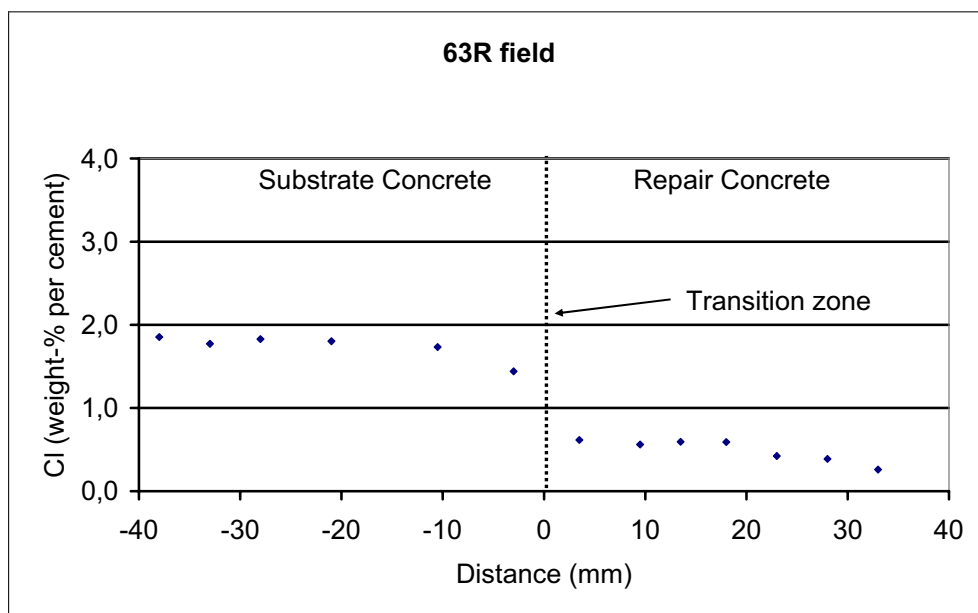
Figure 21. Chloride profile for 63R field analysed with an ion selective electrode method.

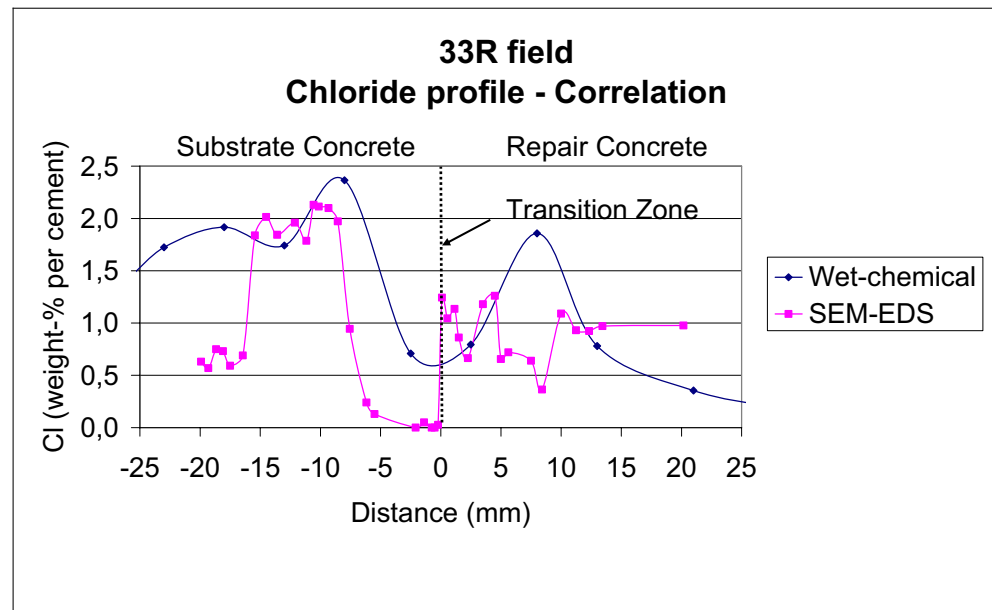
Figure 22. Chloride profile in 33R. Correlation between wet-chemical method with ion-selective electrode and SEM-EDS method.

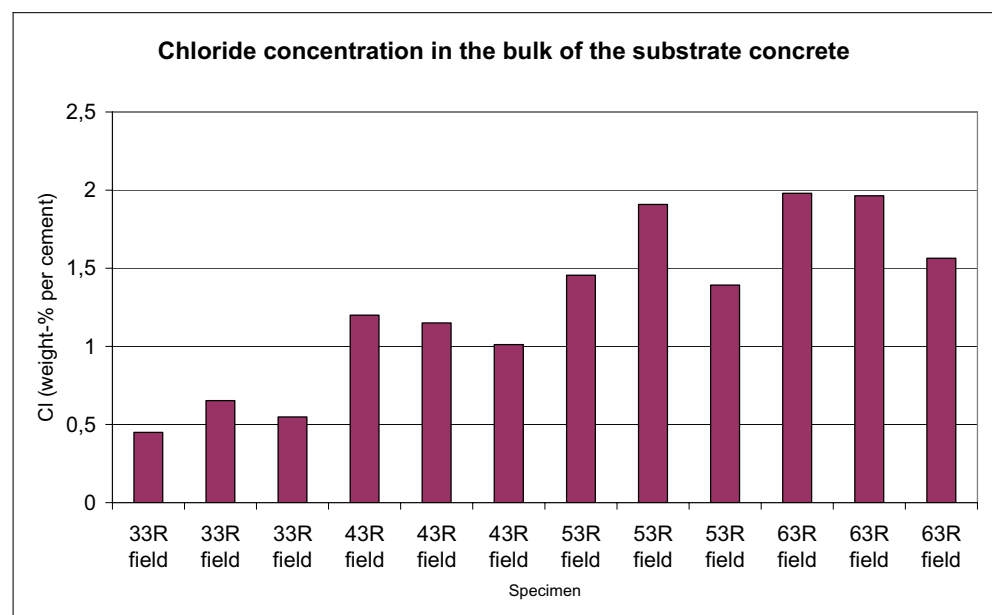
Figure 23. Chloride concentration in the bulk of the substrate concrete for 33R field – 63 R field analysed with ion selective electrode.

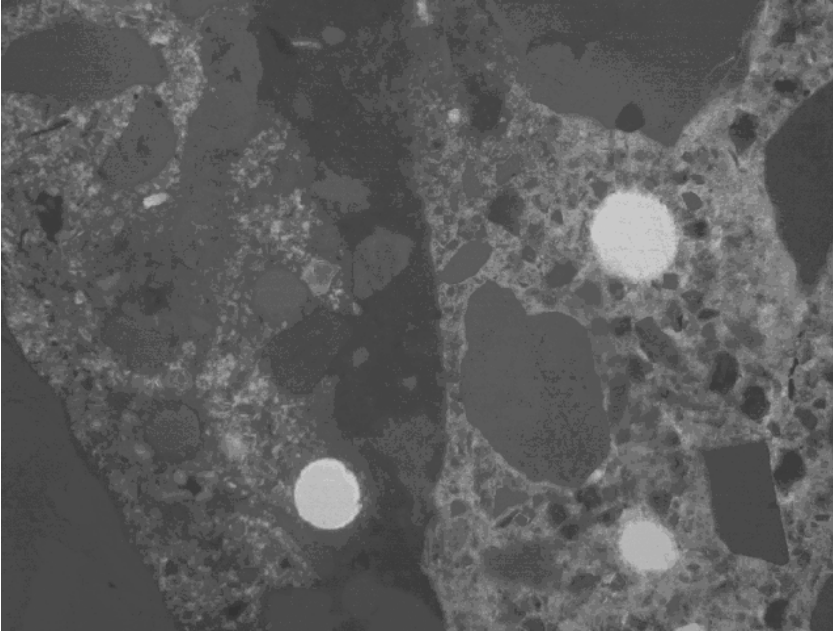
Figure 24. Thin-section of the transition zone between substrate concrete (left) and repair concrete (right). Specimen 33R field. Picture taken in fluorescent light. Total length of the picture is 10mm.

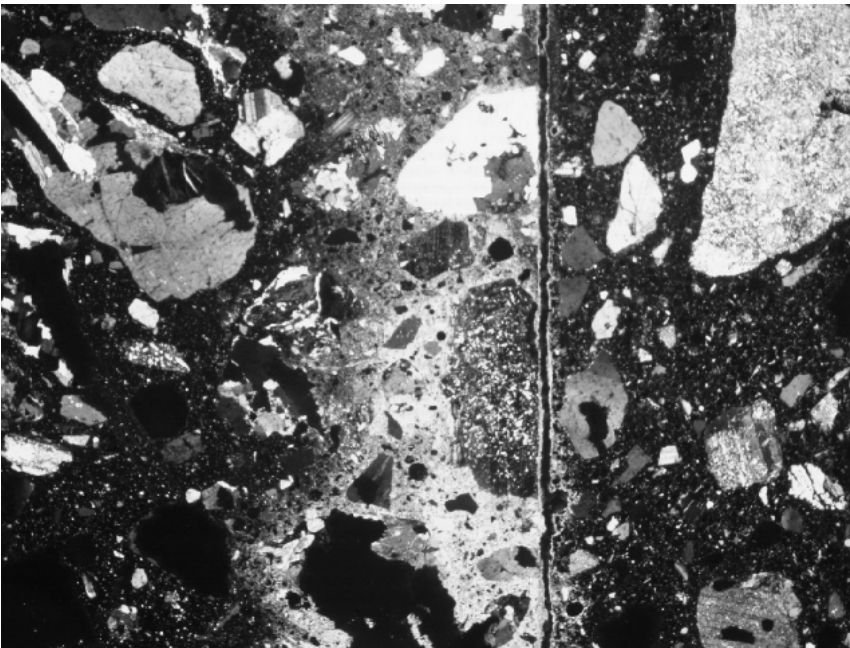
Figure 25. Carbonation from the transition zone and 2-2.5 mm into the substrate concrete (left), the lighter part. The repair concrete to the right is left uncarbonated, dark. Specimen 43R field in polarized light. Total length of the picture is 10mm.
