Chloride Transport and Reinforcement Corrosion in the Vicinity of the Transition Zone between Substrate and Repair Concrete

TRITA-BKN, Bulletin 89, 2006
ISSN 1103-4270
ISRN KTH/BKN/R--89--SE

Licentiate Thesis

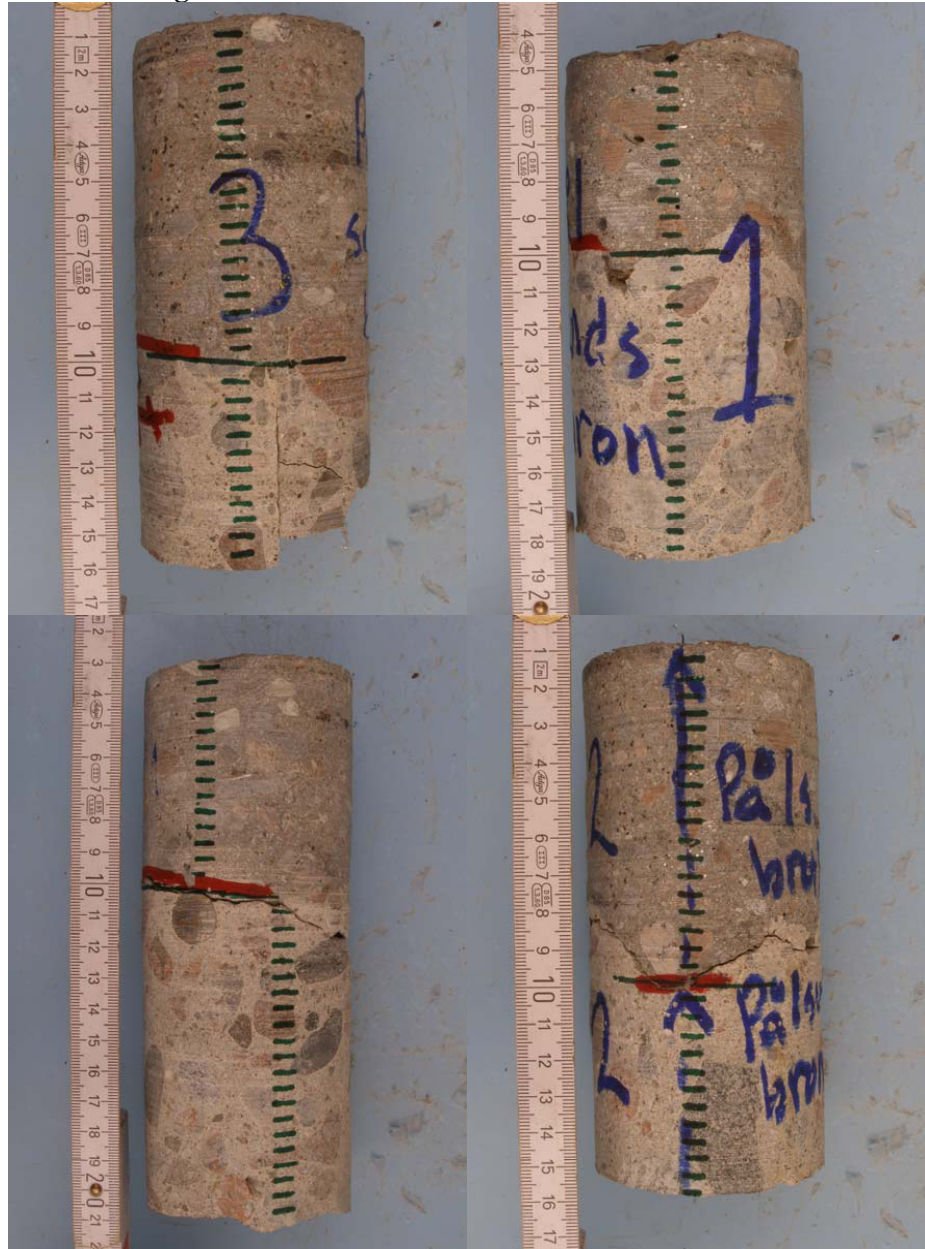
Figure 1. Concrete samples 1, 2, 3, and 4 from the *Pålsund* bridge. The marked levels are the intervals where material was cut out to analyse the chloride content. The darker part of the cores is the repair concrete.

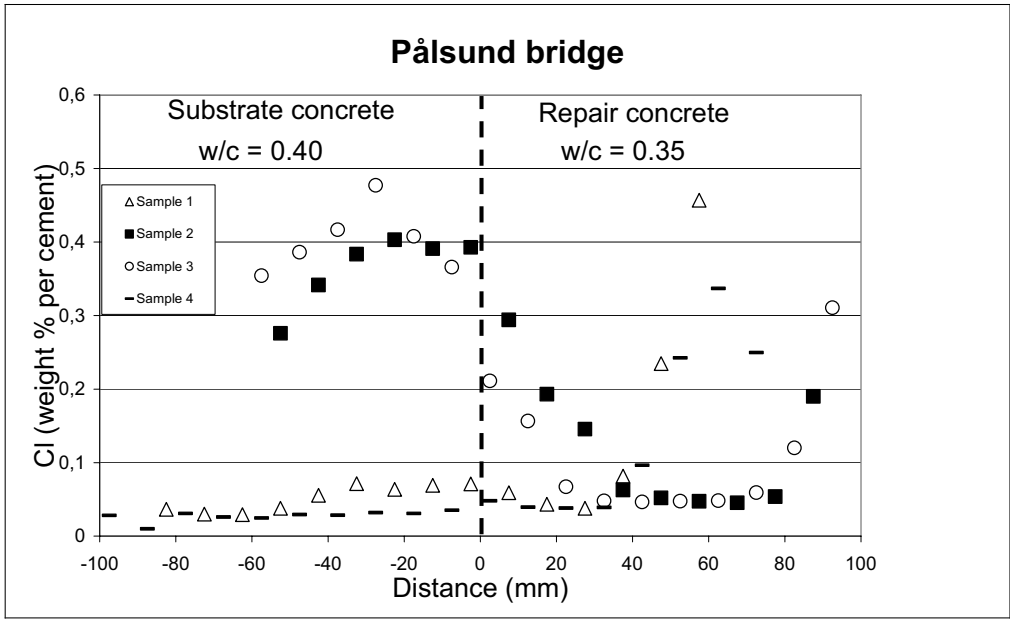
Figure 2. Chloride profile for samples 1-4.

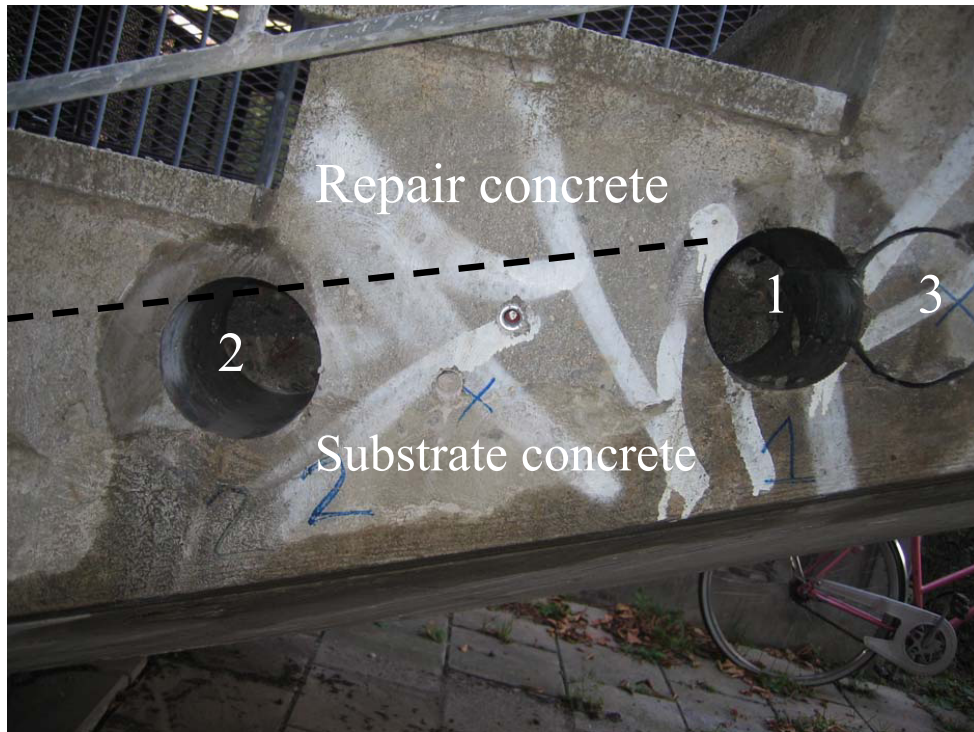
Figure 5. Repair concrete on the top and substrate concrete beneath. Concrete cores 1 and 2 were drilled out.

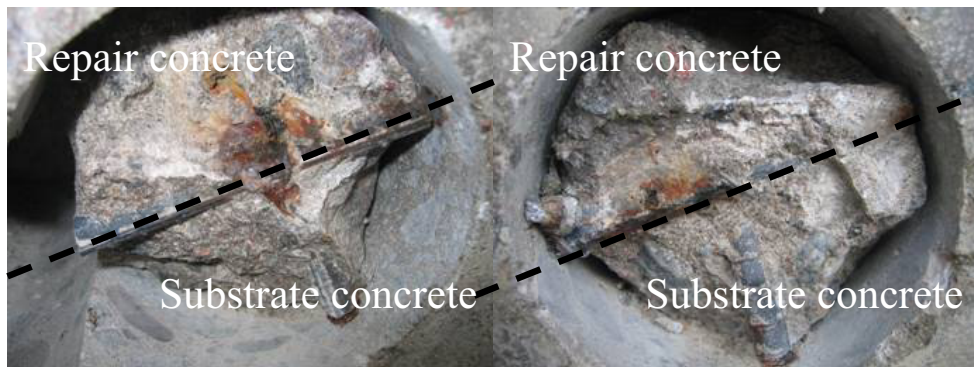
Figure 6. Reinforcement corrosion in the transition zone in.

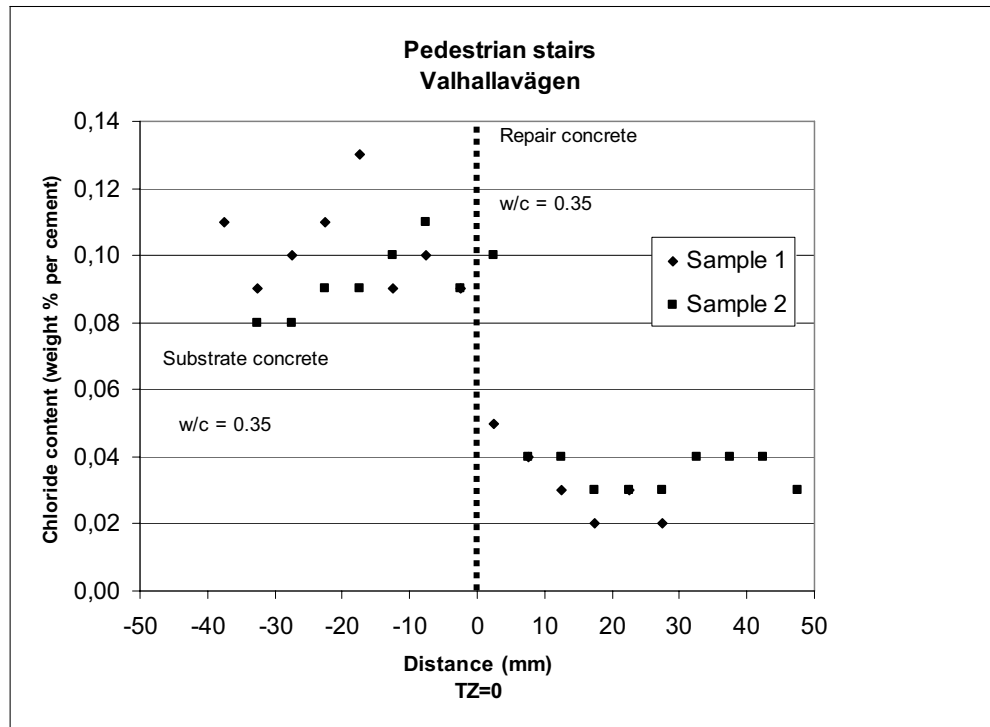
Figure 7. Chloride profile for samples 1-2

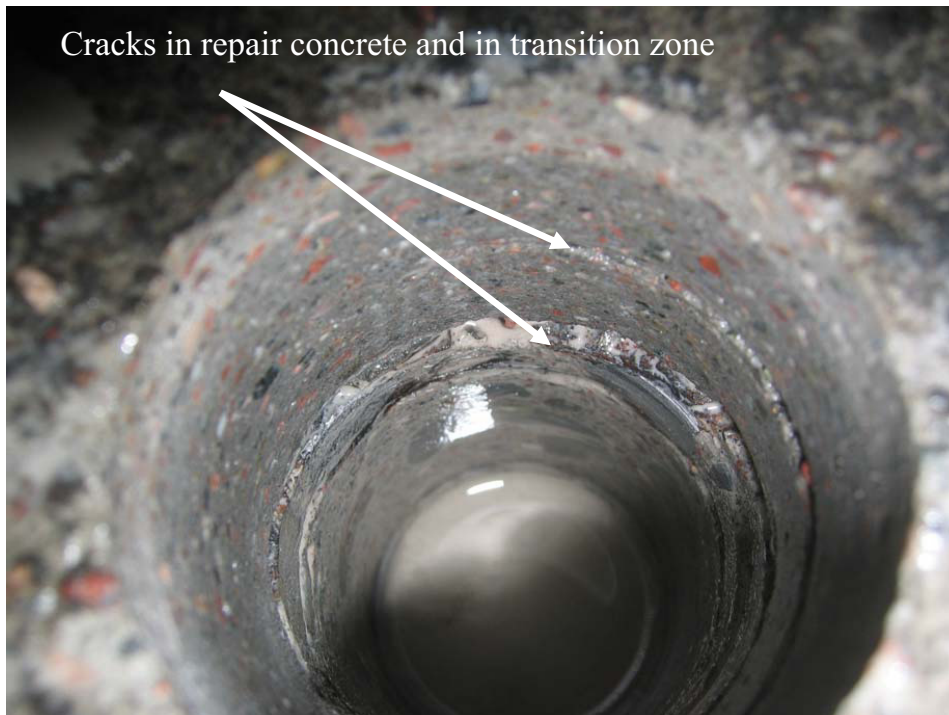
Figure 8. Sample hole in a concrete repair. Note the horizontal cracks.

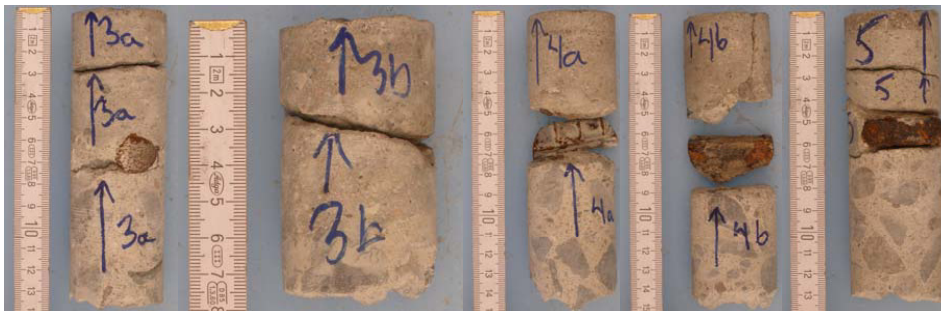
Figure 9. Concrete samples from patch repairs in parking structure *Plankan*. Corroded reinforcement in the transition zone.

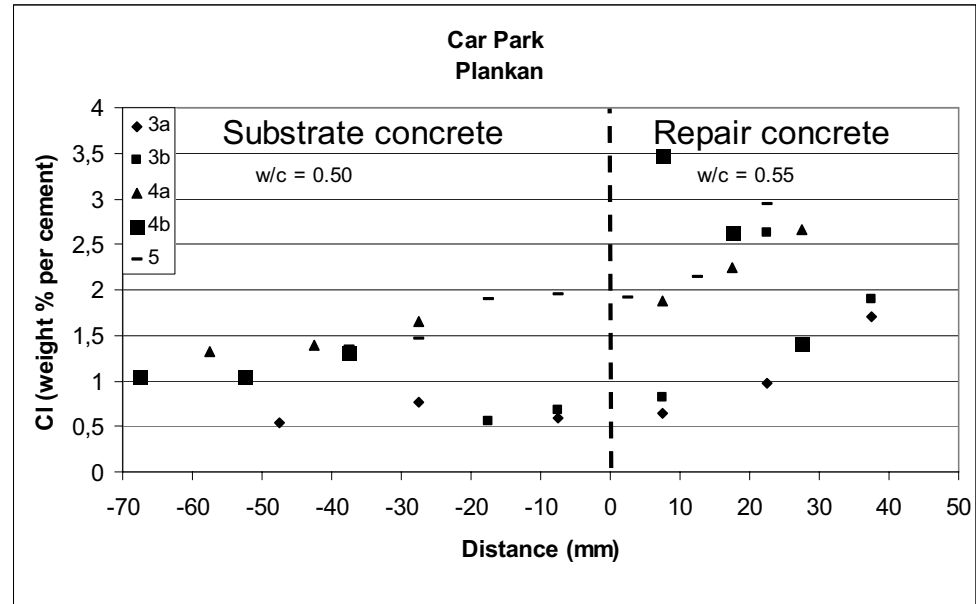
Figure 10. Chloride profile for samples 3a, 3b, 4a, 4b and 5.
