RAT-IR-19/1993

LOADING TEST ON 265 MM HOLLOW CORE
FLOOR WITH TOPPING SUPPORTED ON
PRESTRESSED CONCRETE BEAM

Projektin nimi - Name of project
Flexible Supports II

Toimeksiantaja - Commissioned by
Finnish Association of Building Industry RTT, the
Int. Prestressed Hollow Core Association IPHA,
KB Kristianstads Cementgjuteri, Sweden and
Skanska Prefab AB, Sweden

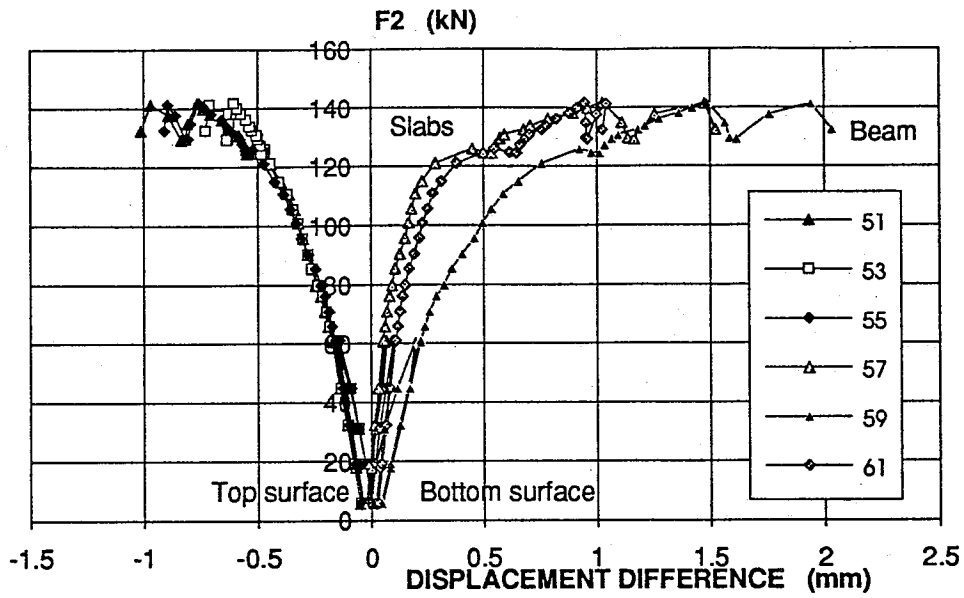
Fig. 21. Displacement differences between the edges of the slab units no 3 and 7 and the corresponding points at the middle beam.

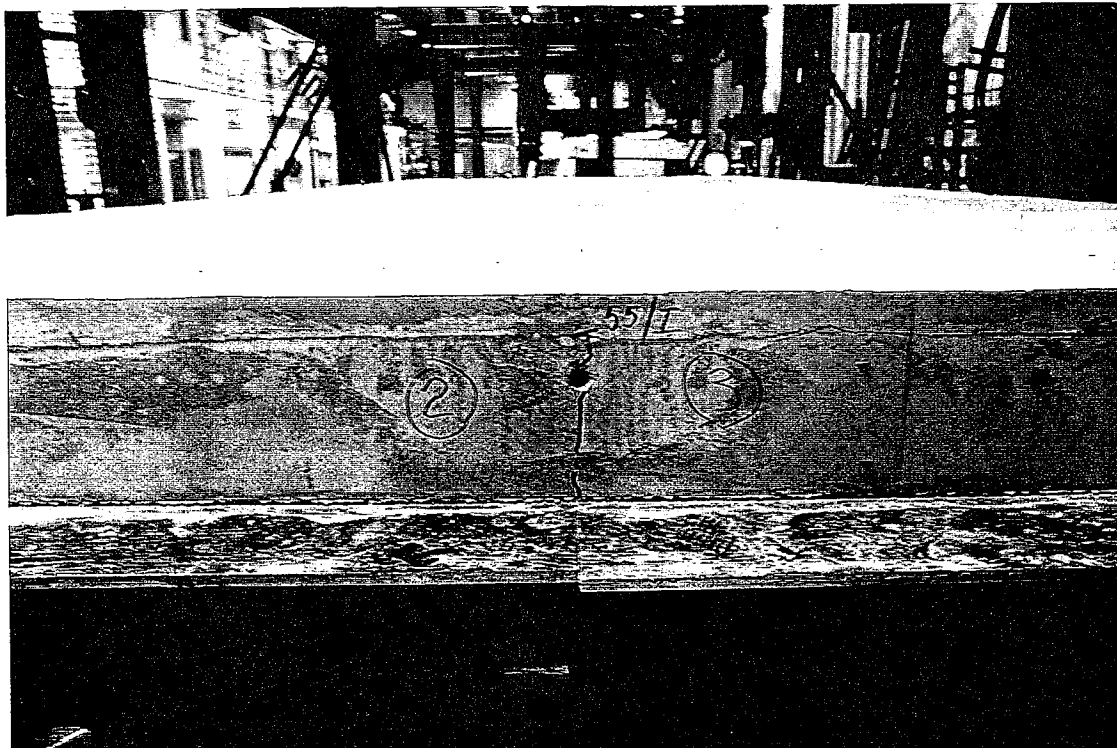
Fig. 8. A crack in the middle of the concrete tie beam, between the slab unit no 2 and 3.

Under the forces $P_i = 55$ kN in the first cycle, vertical cracks could be seen on the upper corner of a flange of the concrete beam, under the slab no 6. One vertical crack on both longitudinal edges of the concrete topping was also induced at or near the vertical joint between the slabs and the middle beam, and these cracks reached about 200 mm on the surface of the topping near the slabs no 4 and 5. A vertical crack developed in the middle of both concrete edge beams cast over the steel beams, between the slabs no 2 and 3, and no 6 and 7.

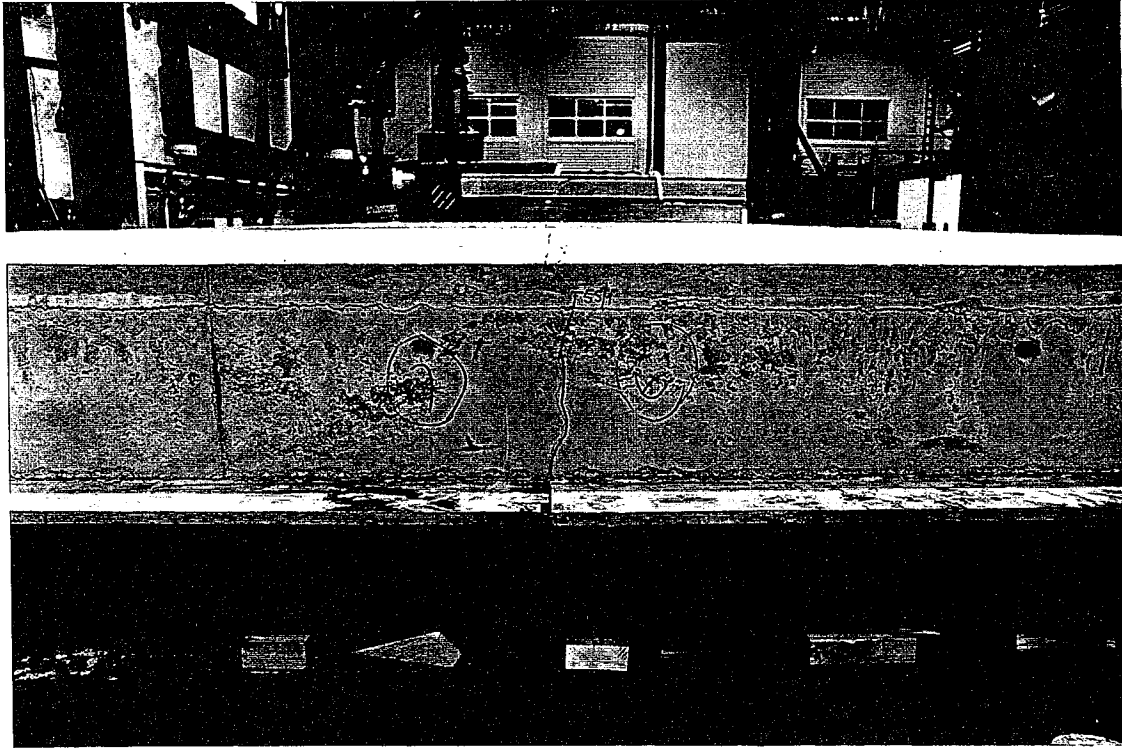
Fig. 9. A crack in the middle of the concrete tie beam, between the slab units no 6 and 7.
