Joints in lattice girder structures

KARIN LUNDGREN, JOHAN HELGESSON,
RASMUS SYLVÉN

Department of Civil and Environmental Engineering
Division of Structural Engineering
Concrete Structures
CHALMERS UNIVERSITY OF TECHNOLOGY
Göteborg, Sweden 2005

Report 2005:9

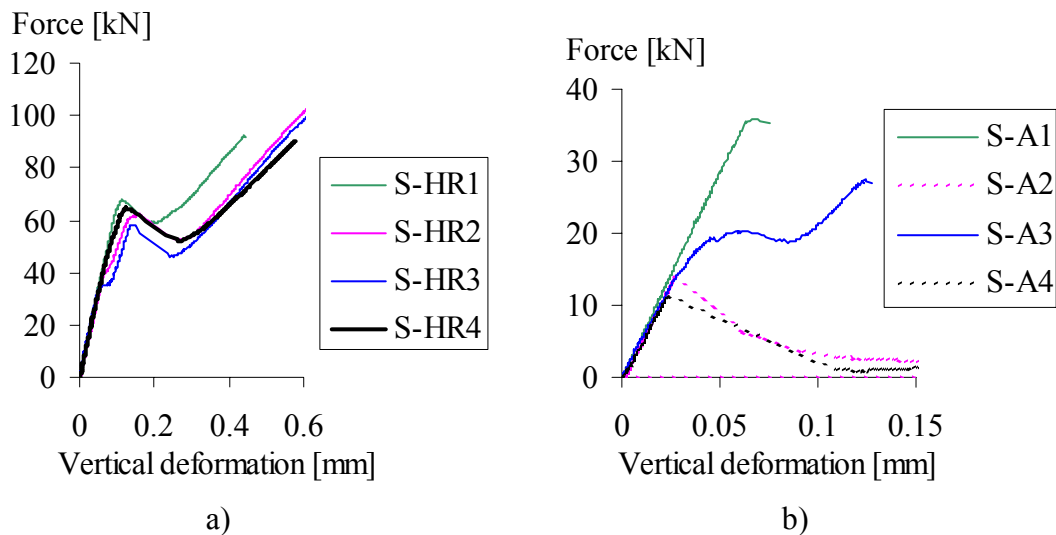
Figure 6 Force versus vertical deformation in shear tests. a) Test specimens from Hedareds Sand & Betong, and b) Test specimens from Abetong. Dashed lines indicate that the descending parts could not be followed; however in these tests it was possible to measure deformation for small loads again. Note the different scales

The shear test results are presented in force versus vertical deformation relationship in Figure 6. The vertical deformation between the two parts (prefab and *in situ*) is calculated as the average of the ones measured in displacement transducers 1-4. In all tests, the failure was very brittle; it was not possible to follow any descending part as the test specimens fell apart at failure, see Figure 7a. Maximum capacities measured in the tests and corresponding bond stresses are tabulated in Table 4. When comparing the tests from Hedareds Sand & Betong and Abetong, there were higher shear capacity and less scatter in the results of the test specimens delivered from Hedareds Sand & Betong.

The four specimen delivered from Hedareds Sand & Betong (S-HR1 – S-HR4, Figure 6a) had almost the same behaviour: linear behaviour until a value about 70 kN, when unfortunately two horizontal cracks appeared, see Figure 7b. The main reason for these cracks were that the test specimens were not perfectly flat at the loading and

support surfaces; thereby the boundary conditions introduced and allowed small rotations. Due to the crack appearance the force decreased, but could then be further increased until the joint collapsed at a final value of about 100 kN. The measured vertical deformations therefore include not only slip over the joint, but also deformations in the cracks. However, the maximum loads were most likely not influenced by the cracks, as failure in all tests took place in the grouted joint.

Figure 6b show the shear test results of specimens S-A1 – SA4. In these tests, the elastic behaviour was similar in all tests, but the peak load had a quite large scatter. Failure in all tests took place in the grouted joint; the parts between the grooves were almost unaffected by the test while the *in situ* cast concrete that had protruded into the grooves were cracked. SA-1 and SA-3 deviated a lot compared to S-A2 and S-A4 and the explanation could be differences of dimensions in the grooves; larger grooves gave higher capacity. The grooves were made by hand which lead to scatters in the dimension. Only one specimen had a horizontal crack during the tests, S-A3.

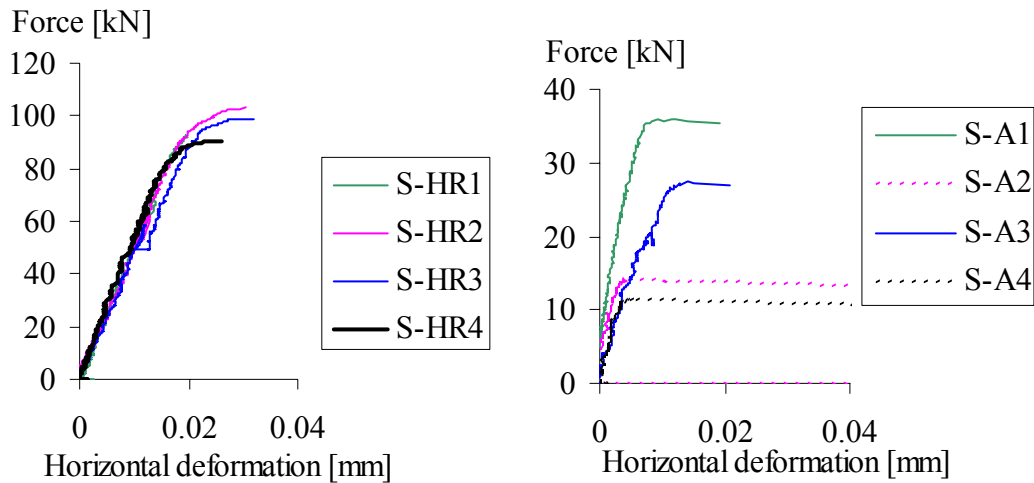
Figure 8 Force versus horizontal deformations. a) Test specimens from Hedareds Sand & Betong, and b) Test specimens from Abetong. Note the different scales.

In the tests, there were also horizontal deformations between the two parts (prefab and *in situ*): normal deformations. The force versus average horizontal deformation, calculated as the average from displacement transducers 5-8, is presented in Figure 8. As can be seen, the horizontal deformations increased just before peak. The normal deformations increase more before peak than the vertical deformations did, as can be seen in Figure 9. The results from test specimens from both suppliers are compared for small slips in Figure 9c; as can be seen, the normal deformations were of the same size. The variation in measurements of both vertical and horizontal deformations was rather small, see Figure 10 for an example and Appendix B for all test results.

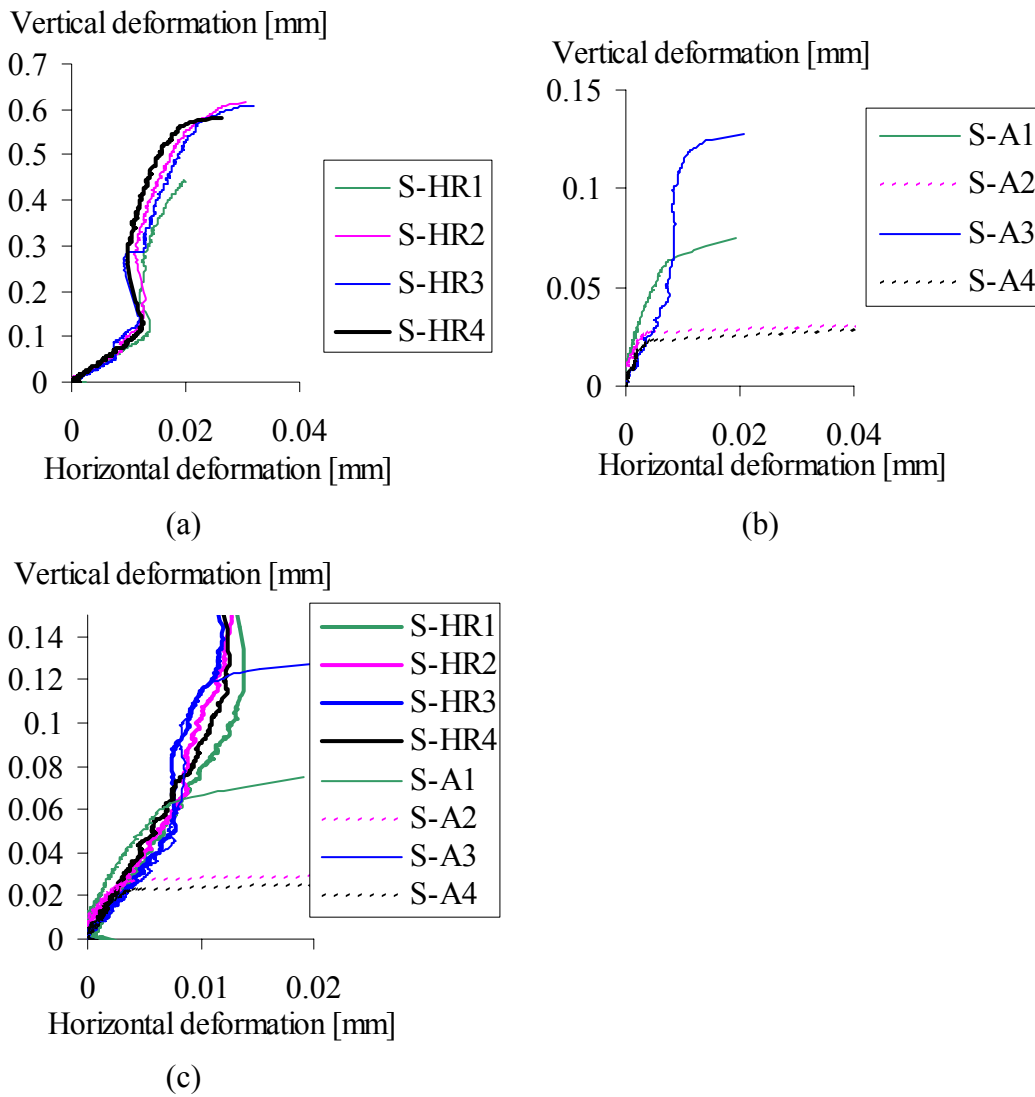
Figure 9 Vertical versus horizontal deformations. a) Test specimens from Hedareds Sand & Betong, b) Test specimens from Abetong, and c) Comparison of all shear tests.

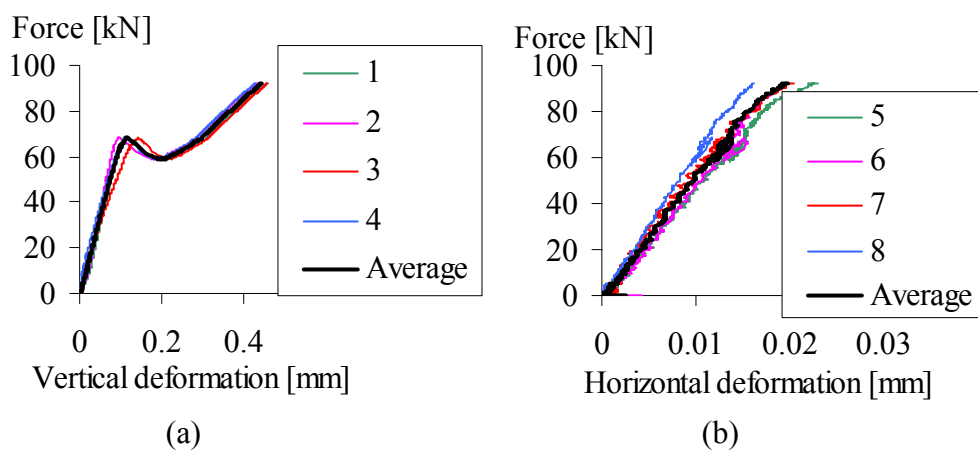
Figure 10 Example of scatter in measurements of a) vertical and b) horizontal deformations. From test no. S-HR1.

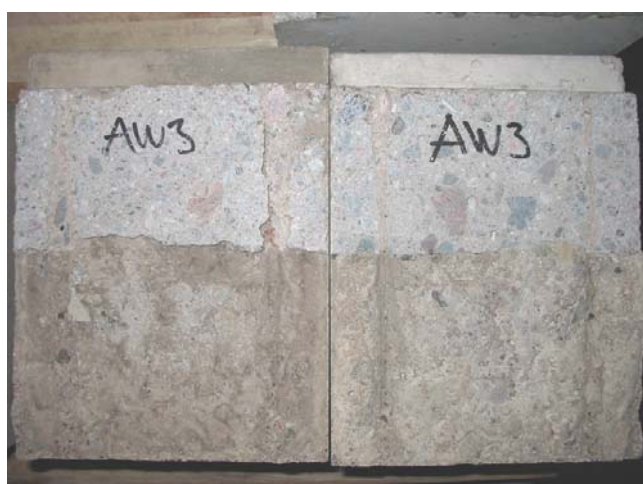
Figure 15 The joint in test W-A3 after testing.

All cracks were perfectly formed in the joint. Figure 15 shows the joint in W-A3. When the crack was initiated it was small and difficult to see. The CMOD increased during the tests and was visible in the end stage.

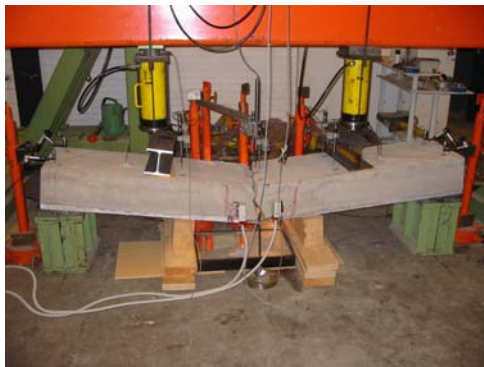
Figure 22 a) First crack for a load of $P = 11$ kN. b) The initiated crack propagated and yield load was reached. c) Test specimen after collapse.

approximately 18-20 kN (P_{yield}) and 1.6-1.9 mm respectively. At this load yielding of the reinforcement occurred and the initiated crack propagated in the same direction as it started, see Figure 22. At yielding stage the load remained almost constant, besides a very small increase of load due to hardening of the steel. Semi-collapse occurred when one of the longitudinal bars ruptured at the load $P_{1stcoll}$, approximately at 20 kN and the deflection about 18-21 mm. The remaining longitudinal bars provided further load-carrying capacity under a decreasing load until $P_{2ndcoll}$ was reached of about 20 kN. Total collapse of the structure occurred at a deflection of about 28-33 mm.

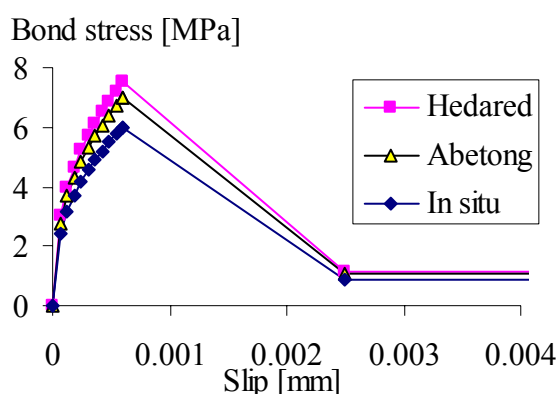
Figure 31 Bond versus slip correlation used as input for the interaction between the concrete and the reinforcement

The reinforcement in the left part was modelled with truss elements. Special interface elements were used between the reinforcement and the concrete, describing a bond-slip relation. The relation was chosen according to CEB (1993), assuming unconfined concrete and other bond conditions; see Figure 31. The welds in the reinforcement mesh were modelled with the reinforcement and the concrete nodes tied to each other at the points of the welds, see Figure 32. The distance d between the reinforcement mesh and top of the *in situ* concrete layer was 177 mm in the FEA. This can be compared with the average in the tests, which was 183 mm (see Table 5). The reason for the difference was that the total thickness of the slab became slightly larger than intended in the tests, 250 mm instead of 247 mm, and that the weight of the concrete pushed down the reinforcement at grouting. The lattice girder truss was modelled by tying the *in situ* and precast nodes to each other in the centre of the truss. This is a

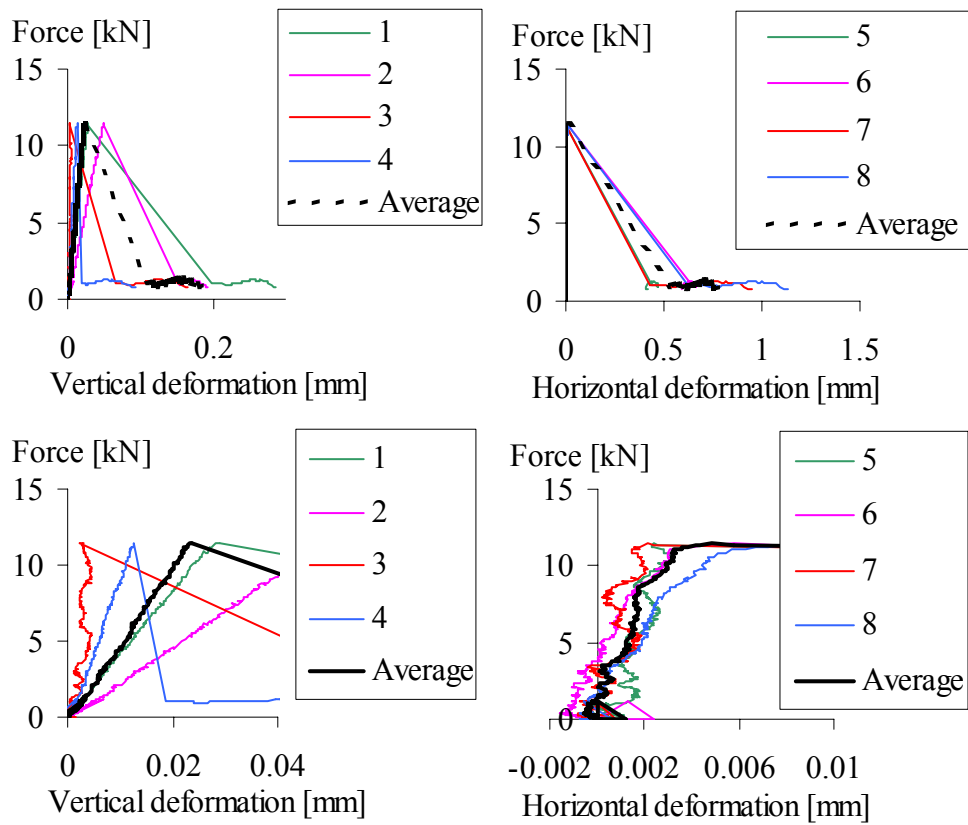
Figure B8 Measured displacements in test no. S-A4. Both vertical and horizontal deformations also shown first part enlarged.
