Moisture Conditions and Frost Resistance of Concrete in Hydraulic Structures

Licentiate thesis

Licentiate Thesis, Report TVBM-3173, Division of Building Materials,
Faculty of Engineering, Lund University, Lund 2013

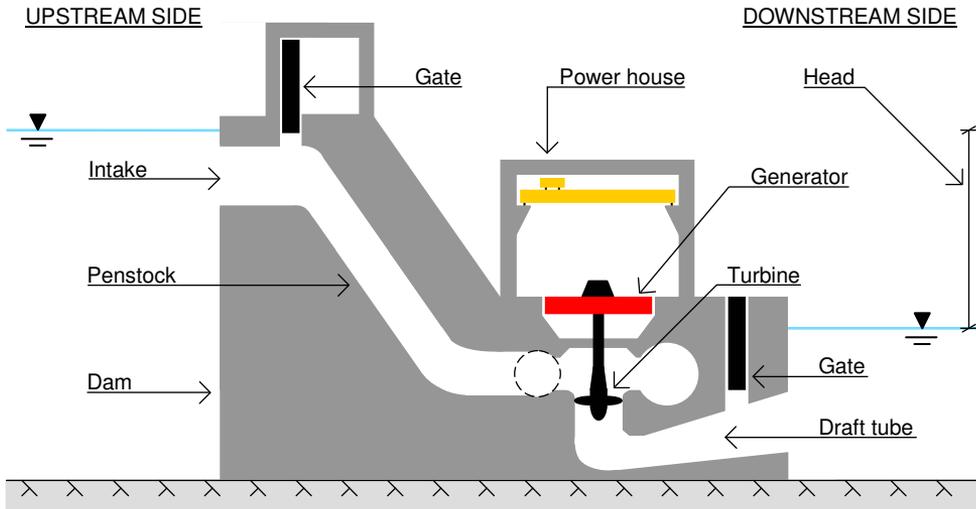
Figure 2-1. Cross section of a hydro power plant.

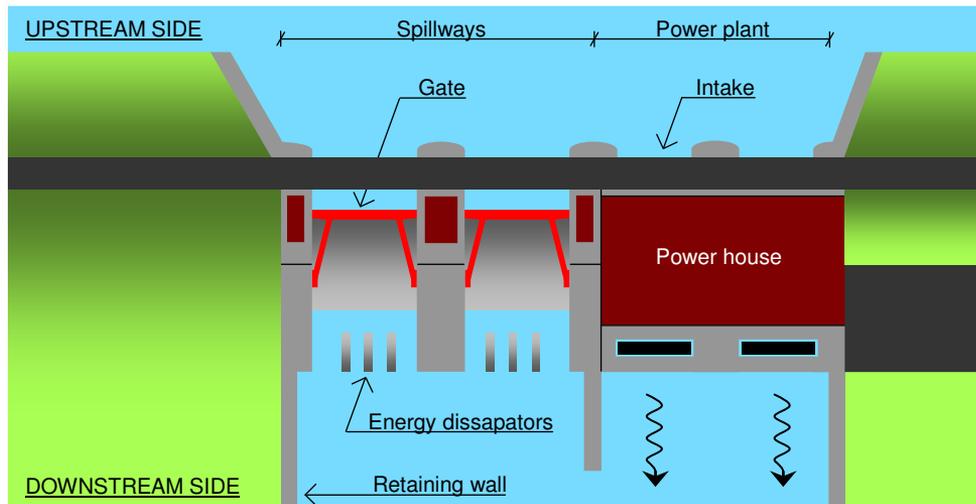
Figure 2-2. Plan of a hydro power plant. Electricity is generated in the power house, whereas surplus water can be released in the spillway.

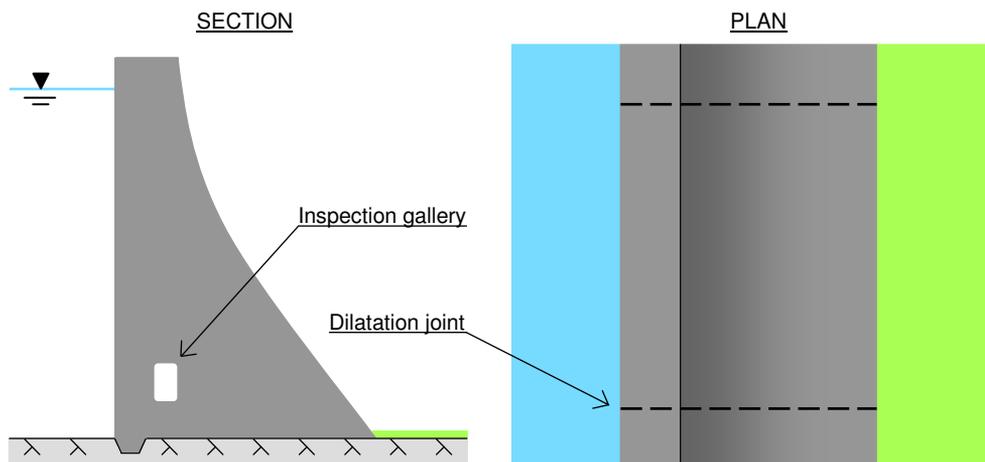
Figure 2-3. Section and plan of a solid gravity dam.

The solid gravity dam uses its own dead weight to resist the hydrostatic pressure trying to overturn the dam (Figure 2-3). The upstream face of the dam is either vertical or somewhat inclined towards the downstream side. An inspection gallery running through the dam can normally be found in the lower part of the dam. The dam is divided into vertical sections by dilatation joints.

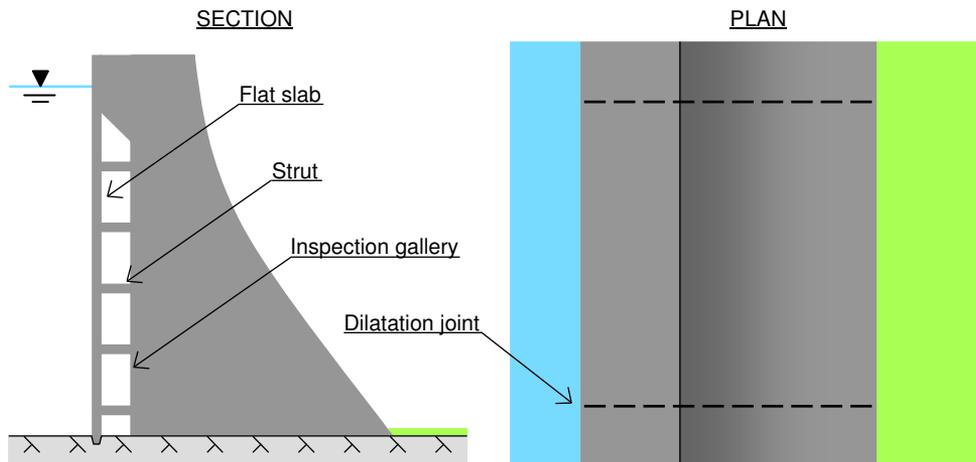
Figure 2-4. Section and plan of a solid gravity dam with flat slab.

Westerberg (1951) reported that the solid gravity dam design was completed with a flat slab on the upstream side of the dam in the early 1930s (Figure 2-4). The main body of the dam could either be made from lean concrete or stone masonry. The dam is divided into vertical sections by dilatation joints.

The flat slab was meant to be water tight and thus protect the lean concrete in the main body of the dam. The flat slab and struts were heavily reinforced. Concrete with high cement content and low water to cement ratio (w/c-ratio) was used. In the event of leakage, the damage could be repaired from the space between the flat slab and the main body of the dam, which was used as an inspection gallery.

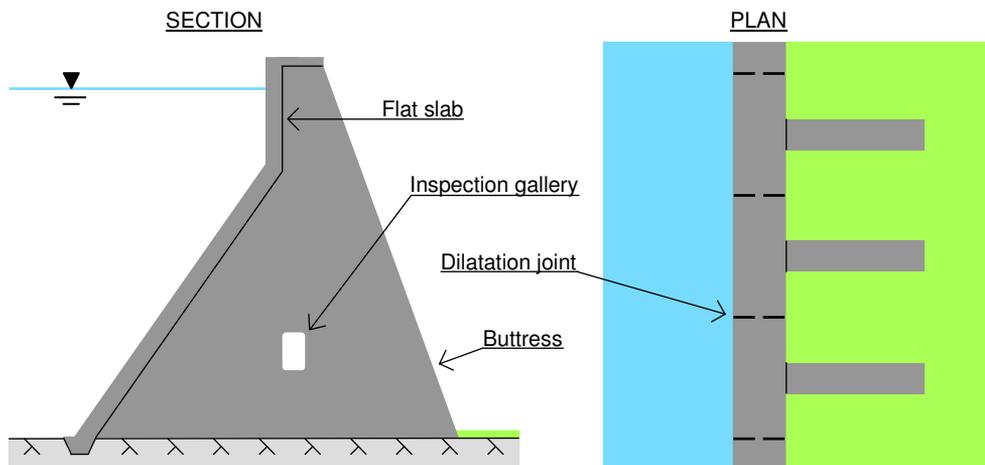
Figure 2-5. Section and plan of a buttress dam (hollow gravity dam).

The buttress dam consists of a flat slab supported by walls (Figure 2-5). The flat slab is heavily reinforced and the walls, also called buttresses, are spaced at intervals on the downstream side. Buttress dams are also called hollow gravity dams. Most of the buttress dams can be classified into the heavy or thin types.

A buttress dam of the heavy type uses only the dead weight of the dam to resist the hydrostatic pressure. The flat slab is normally vertical or somewhat inclined towards the downstream side. A buttress dam of the thin type also takes advantage of the hydrostatic pressure to hold it down. The flat slab is vertical on the upper part of the dam, while it is inclined further down. A section of a buttress dam of the thin type is shown in Figure 2-5.

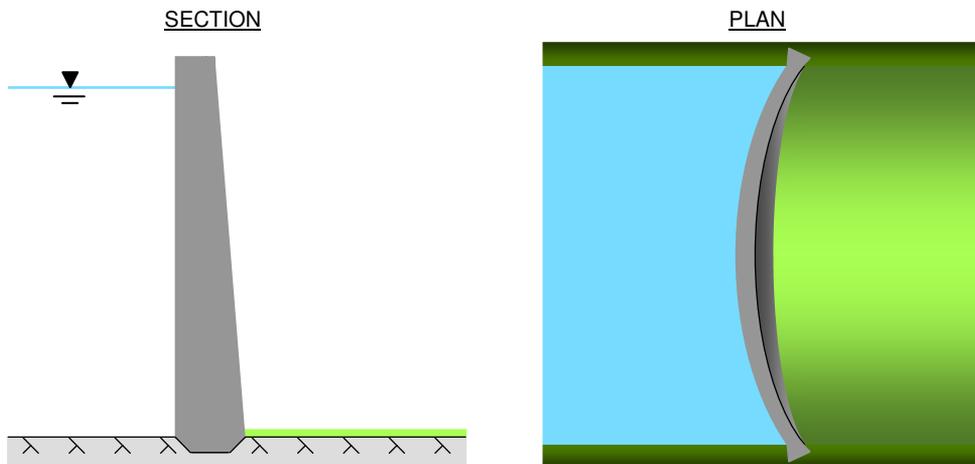
Figure 2-6. Section and plan of an arch dam.

Arch dams are normally thin and require much less concrete than any other type of dam. The arch dam curves upstream while the force from the water behind it pushes the dam into its foundations (Figure 2-6). Therefore, the rock at the dam site has to be strong enough to carry the forces imposed by the dam. Arch dams are normally suitable for narrow and steep sided valleys. Since most valleys are broad in Sweden, arch dams are rather rare. Consequently, other types of dams are more suitable. Arch dams are normally provided with vertical contraction joints.

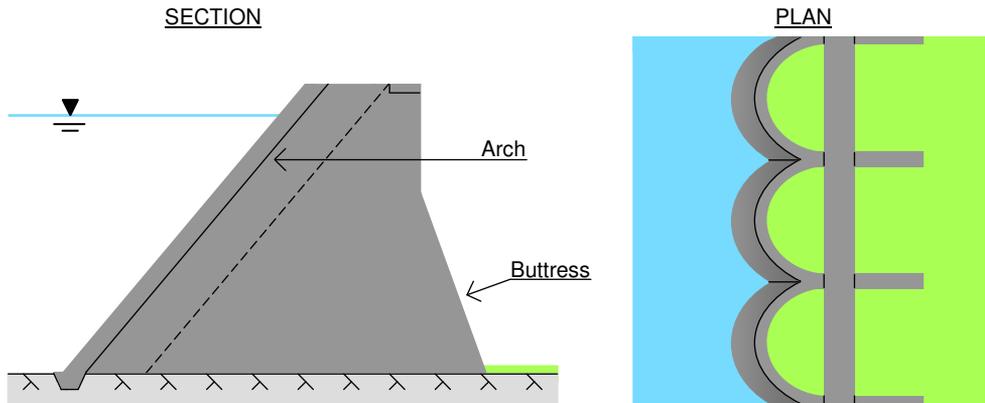
Figure 2-7. Section and plan of a multiple-arch dam.

A multiple-arch dam consists of several contiguous arches facing upstream. The arches are supported by buttresses placed at intervals on the downstream side (Figure 2-7). Multiple-arch dams have usually been constructed at remote areas since less concrete has been needed in comparison with other dam types. Sällström (1967) reported that temperature induced stresses often resulted in cracking of the arches due to large variations between summer and winter temperatures. Consequently, the multiple-arch dam did not become very popular in Sweden.

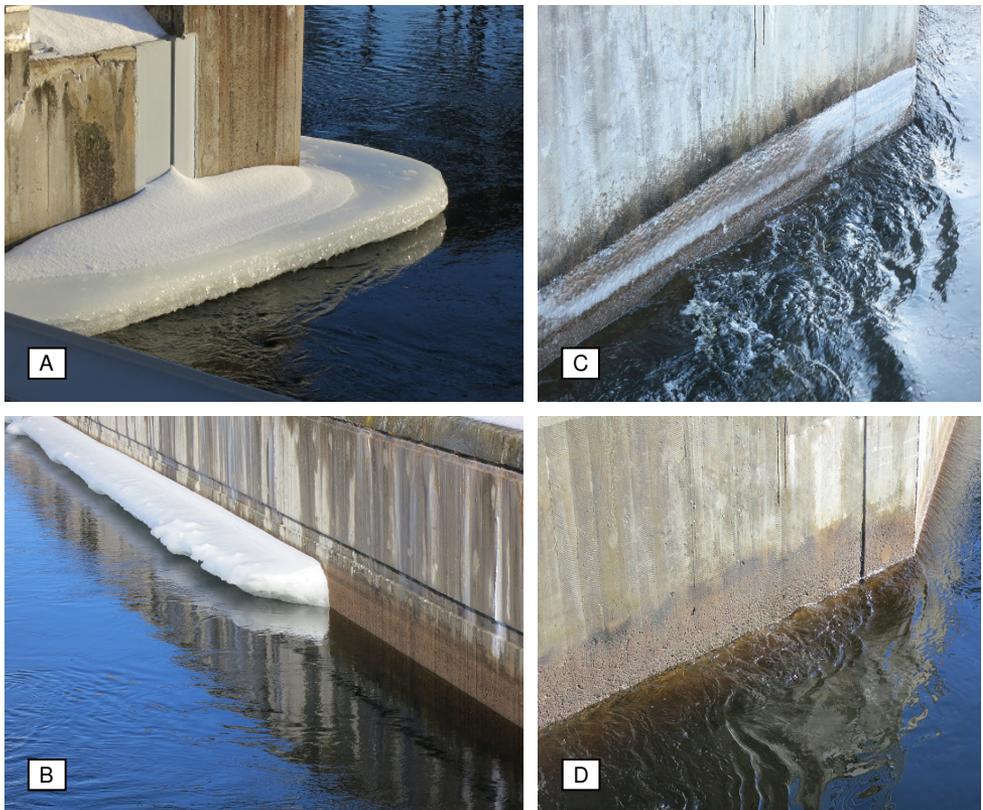
Figure 2-8. In winter, a band of ice frozen solid to the concrete surface can be seen at the waterline of hydraulic structures (A). In spring, the band of ice falls off when the air temperature rises (B). In both spring and autumn, the air temperature frequently crosses the freezing point of water. A small band of ice can therefore be seen at the waterline in the morning (C) while it has been melted away in the evening (D).

The band of ice falls off when the air temperature starts to rise in spring (Figure 2-8 B). However, as previously mentioned, the air temperature frequently crosses the freezing point of water in spring and autumn. Depending on the air temperatures, the band of ice can be re-formed during the nights and later melted away during the days (Figure 2-8 C-D).

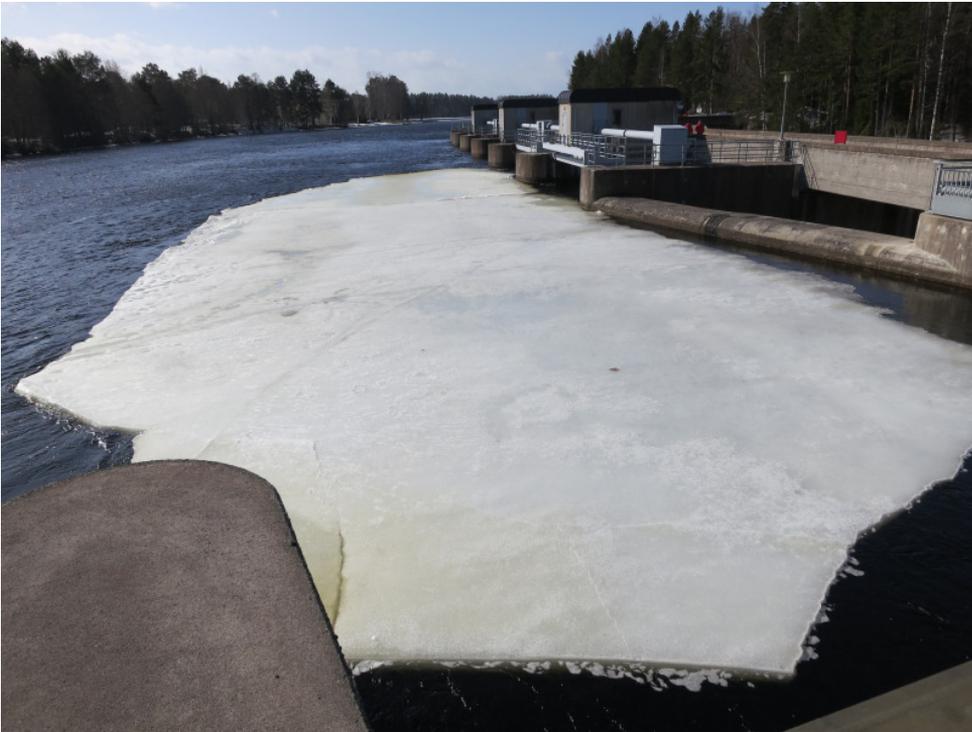
Figure 2-9. Ice floe pushing against a bridge column in spring.

The ice cover breaks up into ice floes of different sizes during spring. The ice floes are then slowly brought downstream by the river current. If the ice floes do not melt away until they reach a hydraulic structure, the ice floes push against the structure until they break apart into pieces or melt away (Figure 2-9).

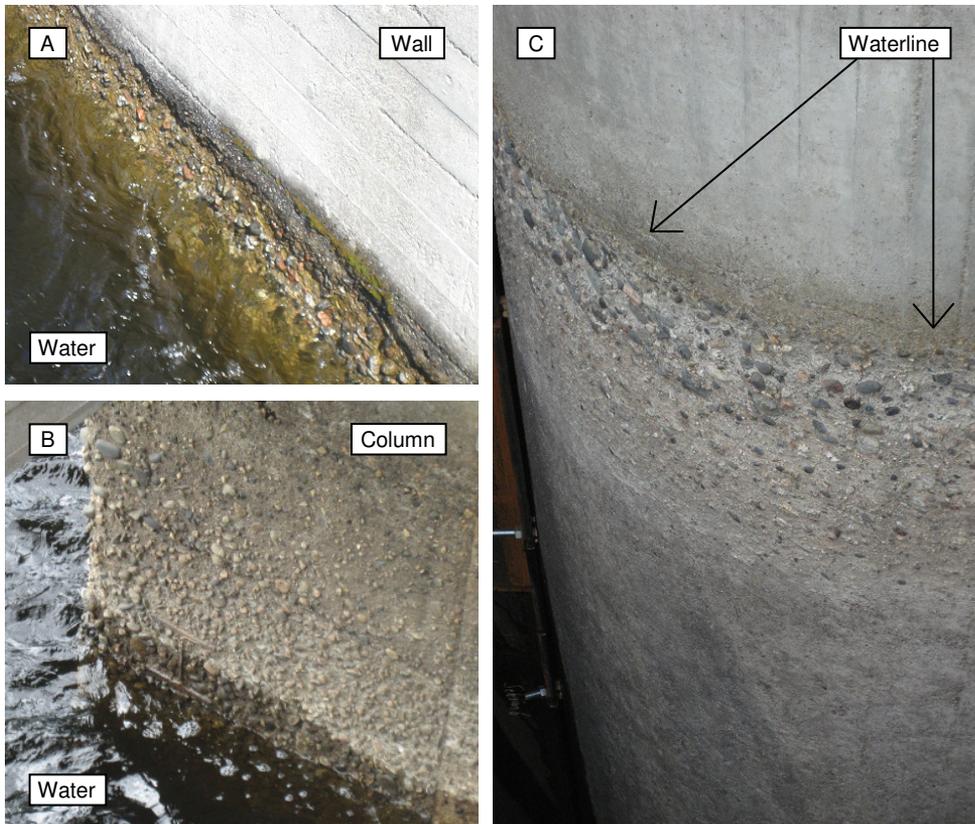
Figure 3-1. Photos of damage to the concrete surface at the waterline of hydro power structures. The photos A and C are taken on the upstream side, whereas the photo B is taken on the downstream side of the dams.

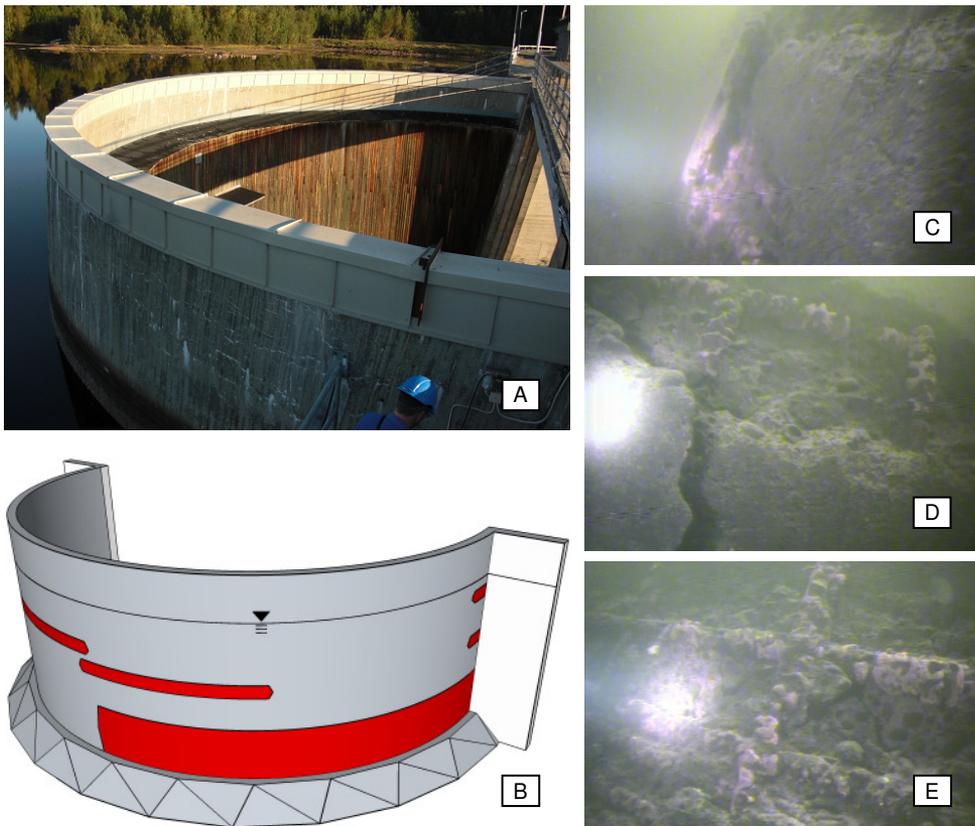
Figure 3-2. The greater part of the damage to the arch dam at Selsfors (A) was found on the lower part of the dam (B). Photos of corroding steel reinforcing bars and loose pieces of concrete on the upstream face (C-E). Photos from Skellefteå Kraft AB.

Spalling of concrete was observed on the upstream and downstream face in the late 1960s. The greater part of the damage to the upstream face was found on the lower part of the dam (Figure 3-2 B). In some cases, divers were able to remove pieces of concrete up to a depth of 150 mm.

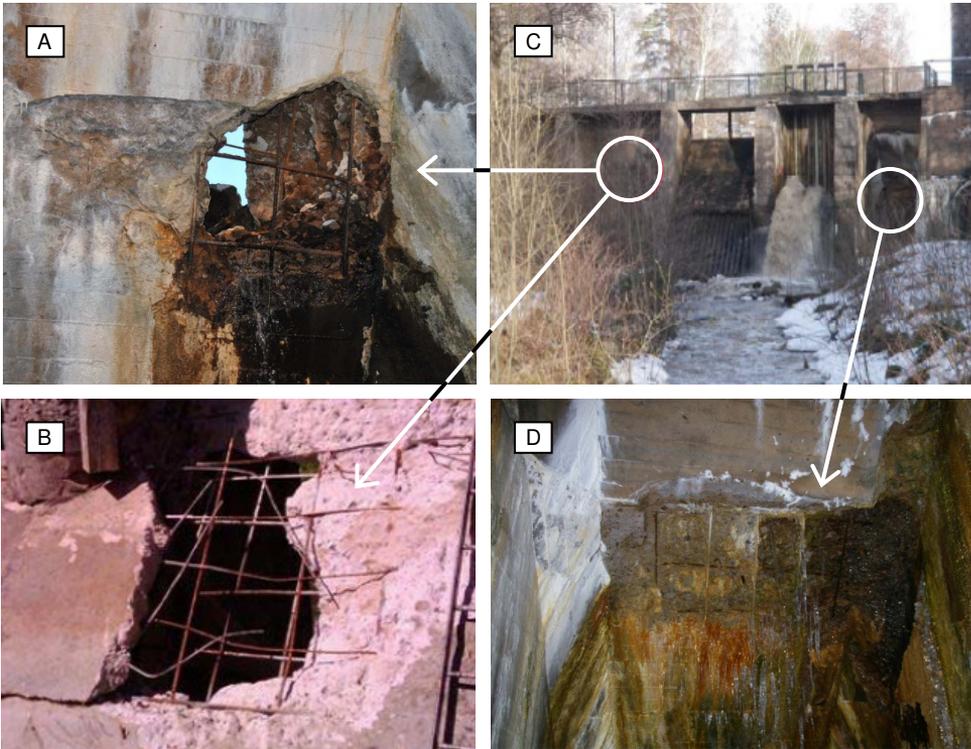
Figure 3-3. A severely damaged buttress dam (C). The concrete cover was missing in some places in the vicinity of water leakage through cracks on the downstream face (D). A hole appeared in the flat slab in another place and water escaped flushing away loose pieces of concrete (A-B). Only the reinforcing steel was left.

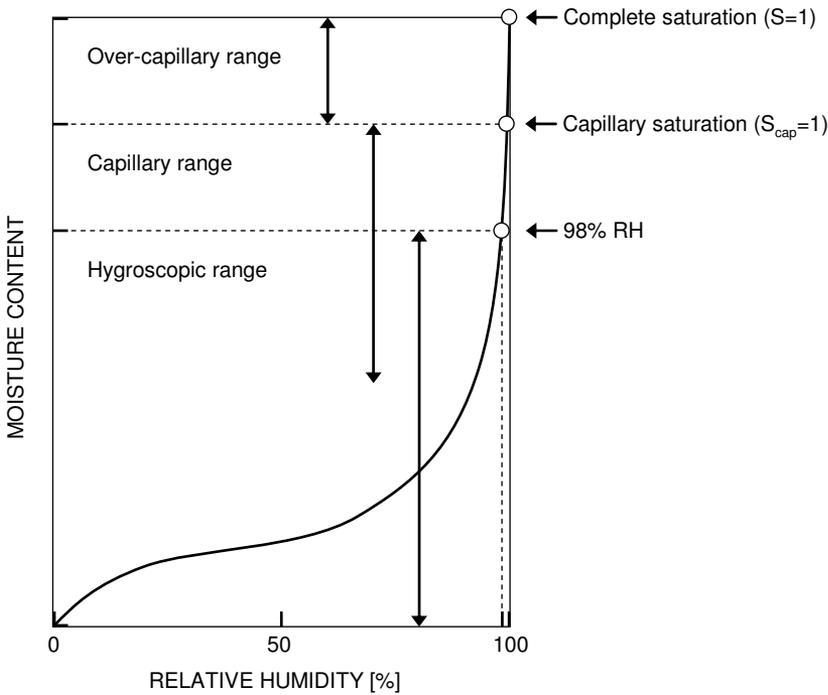
Figure 3-4. Absorption isotherm completed with moisture ranges. Graph from Fagerlund (2006).

entrapped air in compaction voids and air voids. An absorption isotherm completed with moisture ranges is shown in Figure 3-4.

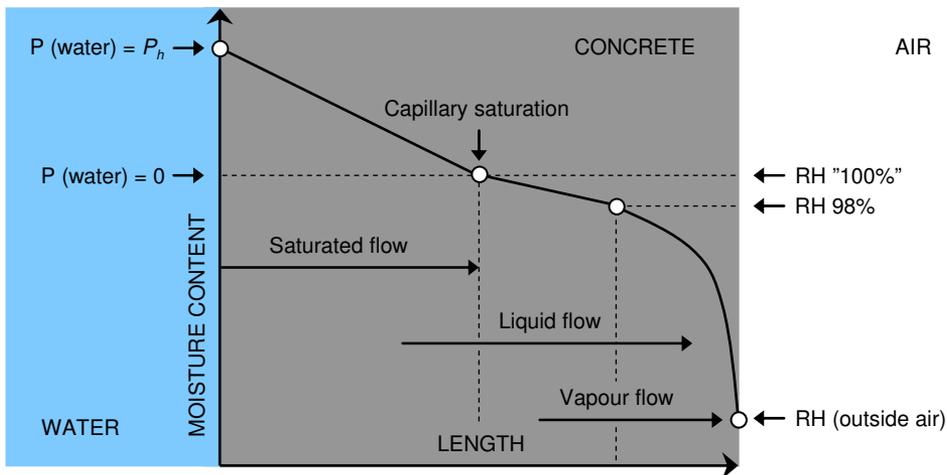
Figure 3-5. A conceptual model of the moisture flow through a concrete dam. The driving potential for moisture flow (saturated flow) close to the upstream face of the dam is the hydrostatic pressure pushing water into the concrete. However, at a certain depth from the upstream face, atmospheric pressure prevails and the moisture flow (liquid flow) is driven by capillary forces. Closer to the downstream face of the dam, the moisture flow (vapour flow) is driven by the difference in water vapour content. In reality, the different types of moisture flows overlap each other as shown in the figure.

The flow of moisture through a concrete dam subjected to hydrostatic pressure is difficult to describe mathematically. One reason for this is that it is difficult to distinguish saturated flow (J_s) from liquid flow (J_l) and liquid flow from vapour flow (J_v). The different types of moisture flows overlap each other and the driving potentials also differ. A conceptual model of the moisture flow through a concrete dam, partly based on Hedenblad (1994), is shown in Figure 3-5.

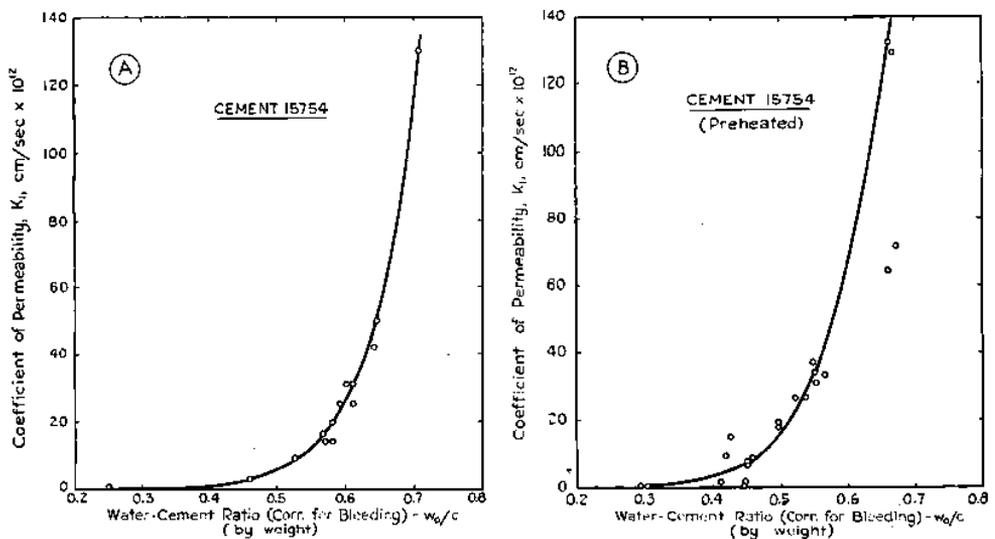
Figure 3-6. Relationships between hydraulic conductivity and w/c-ratio for mature cement paste. Graphs from Powers et al (1954).

According to Powers et al (1954), the overall permeability of concrete depends on the hydraulic conductivity of the cement paste, aggregate particles and the relative proportions of the two. Relationships between the hydraulic conductivity and the w/c-ratio for mature cement paste are shown in Figure 3-6.

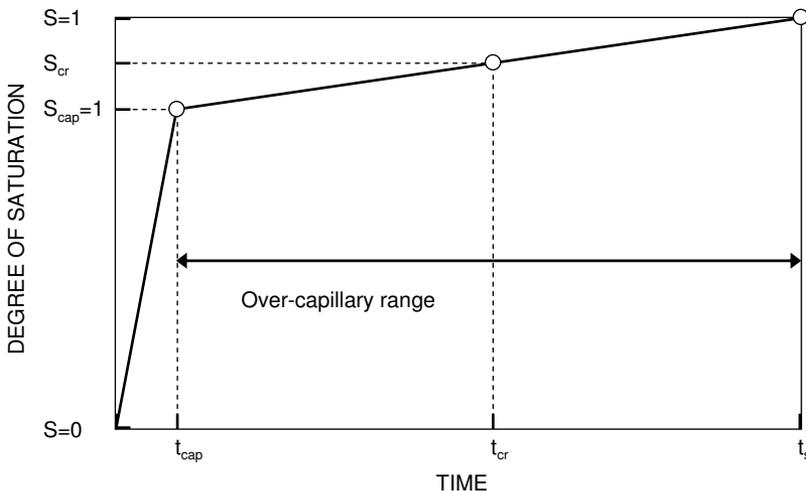
Figure 3-7. Water absorption of concrete as a function of time. The critical degree of saturation (S_{cr}) prevails at the critical time (t_{cr}).

Freezing of air entrained concrete with high moisture content causes a greater amount of damage than freezing of non-air entrained concrete with the same moisture content. The reason in this case is that there is more freezable water in air entrained concrete, since also the air voids are completely or partially filled with water. Hence, the diffusion rate of air out of the air voids and eventually out of the material determines the time (t_{cr}) until the critical degree of saturation (S_{cr}) prevails, see Figure 3-7.

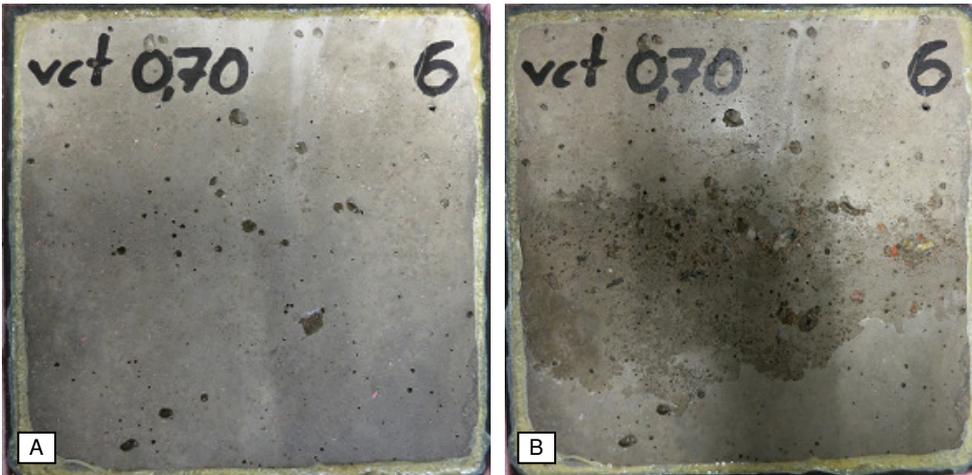
Figure 4-1. Specimen (w/c-ratio 0.70) before (A) and after (B) the test.

Only minor damage to the concrete surface of the specimens with w/c-ratio 0.70 was observed below and at the waterline after 112 freeze-thaw cycles. The damage was concentrated to a band of 20-30 mm width below the waterline (Figure 4-1). All specimens showed similar damage.

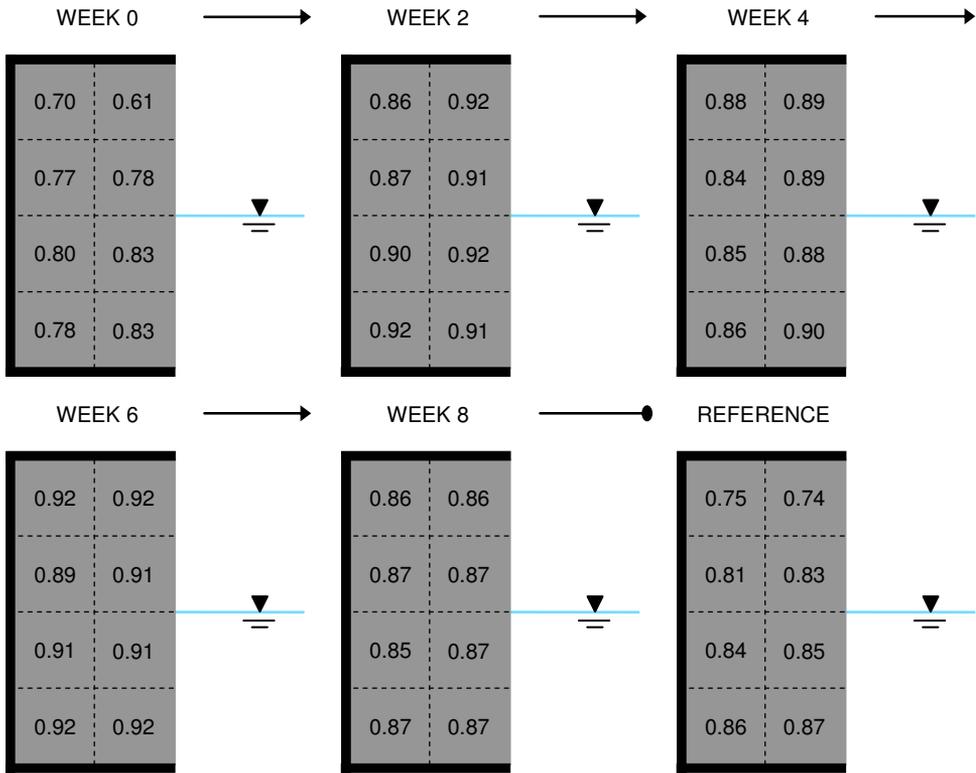
Figure 4-2. Degree of saturation of specimens (w/c 0.70) subjected to the frost test in comparison with the reference specimen kept at +10 °C during the test period.

In spite of varying results from specimen to specimen, capillary saturation ($S=0.86$) was obtained in the concrete below the waterline in the specimens subjected to the frost test within two weeks after the start. Also in the concrete above the waterline, capillary saturation was obtained. However, the degree of saturation of concrete above the waterline was somewhat lower in the reference specimen kept at +10 °C during the test period. Results from the measurements of the degree of saturation (S) are presented in Figure 4-2.

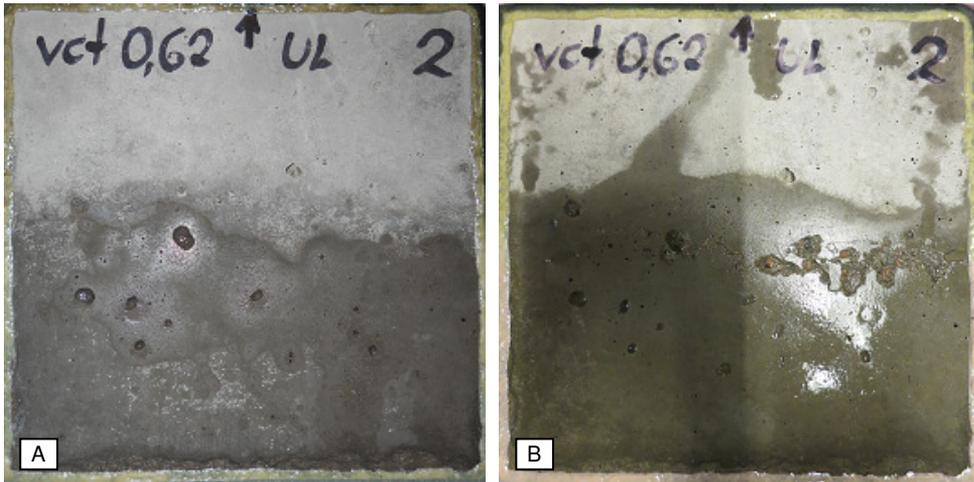
Figure 4-3. Specimen (w/c-ratio 0.62) before (A) and after (B) the test.

Minor damage to the concrete surface of the specimens with w/c-ratio 0.62 was observed at the waterline by the removal of small flakes of cement paste after 112 freeze-thaw cycles (Figure 4-3). The amount of damage varied somewhat between the specimens. Damage to the concrete surface could not be observed below the waterline on any of the specimens.

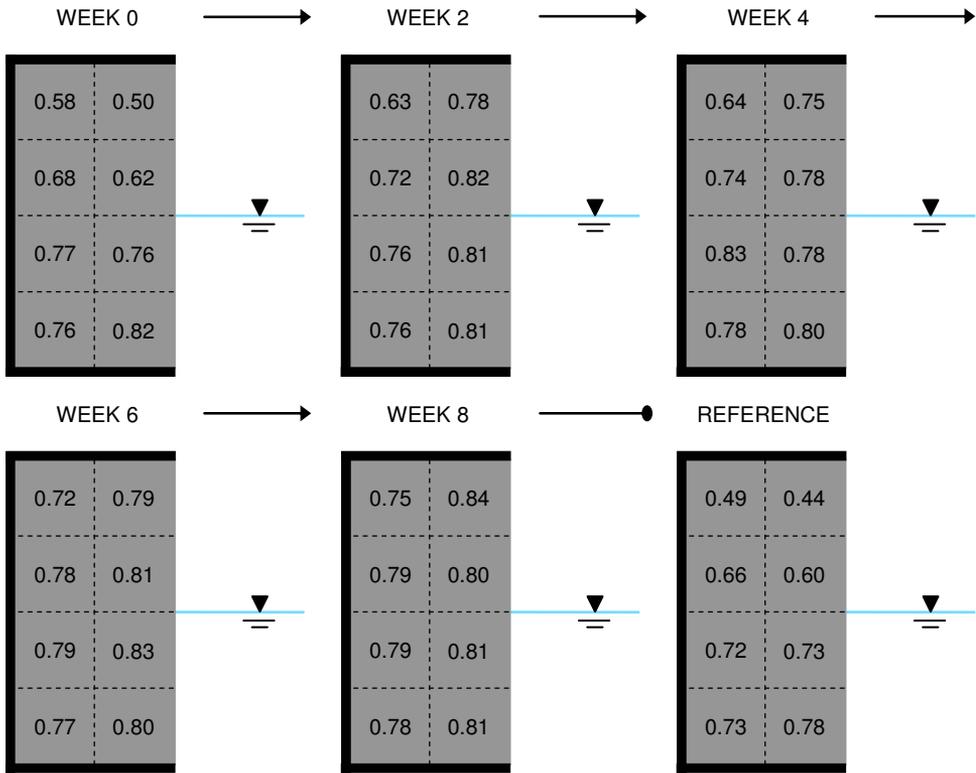
Figure 4-4. Degree of saturation of specimens (w/c 0.62) subjected to the frost test in comparison with a reference specimen kept at +10 °C during the test period.

On the contrary, the moisture content of concrete in the reference specimen kept at +10 °C decreased during the test period. Hence, the drying rate was higher than the absorption rate in isothermal conditions. Results from the measurements of the degree of saturation are presented in Figure 4-4.

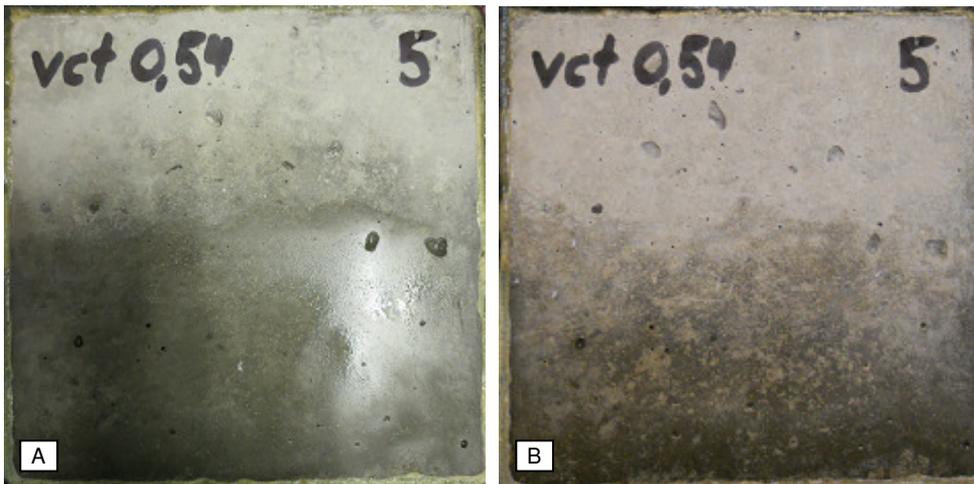
Figure 4-5. Specimen (w/c-ratio 0.54) before (A) and after (B) the test.

No damage to the concrete surface could be observed on any of the specimens with w/c-ratio 0.54 after 112 freeze-thaw cycles (Figure 4-5). The results on the measurements of the moisture content indicate that capillary saturation ($S=0.77$) was obtained within two weeks after the start in the specimens subjected to the frost test. On the contrary, the degree of saturation of concrete in the reference specimen kept at +10 °C decreased during the test period. Also in the case of concrete with w/c-ratio 0.54, the drying rate was higher than the absorption rate in isothermal conditions. Results from the measurements of the degree of saturation are presented in Figure 4-6.

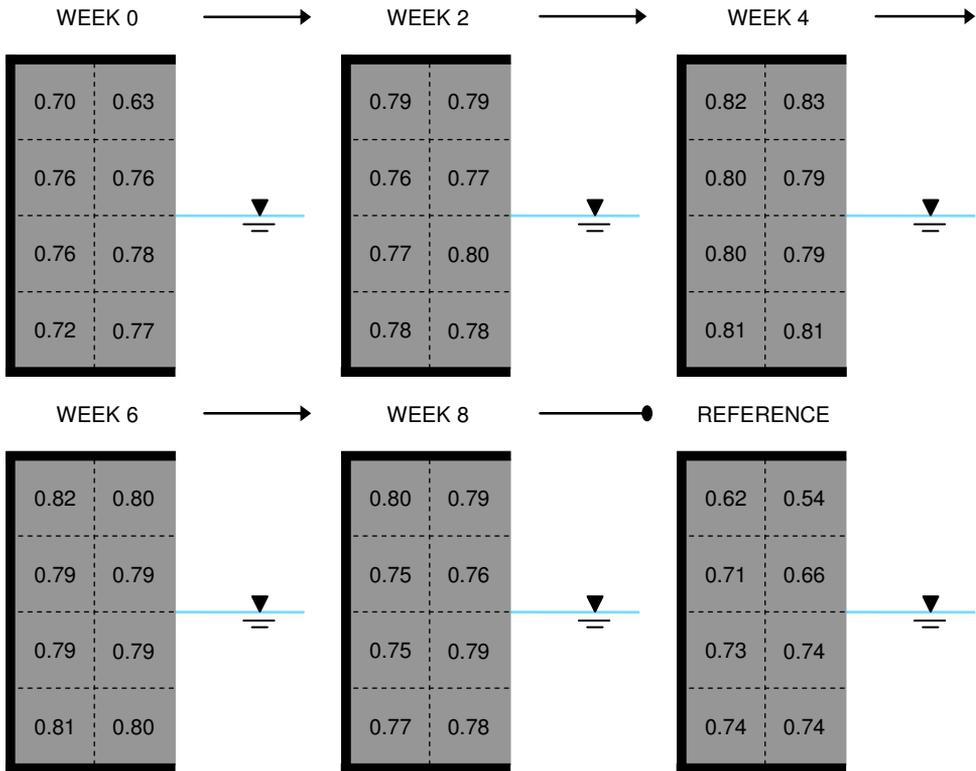
Figure 4-6. Degree of saturation of specimens (w/c 0.54) subjected to the frost test in comparison with a reference specimen kept at +10 °C during the test period.

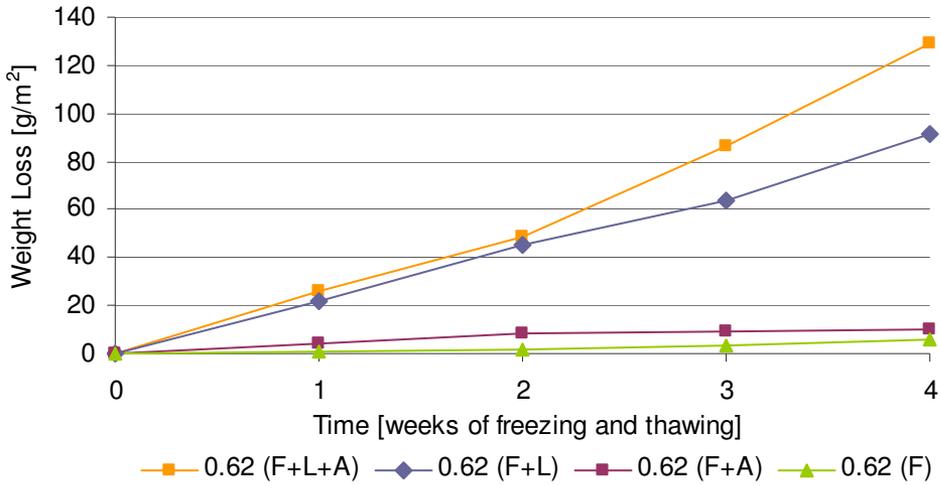
Figure 5-1. Accumulated weight loss of specimens with w/c-ratio 0.62 subjected to different combinations of the deterioration processes; frost action (F), leaching in water at pH 4 (L) and abrasion (A).

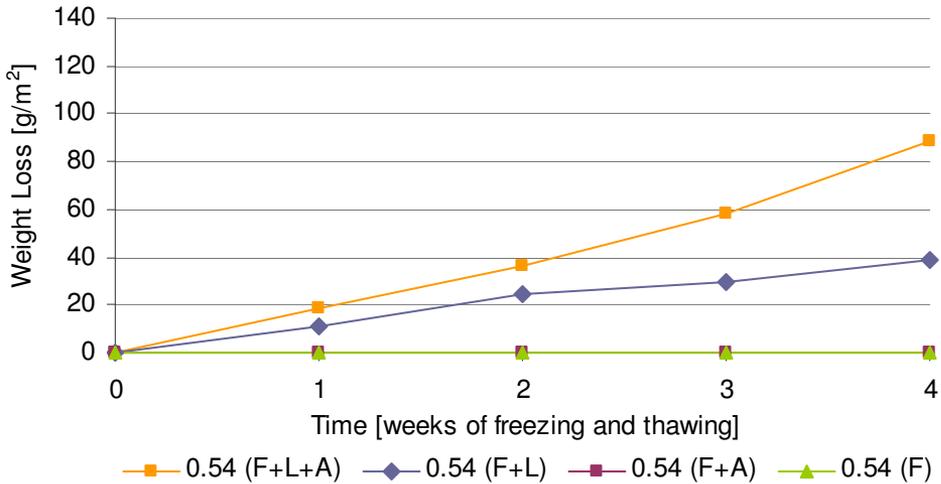
Figure 5-2. Accumulated weight loss of specimens with w/c-ratio 0.54 subjected to different combinations of the deterioration processes; frost action (F), leaching in water at pH 4 (L) and abrasion (A).

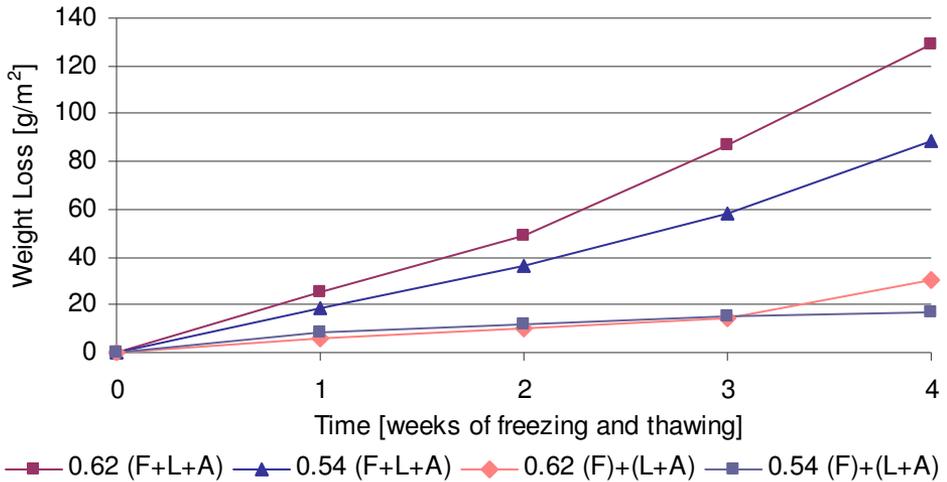
Figure 5-3. Accumulated weight loss of the specimens subjected to all three deterioration processes (F+L+A) compared to the sum of weight loss from the specimens subjected to frost action (F) together with the specimens subjected to leaching and abrasion (L+A). The differences in weight loss indicate synergy between the deterioration processes.

The accumulated weight loss of the specimens subjected to all three deterioration processes (F+L+A) was greater than the sum of the accumulated weight loss of the specimens subjected to frost action (F) together with the specimens subjected to leaching in water at pH 4 and abrasion (L+A). The accumulated weight loss of the specimens with w/c-ratio 0.54 and 0.62 is presented in Figure 5-3.

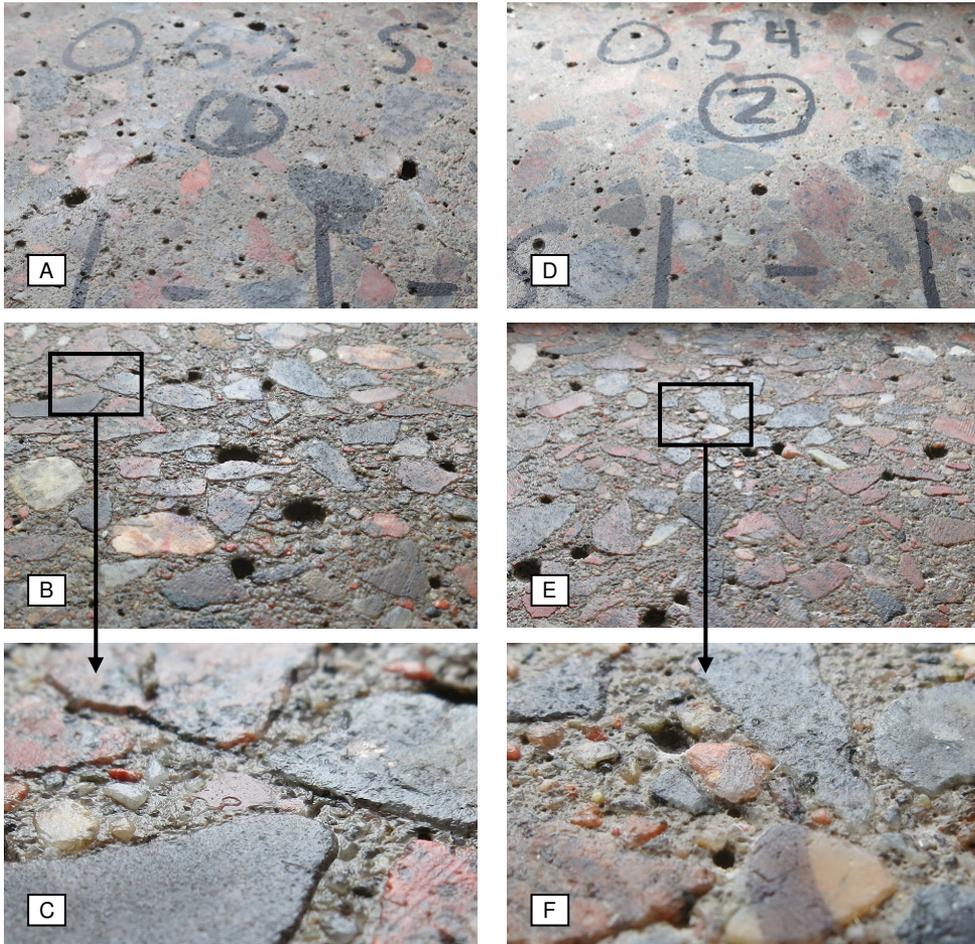
Figure 5-4. Cut surface (w/c 0.62) subjected to (F) in Fig. A compared with the cut surface subjected to (F+L+A) in Fig. B. Enlargement of the area marked by the rectangle in Fig. C. Cut surface (w/c 0.54) subjected to (F) in Fig. D compared with the cut surface subjected to (F+L+A) in Fig. E. Enlargement of the area marked by the rectangle in Fig. F.

The final appearance of the concrete surface of specimens subjected to different combinations of deterioration processes is shown in Figure 5-4. In accordance with the obtained weight losses, the surface of the specimens subjected to frost action (F) remained intact, whereas the surface of the specimens subjected to all three deterioration processes (F+L+A) was deteriorated. The amount of damage to the concrete surface was greater for concrete with w/c-ratio 0.62 in comparison with concrete with w/c-ratio 0.54.

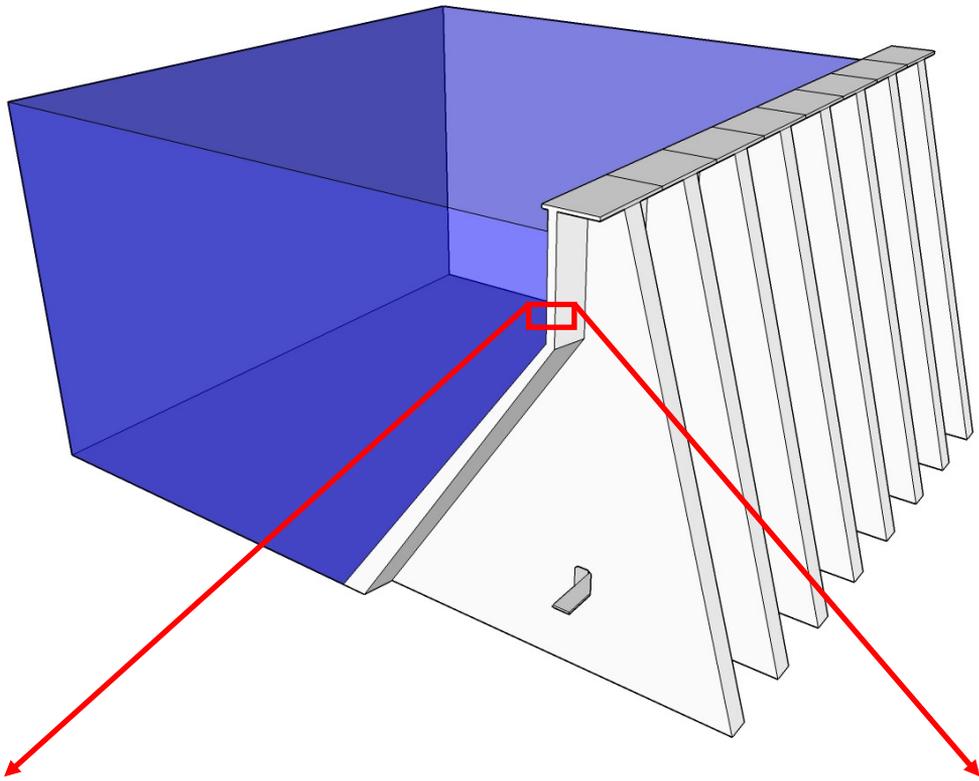
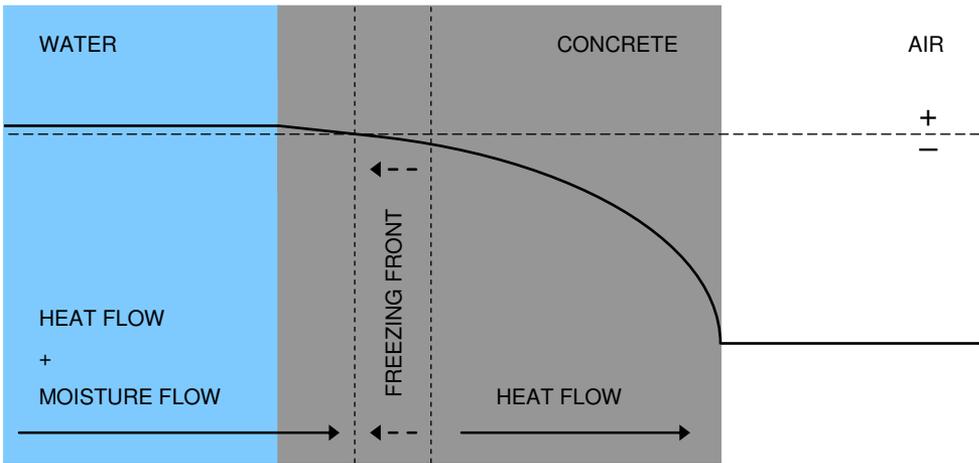
Figure 6-1. Cross-section of a flat slab in winter. Water temperature is slightly above freezing, whereas air temperature is below freezing. A freezing front moves towards the upstream side when heat is conducted towards the cold side, i.e. the downstream side. The risk of concrete spalling due to macroscopic ice lens growth is increased if balance between heat supply and heat loss is reached close to the upstream face where water supply is endless.

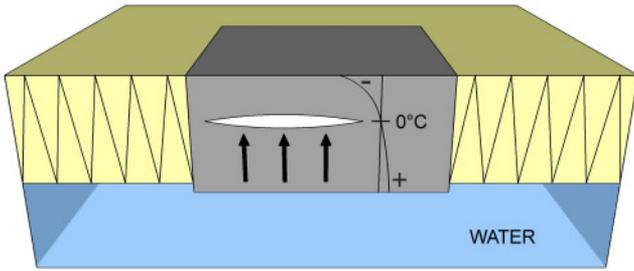
Figure 6-2. Test setup used to subject concrete specimens to freezing.

Eight concrete mixes with w/c-ratio between 0.5 and 1.4 were produced and three types of specimens were prepared; (1) specimens kept dry prior to freezing, (2) specimens saturated, subjected to freezing and then dried prior to freezing, and finally (3) specimens, with sheets of paper cast into the concrete, kept dry prior to freezing. The paper layers represent cavities or other imperfections in the concrete.

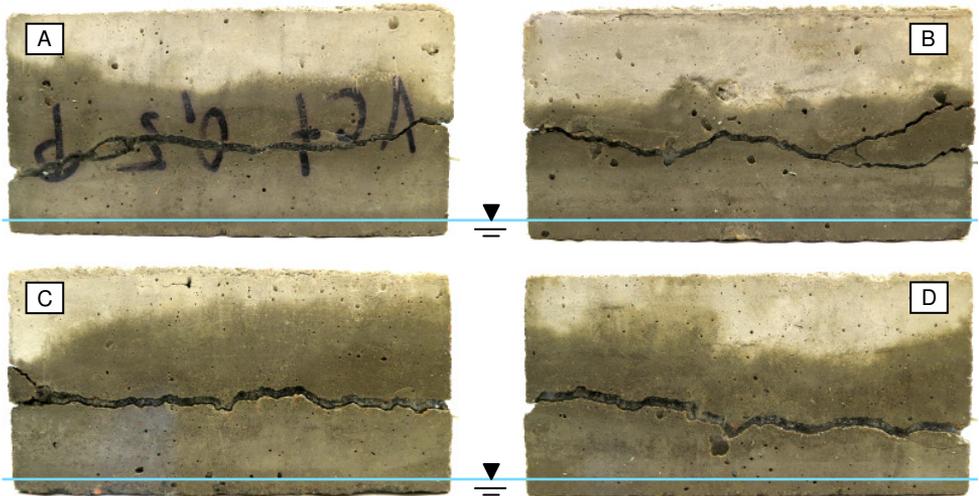
Figure 6-3. Ice lens visible in a specimen with sheets of paper cast into the concrete. All four sides of the specimen with w/c-ratio 0.5 are shown (A-D). The top surface of the specimen was subjected to freezing, while the bottom surface was in contact with unfrozen water.

According to the results obtained in this study, it was shown that macroscopic ice lens growth may occur in undamaged concrete subjected to unidirectional freezing if the w/c-ratio exceeds 0.8. Further, growth of macroscopic ice lenses in concrete damaged by frost action occurs within a few days regardless of the w/c-ratio of the concrete. Also in locations with cavities or other imperfections in the concrete, such as insufficient bond strength between concrete overlay and substrate, there is a risk of concrete spalling due to growth of macroscopic ice lenses. A macroscopic ice lens formed in a specimen with sheets of paper cast into the concrete is shown in Figure 6-3.

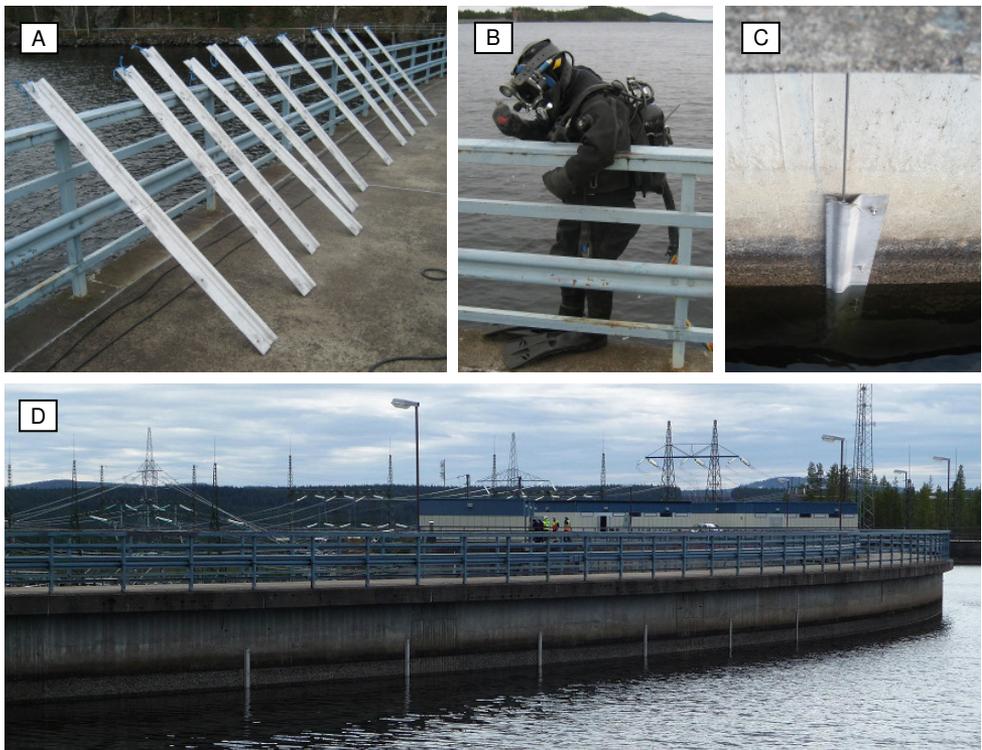
Figure 7-1. Stainless steel profiles (A) to be mounted by divers (B) on the upstream face of the arch dam (D) at Vargfors power plant. The top 0.5 m of the steel profiles are above the maximum water line (C).

Since the upstream face of arch dams is vertical, the arch dam at Vargfors power plant was chosen as the place to subject the specimens to hydrostatic pressure at the depths of 10, 20 and 30 m. The specimens were placed in baskets attached to wires hanging from the dam's crest. To protect the wires from the action of ice in winter, stainless steel profiles (2+2 m) were mounted on the upstream face of the dam in October 2011 (Figure 7-1). The wires run behind the steel profiles.

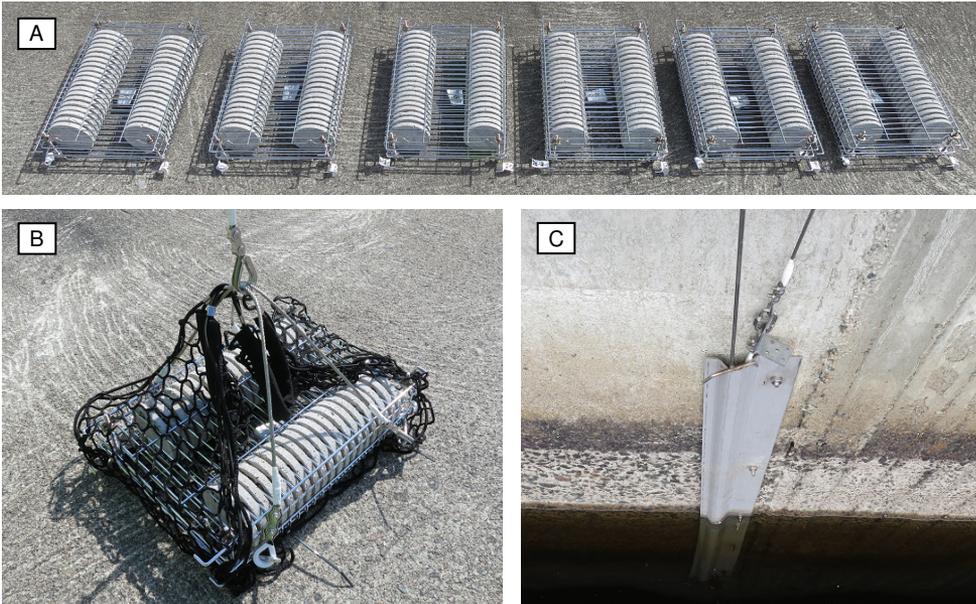
Figure 7-2. The specimens in baskets before submerging at the depths of 10, 20 and 30 m (A and B). Basket submerged with the wire running behind the steel profile (C).

Since the mounted steel profiles were not damaged by ice action during the winter 2011/2012, the specimens were submerged in June 2012 at the water depths of 10, 20 and 30 m (Figure 7-2). The specimens subjected to hydrostatic pressure at the depth of 0 m (atmospheric pressure) are placed in baskets stored in the laboratory.
