**Optimal protection of parking decks for new construction and renovation
Stage I-IV – Surface coating systems**

Ylva Edwards

12th December 2016

Project number: SBUF 13212

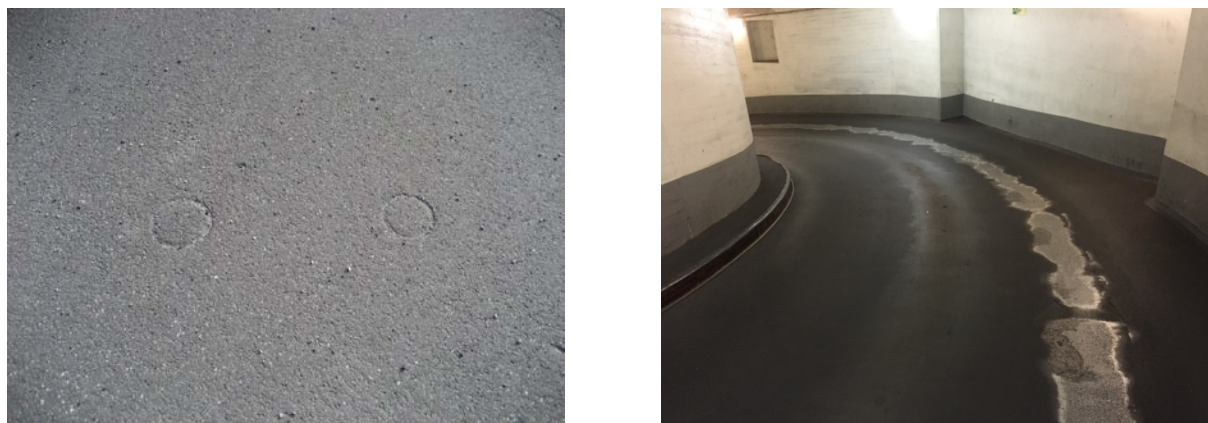
Figure 1.2 Example of damage in the form of sink marks for mastic asphalt (left hand side) and wear for plastic-based systems (right hand side)

Damage to plastic-based coating systems occurs mainly in the form of wear, cracking and adhesion loss. Sink marks may occur in mastic asphalt during prolonged heavy point loads (e.g. a motorcycle leaning on its support). Examples of damage to the mastic asphalt or plastic-based coating are shown in Figure 1.2. As for hard concrete of various kinds, concrete shrinkage may cause cracking.

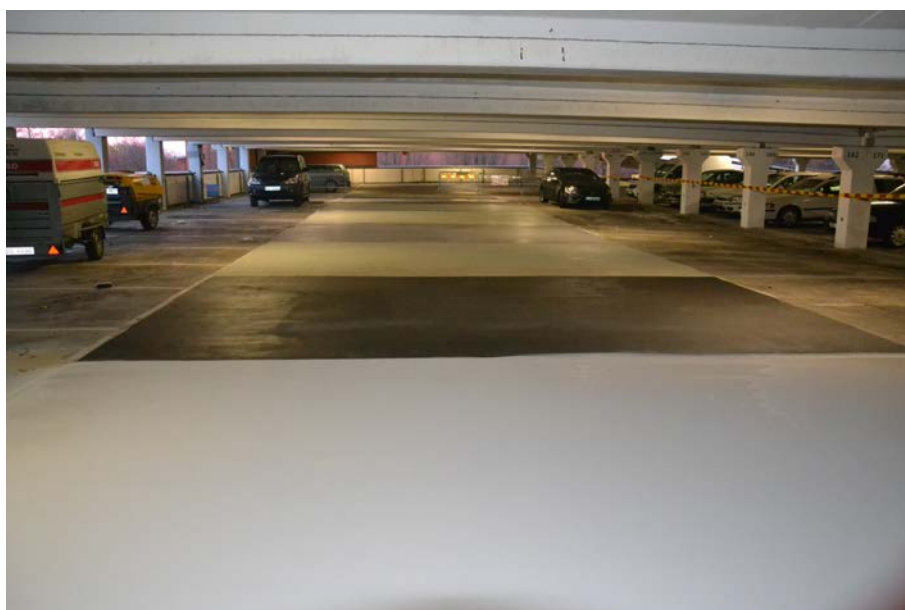
*Figure 2.1 Completed total test area with nine coating systems - Kville 2013
(Photo: Y Edwards)*

Product systems and producers / entrepreneurs who took part in the placing of test areas at the parking garage in Kville are shown in Table 2.1. Completed total test area is shown in Figure 2.1. The parking deck is located at a middle level in a cold garage for residential parking.

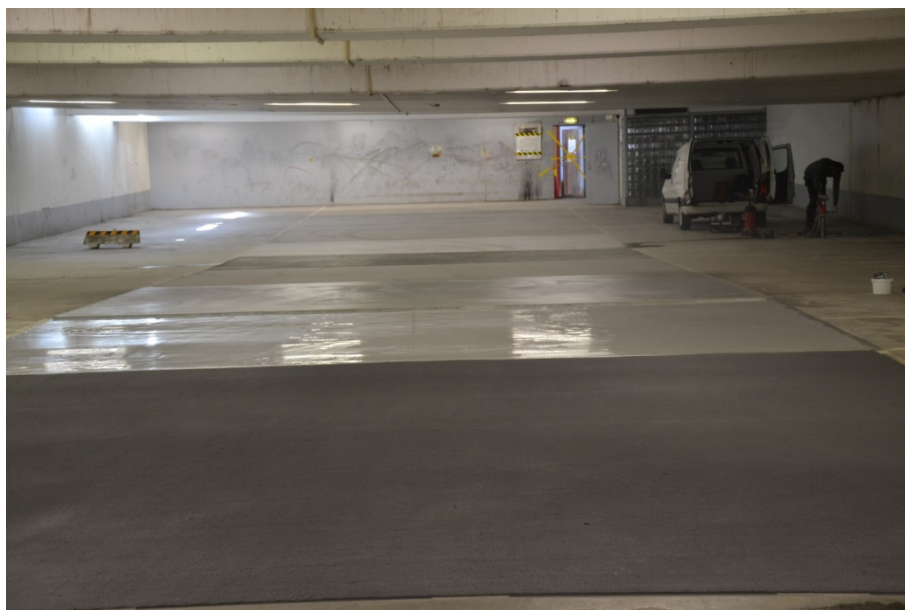
*Figure 2.2 Completed total test area with seven coating systems - Åkeshov 2014
(Photo: Y Edwards)*

Product systems and producers / entrepreneurs who took part in the placing of test areas at the parking garage in Åkeshov are shown in Table 2.2. Completed total test area is shown in Figure 2.2. The parking deck is at ground level close to the Åkeshov swimming hall facilities.

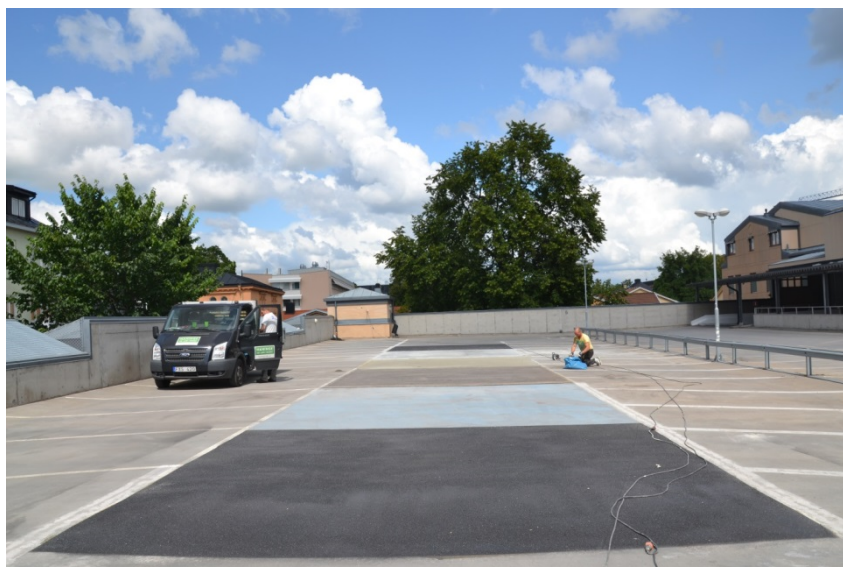
*Figure 2.3 Completed total test area with six coating systems - Baggen 2015
(Photo: Y Edwards)*

Product systems and producers / entrepreneurs who took part in the placing of test areas at the parking garage in Baggen are shown in Table 2.3. Completed total test area is shown in Figure 2.3. The parking deck is outdoors on level five. Baggen is located very centrally in Linköping with a total of 400 parking spaces.

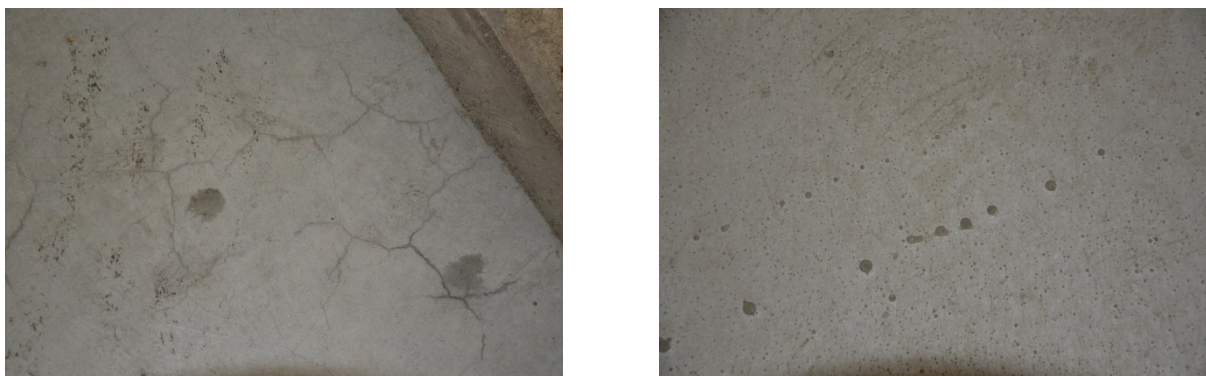
Figure 2.5 Crazing (left hand side) on test area 5 (2016) and pinholes (right hand side) on test area 6 (2015) (Photo: Y Edwards)

- no cracks, but noticeable crazing on test area 5 (Mastertop)
- no adhesion loss
- pits (a few on test area 1, 2 and 7) and lots of pinholes down to the concrete on test area 6 (epoxy Micopox)
- abrasion from studded tyres (marks on all test areas but most noticeably on test area 6 and least on test area 7)

Crazing and pinholes are shown in Figure 2.5. For more detailed information, please refer to previous SBUF reports in Swedish.

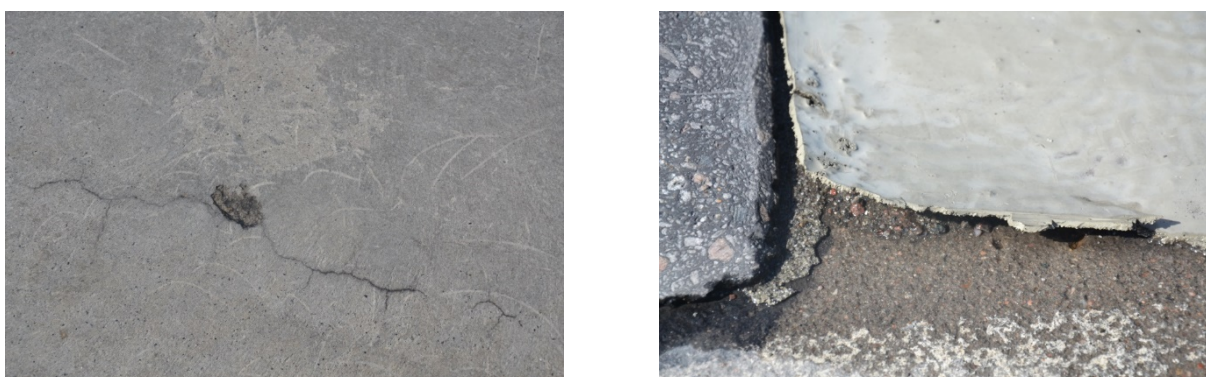
Figure 2.6 Crazing/minor damage (left hand side) on test area 5 (2016) and adhesion loss (right hand side) on test area 4 (2016) (Photo: Y Edwards)

- no cracks, but minor damage on test area 5 (Sikafloor-1+Corecrete)
- no adhesion loss except at the edge of test area 4 (Micorea HS)
- pits, a few and blistering on test area 4 (Micorea HS)
- abrasion from studded tyres (marks on all test areas)

Crazing and adhesion loss are shown in Figure 2.6. For more detailed information, please refer to previous SBUF reports in Swedish.

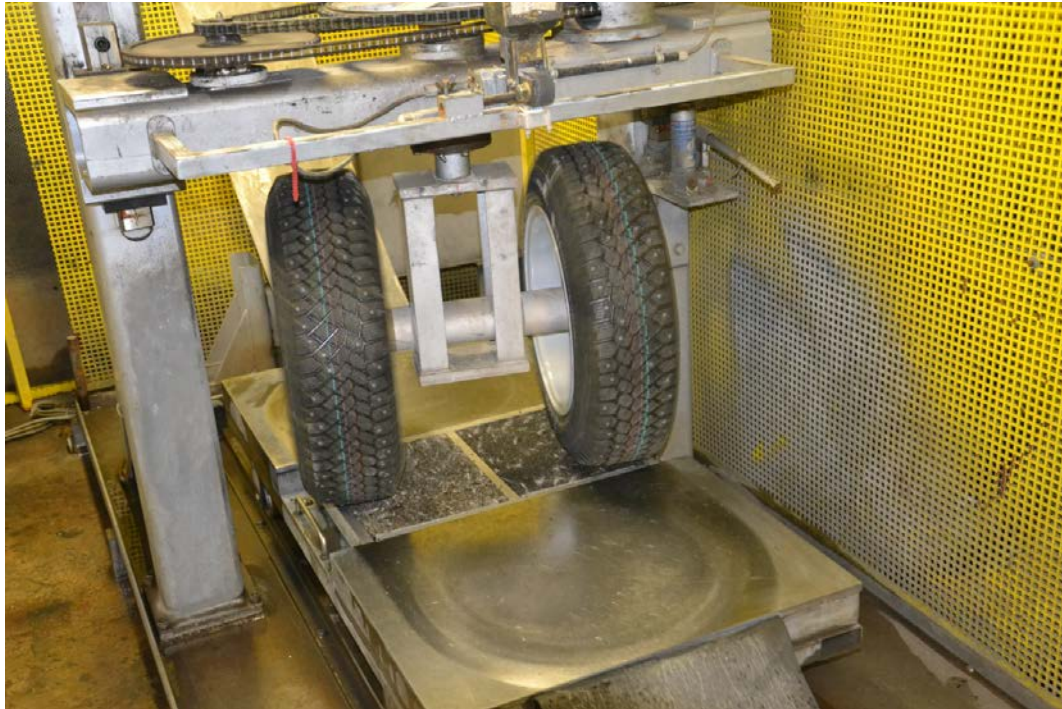
Figure 2.7 Equipment for testing Scuffing resistance, with studded tyres (Photo: Y Edwards)

The modification of the Resistance to Scuffing test method consists primarily of fitting the equipment with studded tyres for the simulation of traffic with studded tyres in Swedish / Scandinavian garages. The equipment is shown in Figure 2.7.

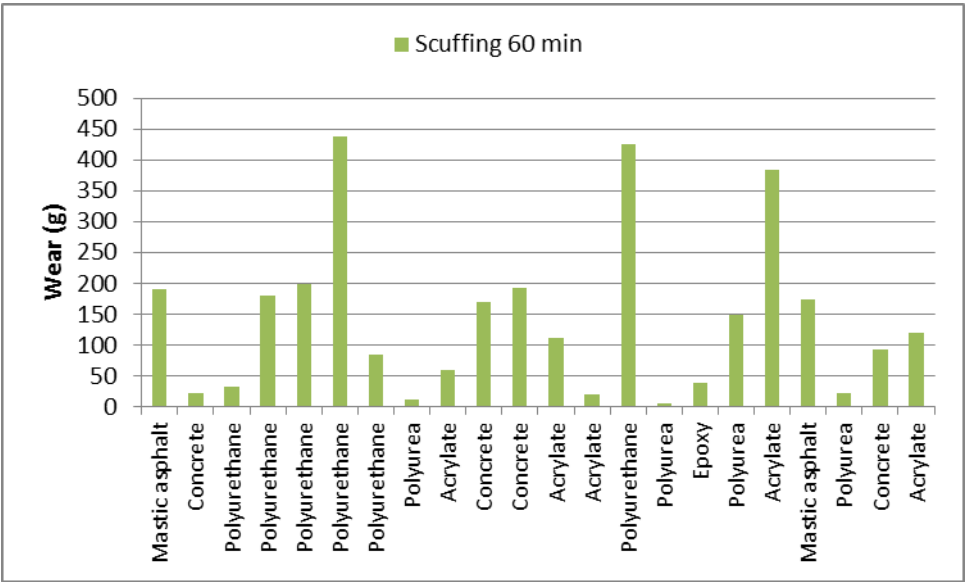
Figure 2.8 Scuffing – Wear expressed as weight loss in grams after 60 minutes (y-axis) at 20°C, all 22 systems. The systems are shown starting from the left in Kville (9 systems), Åkeshov (7 systems) and Baggen (6 systems)

Figure 2.8 shows results obtained in terms of weight loss according to the Scuffing resistance test method for all systems. Only the type of product (concrete, PGJA, polyurethane, polyurea, acrylic or epoxy) is specified in the diagrams. With concrete, two different types of

Testing with various long test periods shows that a period of 60 minutes is suitable for the method. Initially in the project, the test time was 210 minutes, but during the project it was reduced to 60 minutes in a draft method description as the wear after longer test periods also may include concrete wear, and thus be misleading.
